**City of Salem,  
Massachusetts**

December 2019

# Salem City Hall

## City of Salem ADA Transition Plan

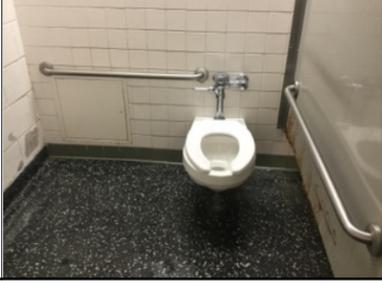
Side or rear grab bar < 42" long Non-compliant toilet paper dispenser	24.5" -	Provide a rear wall grab bar that is 42" long located 6" max. from the interior corner. Provide a toilet paper dispenser. Locate it so that it is between 14"- 19" above the floor and between 7"- 9" in front of the toilet. Ensure dispensers and other devices are not mounted above grab bars.	1	1204	\$1204

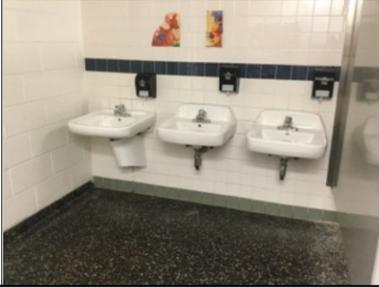
ID	Location	Floor	Room	Element	Type	Photo	Issues	Current Measure	Recommendations	Quantity	Price	Cost Estimation
<b>Lavatory</b>												
49	Girls' Toilet Room Near C027	1		Lavatory	N/A

Exposed plumbing underneath	-	Insulate or otherwise configure pipes to prevent contact, for at least one lavatory.	1	69	\$69
50	Kindergarten Toilet Room	1	D041	Lavatory	N/A

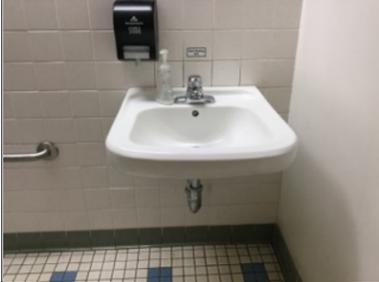
Exposed plumbing underneath	-	Insulate or otherwise configure pipes to prevent contact, for at least one lavatory.	1	69	\$69
51	Boys' and Girls' Toilet Rooms	B		Lavatory	N/A

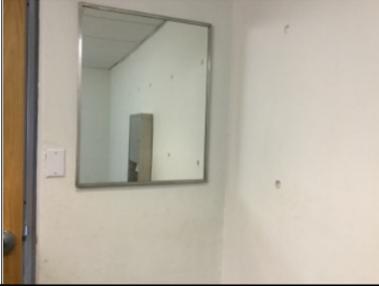
Mirror above lavatory w/reflective surface > 31"	46.5"	Lower mirror so that the bottom surface is at 31" above finished floor.	2	192	\$384
<b>Additional Access</b>												
<b>Drinking Fountains</b>												
52	Near C022	1		Drinking Fountains	Low

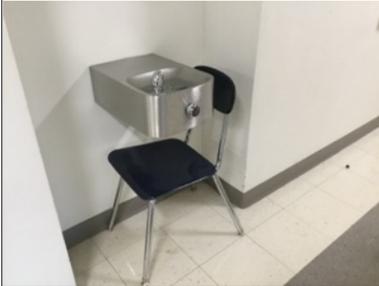
Clear floor space not provided No drinking fountain provided for standing users	- -	Provide a 30" by 48" clear floor space positioned for a forward approach by relocating chair. Provide an additional drinking fountain for standing users or install a Hi-Lo drinking fountain.	1	Labor 3021	\$3021

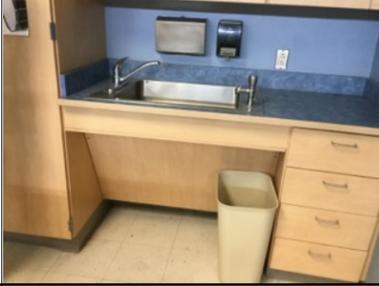
53	Music Room	B	A026	Drinking Fountains	N/A

Operable parts malfunctioning	-	Repair non-operable drinking fountain.	1	Labor	\$0

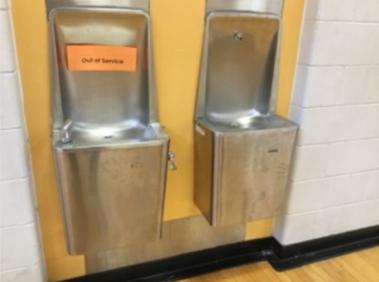
ID	Location	Floor	Room	Element	Type	Photo	Issues	Current Measure	Recommendations	Quantity	Price	Cost Estimation
54	Gym	B		Drinking Fountains	Hi-Lo

Operable parts malfunctioning No drinking fountain provided for seated users	- -	Repair or replace drinking fountain to ensure operable parts are working. Provide an additional drinking fountain for seated users or install a Hi-Lo drinking fountain.	1	Labor 3021	\$3021
55	Near Gym	B		Drinking Fountains	Low

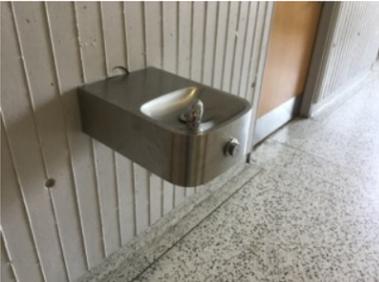
No drinking fountain provided for standing users	-	Provide an additional drinking fountain for standing users.	1	3021	\$3021
56	Hallway D	1		Drinking Fountains	Low

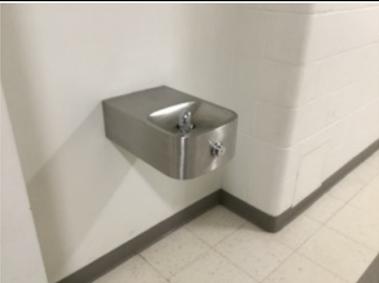
No drinking fountain provided for standing users	-	Provide an additional drinking fountain for standing users.	1	3021	\$3021
<b>Sink</b>												
57	Psychologist's Office	1	B032	Sink	Other

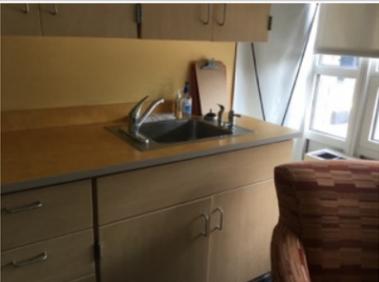
Clear floor space not provided at sink Toe and knee clearances not provided	- -	Provide a 30" by 48" clear floor space positioned for a forward approach. Ensure there is a 27" knee clearance positioned for a forward approach by relocating chair.	1	1265	\$1265

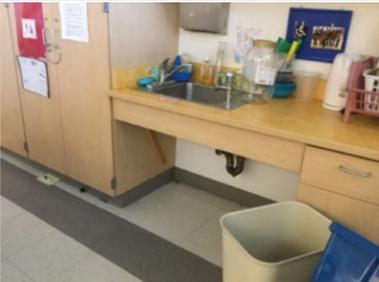
<b>Sinks for Children's Use</b>												
58	OT/PT Room	1		Sinks for Children's Use	Classroom

Exposed plumbing underneath Knee or toe clearance not provided	- 23.75"	Ensure there is a 25" knee clearance positioned for a forward approach. Insulate or otherwise configure pipes at sink.	1	1334	\$1334

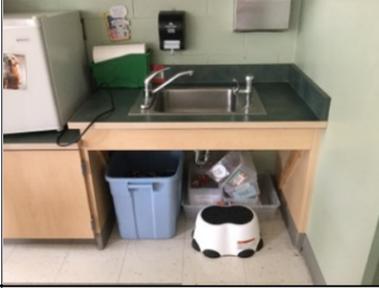
ID	Location	Floor	Room	Element	Type	Photo	Issues	Current Measure	Recommendations	Quantity	Price	Cost Estimation
59	Classroom	1	D025	Sinks for Children's Use	Classroom

Exposed plumbing underneath Knee or toe clearance not provided	- 23"	Insulate or otherwise configure pipes to prevent contact, for at least one sink. Remove clutter under sink.	1	69	\$69
60	Classrooms Throughout School	1, 2		Sinks for Children's Use	Classroom

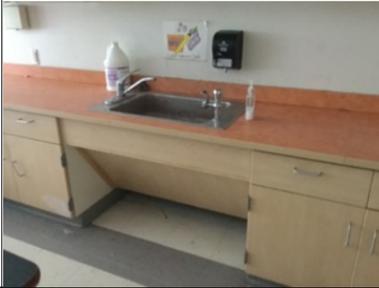
Knee or toe clearance not provided	23"	Provide at least one sink per grade with 25" knee and toe clearance positioned for a forward approach.	6	1265	\$7590
61	STEM Room	1	C009	Sinks for Children's Use	Classroom

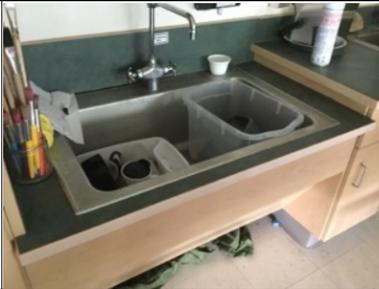
Knee or toe clearance not provided	-	Relocate clutter under sink.	1	Labor	\$0
<b>Play and Sport Areas</b>												
<b>Play Areas</b>												
62	Playground			Play Areas	N/A

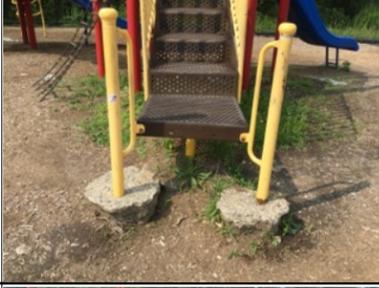
Accessible route not provided to ground level play components No compliant transfer system Surface not stable, firm, and slip-resistant	- - -	Ensure an accessible route is provided to one of each type of ground level play component. Alteration to the transfer system might be technically infeasible. Repair surface and ensure that surface is firm, stable and slip-resistant.  (Cost based on 280' of 5' wide poured in place rubber to play components.)	1	29400	\$29400

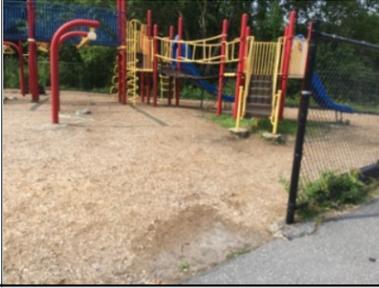
63	Playground	Ext.		Play Areas	N/A

Not connected to an accessible route	-	Provide an accessible route to and around play areas.  (Cost based on 300' by 4' wide asphalt route around playground.)	1	7650	\$7650

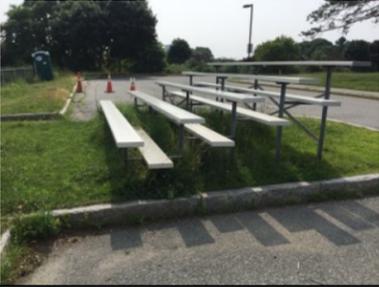
ID	Location	Floor	Room	Element	Type	Photo	Issues	Current Measure	Recommendations	Quantity	Price	Cost Estimation
<b>Field</b>												
64	Baseball Field	Ext.		Field	Baseball

Accessible spaces not provided at sidelines seating Not connected to an accessible route	-	Provide a 36" x 48" clear floor space at sidelines seating. Ensure fan seating is connected to an accessible route.  (Cost based on a wheelchair space and 35' by 4' wide stone dust route from curb ramp at baseball field renovation to the accessible space.)	1	918	\$918
65	Baseball Field	Ext.		Field	Baseball

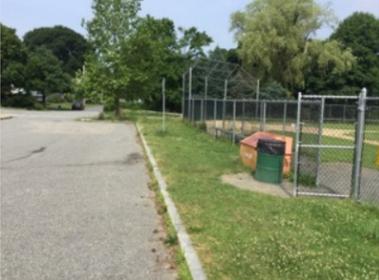
Field not connected to an accessible route	-	Ensure edge of baseball field is connected to an accessible route.  (Cost based on one curb ramp, striping at entrance to ensure people do not park in the accessible route, and 60' by 4' wide stone dust route to edge of field as well as maintaining the route to the dugouts.)	1	4465	\$4465

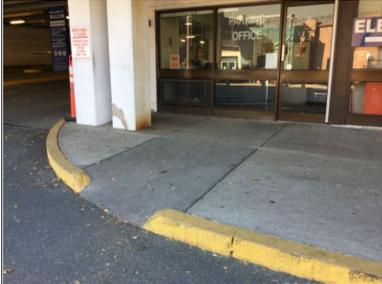
ID	Location	Floor	Room	Element	Type	Photo	Issues	Current Measure	Recommendations	Quantity	Price	Cost Estimation
<b>Approach and Entrance</b>												
<b>Curb Ramp</b>												
1	Towards Parking Office	Ext.		Curb Ramp	N/A

Running slope > 1:12 (8.33%)	18%	Reduce running slope to be no steeper than 1:12 (8.33%).	1	2800	\$2800
<b>Off-Street Parking Lot or Garage</b>												
2	Accessible Parking Spaces	1		Off-Street Parking Lot or Garage	Visitor

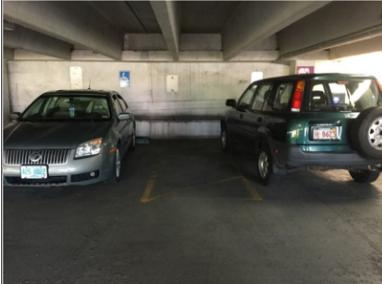
Sign does not have the designation "Van Accessible"	-	Add the designation "Van Accessible" to the signs located at the van accessible spaces.	4	375	\$1500
3	Towards Elevator	2A		Off-Street Parking Lot or Garage	Visitor

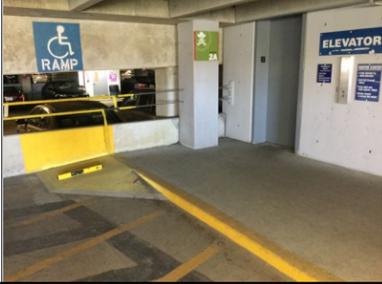
Running slope > 1:12 (8.33%) Curb ramp flares > 1:10 (10%)	8.9% 11%	Reduce running slope to be no steeper than 1:12 (8.33%). Reduce slope at curb ramp flares to be no steeper than 1:10 (10%).	1	2800	\$2800
4	Accessible Parking Spaces	2A		Off-Street Parking Lot or Garage	Visitor

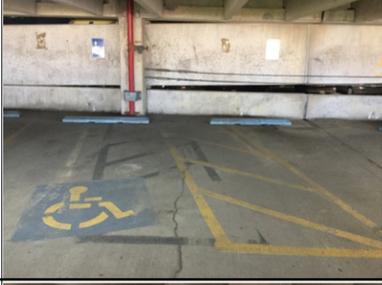
Access aisle < 96" wide at van space	61"	Provide a marked access aisle that is at least 96" wide.	1	338	\$338

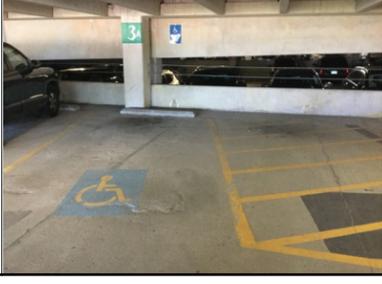
5	Accessible Parking Space	3A		Off-Street Parking Lot or Garage	Visitor

Sign does not have the designation "Van Accessible"	-	Add the designation "Van Accessible" to the sign located at the van accessible space.	1	375	\$375

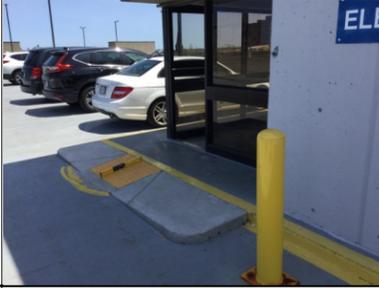
ID	Location	Floor	Room	Element	Type	Photo	Issues	Current Measure	Recommendations	Quantity	Price	Cost Estimation
6	Towards Elevators	4		Off-Street Parking Lot or Garage	Visitor

Running slope > 1:12 (8.33%)	15.6%	Reduce running slope to be no steeper than 1:12 (8.33%).	1	2800	\$2800
7	Accessible Parking Spaces	4		Off-Street Parking Lot or Garage	Visitor

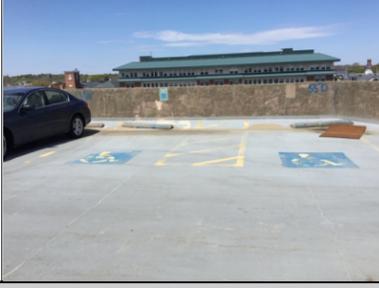
Sign not provided	-	Provide a sign with the bottom of the sign 60" min. above the ground and the top 96" max. above the ground.	1	375	\$375
<b>Entrance</b>												
8	Towards Elevators	R		Entrance	N/A

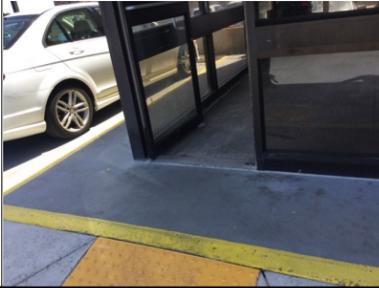
Threshold > 1/2" high	1"	Alter threshold to be 1/2" high max.	1	113	\$113
<b>Access to Goods and Services</b>												
<b>Elevator</b>												
9	Near Pay Machines	1A		Elevator	Interior

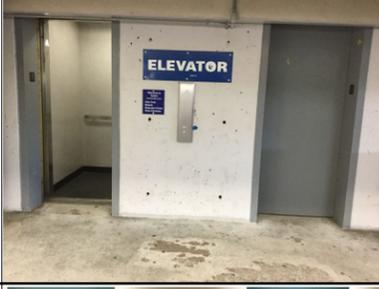
Elevator car dimension not compliant	-	Repair may require major renovation at elevator cab and hoistway and may not be practical until system is replaced.	1	-	\$0

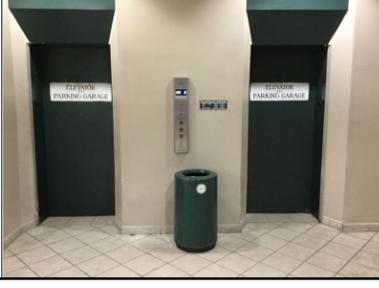
10	Lobby - Mall Level	M		Elevator	Interior

Clear floor space not provided at call buttons	-	Relocate trash can to maintain the clear floor space at call buttons.	1	-	\$0

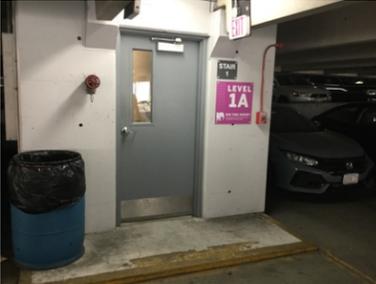
ID	Location	Floor	Room	Element	Type	Photo	Issues	Current Measure	Recommendations	Quantity	Price	Cost Estimation
<b>Signage</b>												
11	Stair #1	1A		Signage	Egress

Raised characters not provided Braille not provided Sign not located on the latch side of the door	- - -	Provide text with raised characters duplicated in braille. Locate sign alongside the door on the latch side.	2	174	\$348
12	Stair #1	2A		Signage	Egress

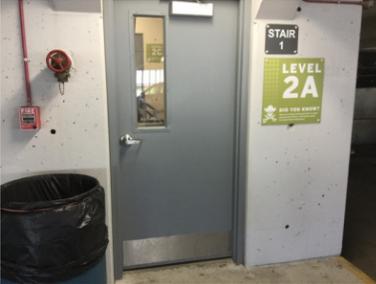
Raised characters not provided Braille not provided Sign not located on the latch side of the door	- - -	Provide text with raised characters duplicated in braille. Locate sign alongside the door on the latch side.	1	174	\$174
13	Stair #3	2A		Signage	Egress

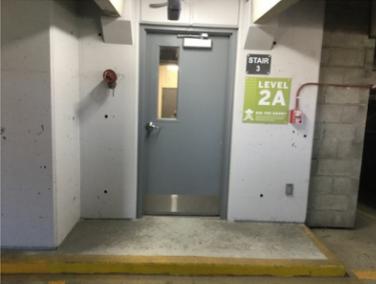
Raised characters not provided Braille not provided Sign not located on the latch side of the door	- - -	Provide text with raised characters duplicated in braille.- Locate sign alongside the door on the latch side.	2	174	\$348

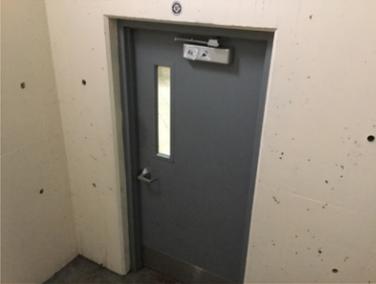
14	Stair #4	2C		Signage	Egress

Not provided	-	Provide text with raised characters duplicated in braille. Locate signage alongside the door on the latch side.	1	174	\$174
15	Stair #3	2C		Signage	Egress

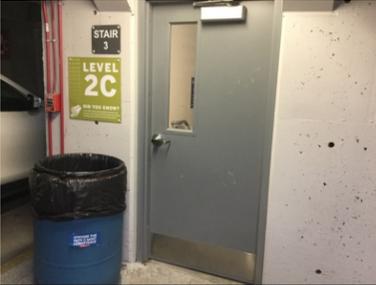
Raised characters not provided Braille not provided	- -	Provide text with raised characters duplicated in braille. Relocate trash can to ensure an 18" by 18" clear floor space is provided in front of the sign.	2	116	\$232

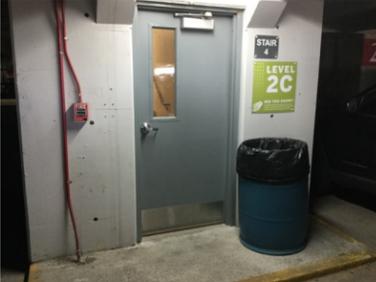
ID	Location	Floor	Room	Element	Type	Photo	Issues	Current Measure	Recommendations	Quantity	Price	Cost Estimation
16	Stair #4	2C		Signage	Egress

<p>Raised characters not provided Braille not provided Sign not located on the latch side of the door</p>	<ul style="list-style-type: none"> <li>-</li> <li>-</li> <li>-</li> </ul>	<p>Provide text with raised characters duplicated in braille. Locate sign at permanent rooms alongside the door on the latch side. Relocate trash can to ensure an 18" by 18" clear floor space is provided in front of the sign.</p>	2	174	<b>\$348</b>
17	Stair #1	3A		Signage	Egress

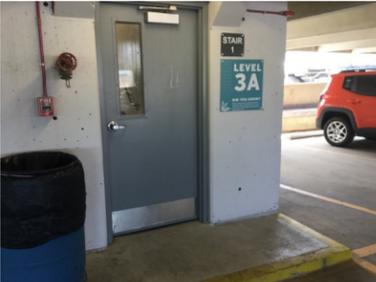
<p>Raised characters not provided Braille not provided Sign not located on the latch side of the door</p>	<ul style="list-style-type: none"> <li>-</li> <li>-</li> <li>-</li> </ul>	<p>Provide text with raised characters duplicated in braille. Locate sign alongside the door on the latch side.</p>	2	174

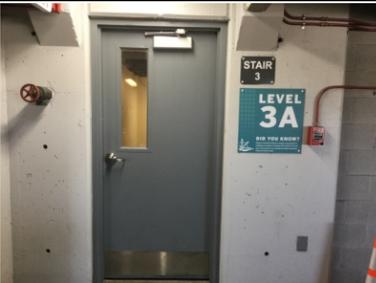
18	Stair #3	3A		Signage	Egress

<p>Raised characters not provided Braille not provided Sign not located on the latch side of the door</p>	<ul style="list-style-type: none"> <li>-</li> <li>-</li> <li>-</li> </ul>	<p>Provide text with raised characters duplicated in braille. Locate sign alongside the door on the latch side.</p>	2	174	
19	Stair #2	3B		Signage	Egress

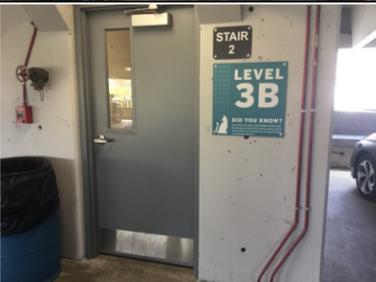
<p>Raised characters not provided Braille not provided Sign not located on the latch side of the door</p>	<ul style="list-style-type: none"> <li>-</li> <li>-</li> <li>-</li> </ul>	<p>Provide text with raised characters duplicated in braille. Locate sign alongside the door on the latch side.</p>	2	174	
20	Stair #4	3B		Signage	Egress

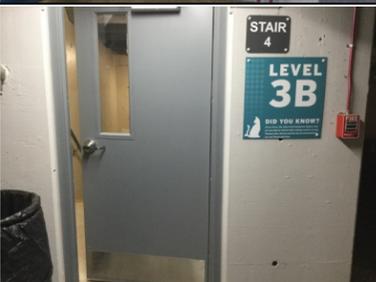
<p>Raised characters not provided Braille not provided Sign not located on the latch side of the door</p>	<ul style="list-style-type: none"> <li>-</li> <li>-</li> <li>-</li> </ul>	<p>Provide text with raised characters duplicated in braille. Locate sign alongside the door on the latch side.</p>	2	174

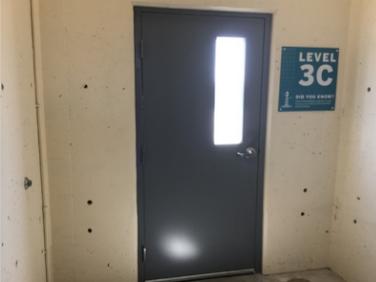
ID	Location	Floor	Room	Element	Type	Photo	Issues	Current Measure	Recommendations	Quantity	Price	Cost Estimation
21	Stair #3	3C		Signage	Egress

Raised characters not provided Braille not provided	- -	Provide text with raised characters duplicated in braille.	2	174	<b>\$348</b>
22	Stair #1	3C		Signage	Egress

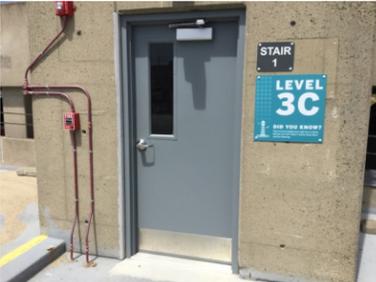
Raised characters not provided Braille not provided Sign not located on the latch side of the door	- - -	Provide text with raised characters duplicated in braille. Locate sign alongside the door on the latch side.	2	174	
23	Stair #2	3C		Signage	Egress

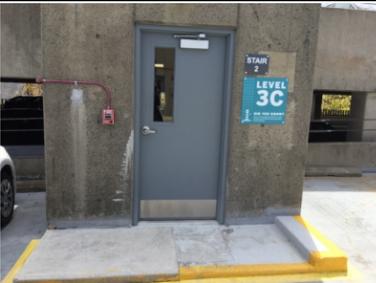
Raised characters not provided Braille not provided Sign not located on the latch side of the door	- - -	Provide text with raised characters duplicated in braille. Locate sign alongside the door on the latch side.	2	174	
24	Stair #4	3C		Signage	Egress

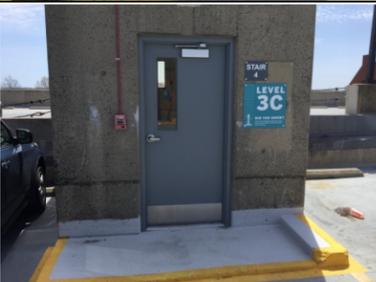
Raised characters not provided Braille not provided Sign not located on the latch side of the door	- - -	Provide text with raised characters duplicated in braille. Locate sign alongside the door on the latch side.	2	174

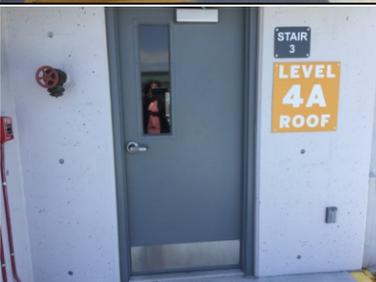
25	Stair #3	4A		Signage	Egress

Raised characters not provided Braille not provided Sign not located on the latch side of the door	- - -	Provide text with raised characters duplicated in braille. Locate sign alongside the door on the latch side.	2	174

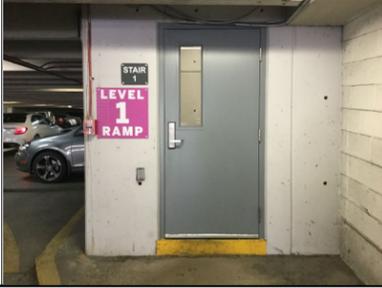
ID	Location	Floor	Room	Element	Type	Photo	Issues	Current Measure	Recommendations	Quantity	Price	Cost Estimation
26	Stair #1	Ext.		Signage	Designation

Raised characters not provided Braille not provided	- -	Provide text with raised characters duplicated in braille. Provide braille.	2	174	\$348

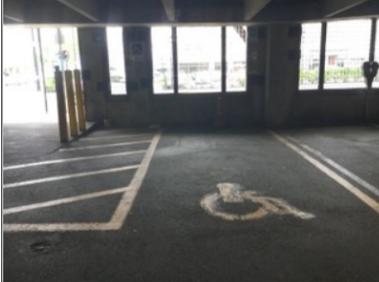
ID	Location	Floor	Room	Element	Type	Photo	Issues	Current Measure	Recommendations	Quantity	Price	Cost Estimation
<b>Approach and Entrance</b>												
<b>Off-Street Parking Lot or Garage</b>												
1	First Floor Accessible Parking	1		Off-Street Parking Lot or Garage	N/A

Vehicle space < 132" wide at van space Sign does not have the designation "Van Accessible"	93.5" -	Provide a van accessible space that is at least 132" wide with a marked access aisle at least 60" wide. Add the designation "Van Accessible" to the sign located at the van accessible space.  (Cost based on restriping and a sign.)	1	600	\$600
2	Fourth Floor Accessible Parking by Elevator	4		Off-Street Parking Lot or Garage	N/A

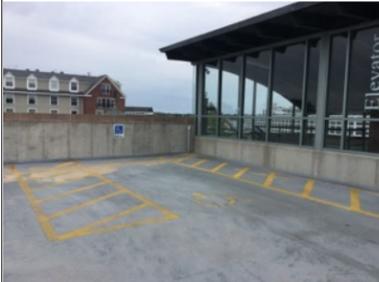
Vehicle space < 132" wide at van space Sign does not have the designation "Van Accessible" Sign bottom < 60" above finished grade	- - -	Provide a van accessible space that is at least 132" wide with a marked access aisle at least 60" wide. Add the designation "Van Accessible" to the sign located at the van accessible space. Locate sign with the bottom of the sign 60" min. and 96" max. above the ground.  (Cost based on restriping and a sign.)	1	600	\$600

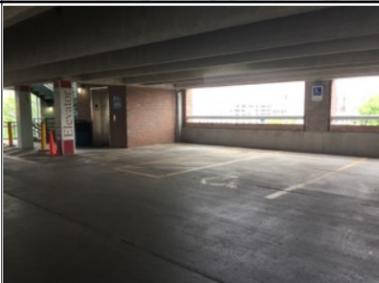
3	Third Floor Accessible Parking by Elevator	3		Off-Street Parking Lot or Garage	N/A

Sign not provided	-	Provide a sign with the International Symbol of Accessibility (ISA) with the bottom of the sign 60" min. above the ground and the top 96" max. above the ground.	1	375	\$375
4	Second Floor Accessible Parking by Elevator	2		Off-Street Parking Lot or Garage	N/A

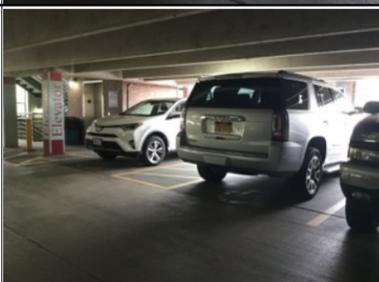
Sign not provided	-	Provide a sign with the International Symbol of Accessibility (ISA) with the bottom of the sign 60" min. above the ground and the top 96" max. above the ground.	1	375	\$375
<b>Access to Goods and Services</b>

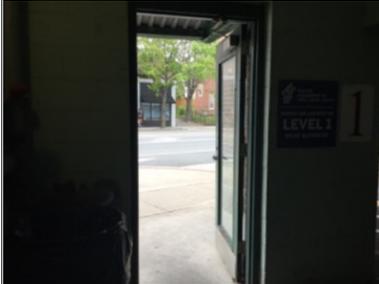
ID	Location	Floor	Room	Element	Type	Photo	Issues	Current Measure	Recommendations	Quantity	Price	Cost Estimation
<b>Means of Egress</b>												
5	First Floor Egress	1		Means of Egress	N/A

<p>Illuminated exit sign not provided</p> <p>Illuminated International Symbol of Accessibility not provided</p> <p>Tactile exit sign not provided</p>	- -	<p>Ensure illuminated exit signs are provided at exits and exit doors. Include an illuminated International Symbol of Accessibility (ISA) on the illuminated exit sign.</p> <p>Ensure tactile exit signs with raised characters and braille are provided at exit doors. Mount signs between 48"- 60" above finished floor located on the latch side of the door.</p>	1	474	\$474
6	Fourth Floor by Elevator	4		Means of Egress	N/A

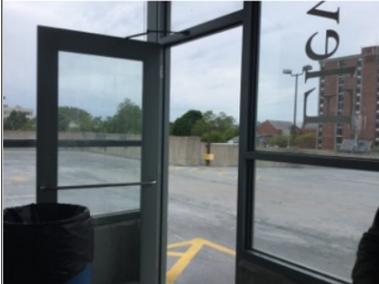
Tactile exit sign not provided	-	<p>Ensure tactile exit signs with raised characters and braille are provided at exit doors. Mount signs between 48"- 60" above finished floor located on the latch side of the door.</p>	1	174	\$174

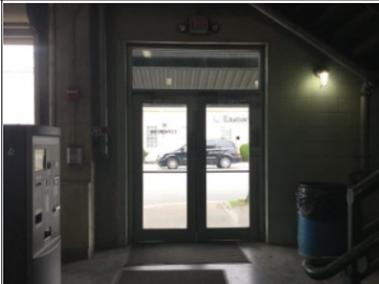
7	First Floor	1		Means of Egress	N/A

<p>Tactile exit sign not provided</p> <p>Illuminated sign lacks the International Symbol of Accessibility</p> <p>Mat not securely attached</p>	-	<p>Ensure tactile exit signs with raised characters and braille are provided at exit doors. Mount signs between 48"- 60" above finished floor located on the latch side of the door.</p> <p>Provide an illuminated International Symbol of Accessibility (ISA) at the illuminated exit sign.</p> <p>Securely attach walk-off mat.</p>	1	324	\$324
8	Fourth Floor by Elevator	4		Means of Egress	N/A

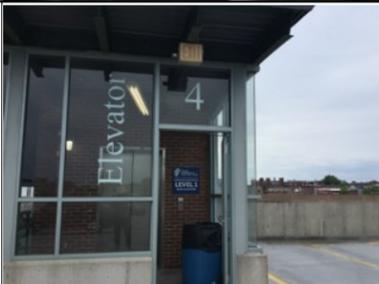
<p>Tactile exit sign not provided</p> <p>Illuminated sign lacks the International Symbol of Accessibility</p>	-	<p>Ensure tactile exit signs with raised characters and braille are provided at exit doors. Mount signs between 48"- 60" above finished floor located on the latch side of the door.</p> <p>Provide an illuminated International Symbol of Accessibility (ISA) at the illuminated exit sign.</p>	1	324	\$324

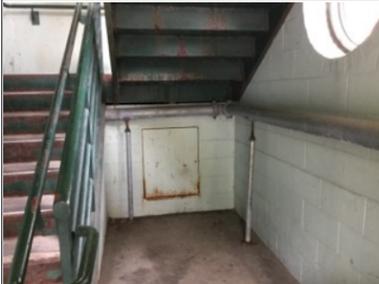
<b>Interior Access Route</b>												
9	Floor 1 Stairwell	1		Interior Access Route	N/A

Obstructed by protruding objects	-	<p>Provide a cane-detectable barrier.</p> <p>(Cost based on a 6"x4' pipe rail under stairs.)</p>	1	720	\$720

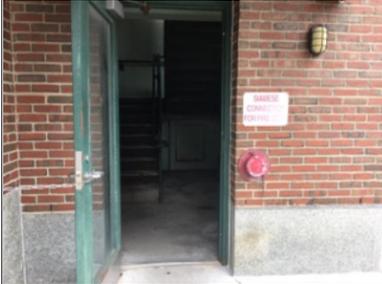
ID	Location	Floor	Room	Element	Type	Photo	Issues	Current Measure	Recommendations	Quantity	Price	Cost Estimation
<b>Doors, Doorways, &amp; Gates</b>												
10	Entrance on Derby St	1		Doors, Doorways, & Gates	Other

Threshold > 1/2" high	1"	Alter threshold to be 1/2" high max.  (Threshold seemed to be not firm and deteriorated.)	1	113	\$113
