# Phase II Report for the South River Drainage Improvement Project

Project No: 218953.02  
April 2011

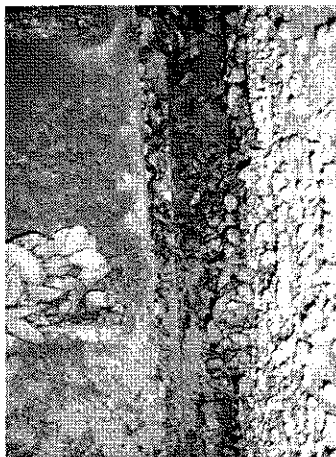
**Photo 3 – South Tide Gate Spall:** A small concrete spall was present at the north edge of the south tide gate. The surrounding concrete appeared to be sound.

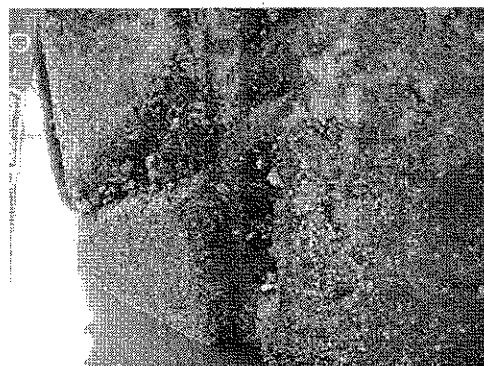
**Photo 6 – Concrete Fines Washout at South Tide Gate:** At several locations the fine aggregate and the mortar had been washed out of the concrete matrix leaving the coarse aggregate exposed.

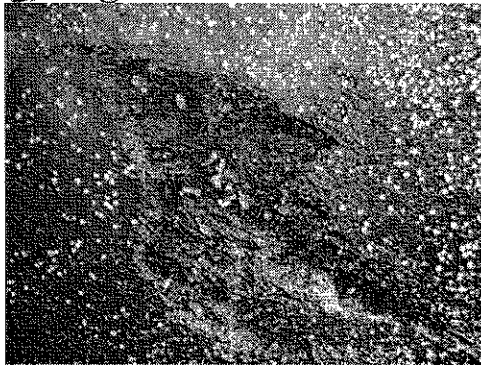
**Photo 7 – Concrete Fines Washout at North Tide Gate**

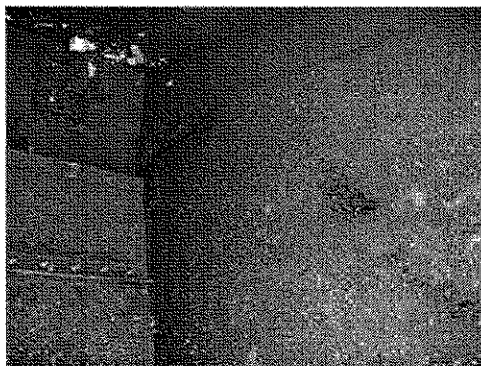
**Photo 8 – Concrete Fines Washout at North Tide Gate**

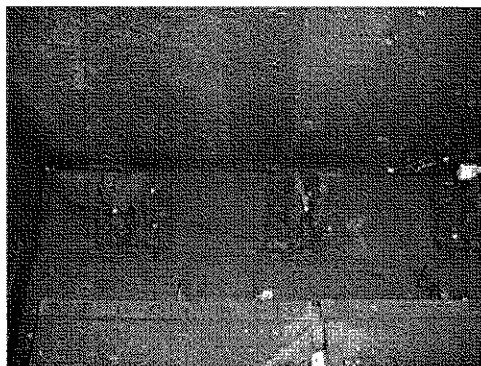
**Photo 9 – Crack on Header Above North Tide Gate:** A crack in the concrete starts at the upper left corner of the header and extends down and to the right looking at Photo #9.

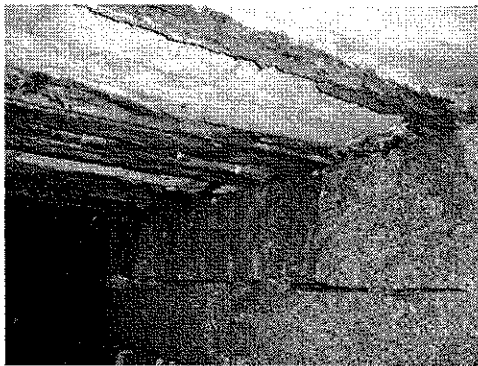
**Photo 21 – Corroding Embedded Steel at Station 14+60:** Although the steel sections have lost significant area due to corrosion the concrete infill appears to be sound.

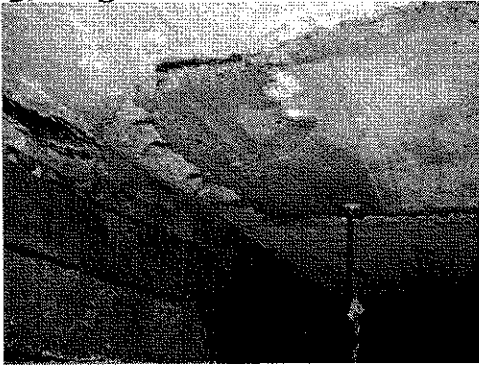
Beyond the timber beams the roof slab is framed with reinforced concrete beams which are cast integrally with the roof slab. Most of the concrete beams are in fair to good condition however several had exposed reinforcing bars which are actively corroding. Many of the exposed reinforcing bars did not appear to have adequate concrete cover when the beams were originally cast. The lack of concrete cover may be the reason for the corrosion of the bars. One of the concrete beams in particular contained a deep split along the bottom surface. This particular beam sounded hollow when knocked on with a hammer which indicates a failure within the concrete.

**Photo 23 – Exposed Rebar at Station 3+10**
