# Forest River Park Pool Evaluation-DRAFT

City of Salem, Massachusetts  
93 Washington Street  
Salem, MA 01970

JUNE 2017

## **ENGINEER'S REPORT**

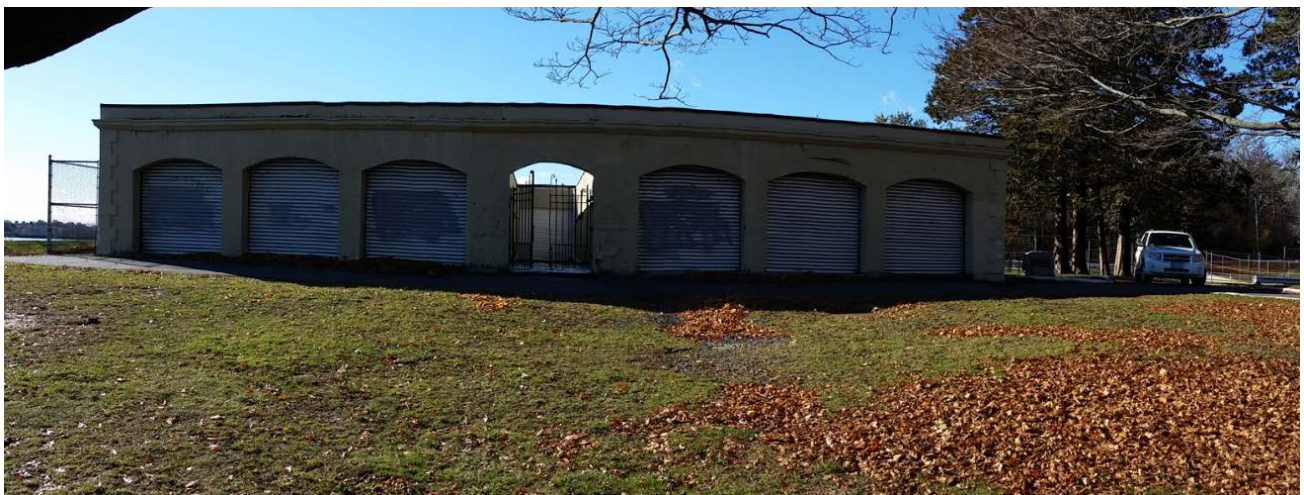
Figure A: Front of Bath House Building

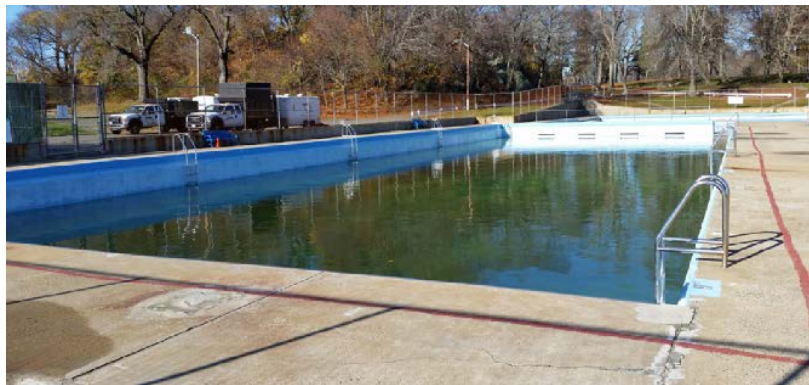
Figure C: Photo of Current Lap Pool

The main pool layout configuration is split into two separate portions. The long lap lane portion of the pool is approximately 65-feet wide by 187-feet long with depths from 3.0-feet on the north side of the lap lanes, sloping to depth of 9-feet in the south end of the pool. The pool

is used for general swim recreation, swim lessons, lap swim and is not used for competition swimming. A photo of the lap pool area can be seen in Figure C above.

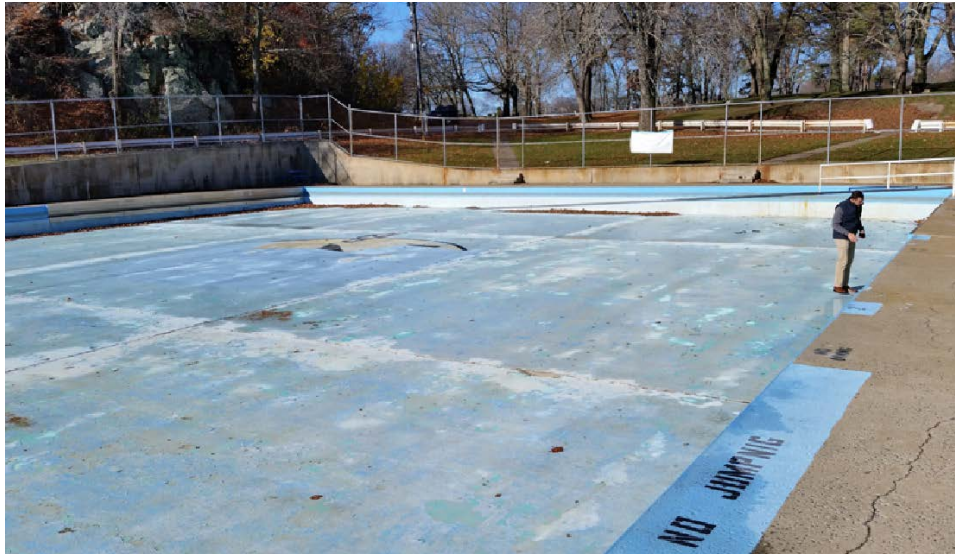
Figure D: Photo of Wading Pool

The pool also contains a shallow children area (Figure D). This section of the pool is approximately 50-feet wide by 60-feet long, with depths of 1'-9" deep to depths of 3 FT. This section of the pool has a ramp system that allows patrons to enter the pool. The entire pool approximately has a surface area of approximately 15,150 square feet, contains 610,000 gallons of water, with 724 linear feet of perimeter. Water flows from the children's pool into the lap pool through the gate area and a series of weirs at the base of the dividing wall between the two pool areas.

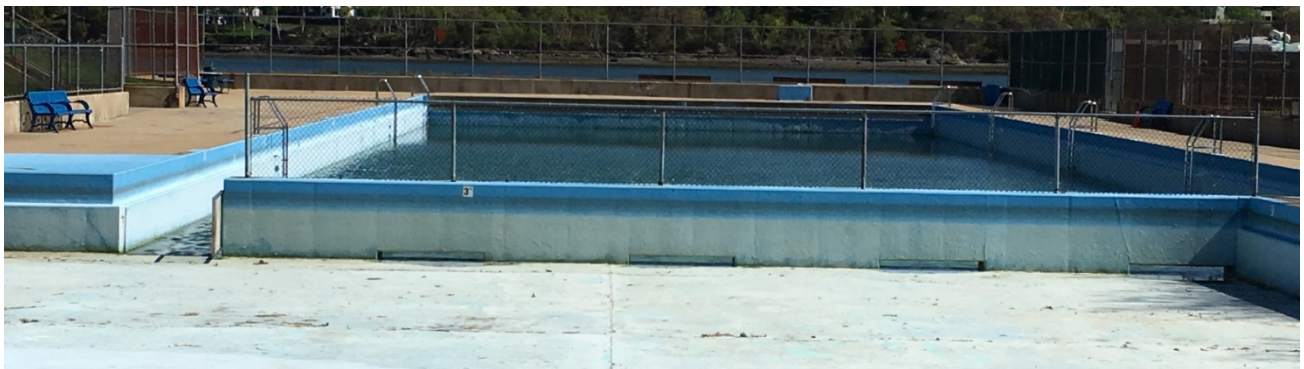
Figure D: Weirs in dividing wall
