**Fort Lee and Fort Pickering
Conditions Assessment, Cultural Resources Survey, and
Maintenance and Restoration Plan**

City of Salem

Massachusetts Historic Commission

2003

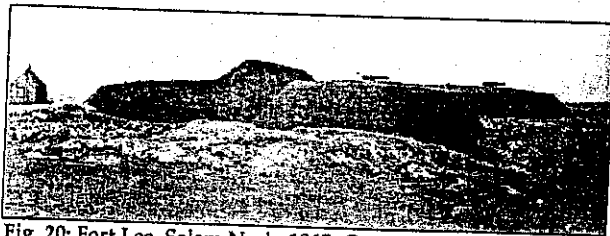
Fig. 20: Fort Lee, Salem Neck, 1865. Courtesy, Peabody Essex Museum, Salem, MA.

The site has been severely overgrown over the past thirty years. Original earthen berms as shown in figure 20 have suffered isolated erosion and settlement. The flat-topped formations that contrast with natural terrain have been obscured and eroded. Larger trees have intruded on the ramparts and surrounding defensive ditch as well as the landscape that forms the setting for the fort to the surrounding streets view of the fort and from the fort are blocked.

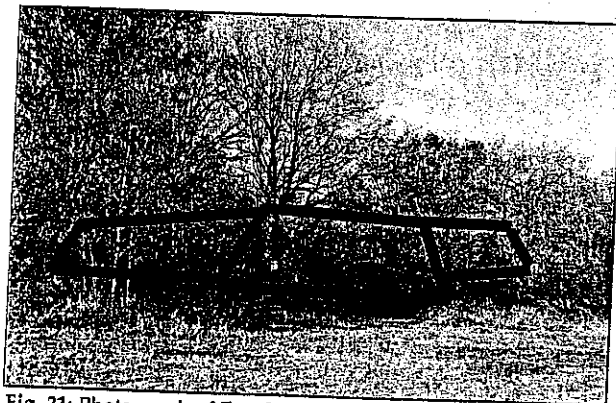
Fig. 21: Photograph of Fort Lee from Fort Ave. 2003. Black line shows the approximate location of the fort rampart walls.

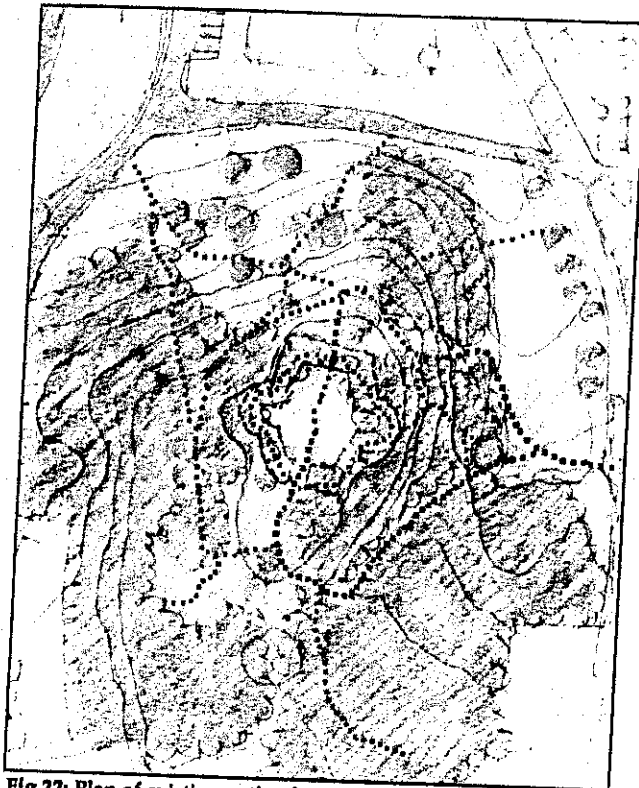
Some structured paths exist from earlier restorations. These include the granite steps near the top of the fort and a cleared path from the Fort Avenue parking area to the rear fort entry. These paths are appropriate ways of approaching the

Fig.22: Plan of existing paths shown in red.

fort. Other paths have been created through wooded areas. It is recommended that these be abandoned and that with the clearing of the vegetation these paths be seeded over. It is also recommended that wheelchair access to the top of the ramparts should be created by constructing an earth ramp within the fort with a slope of 5%. Handrail should not be installed. A visitor parking area can be created in the level area off Fort Avenue as recommended above. These paths and would lead to the fort enclosure and to the ramparts for viewing. View corridors should be sited from these viewing areas and the vegetation cleared. This work should only commence once the final restoration plan is developed following more archeological investigation.

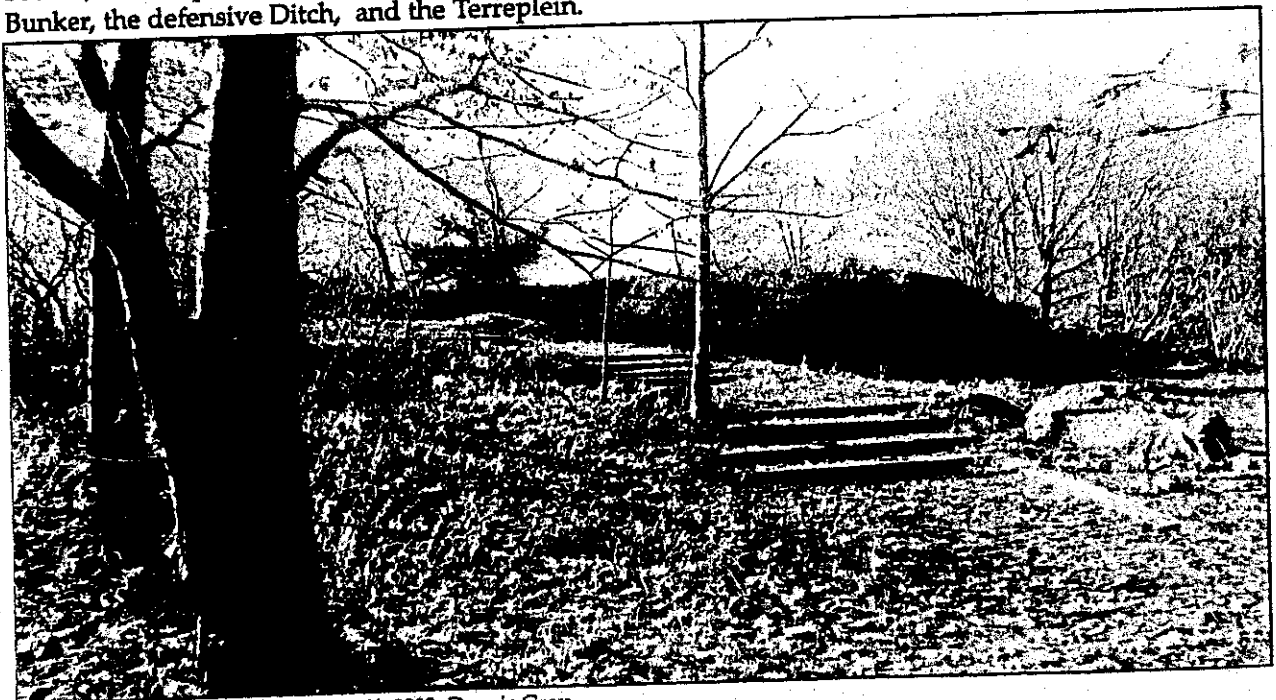
Fig. 25: Granite stairs installed in 1976. 2003, Dennis Gray

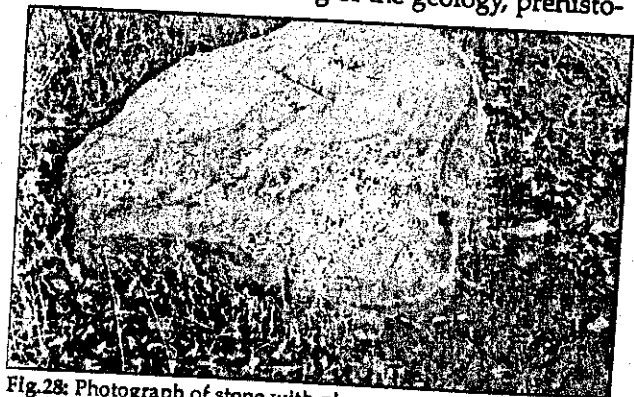
Fig. 28: Photograph of stone with plaque removed, Fort Lee. 2003, Dennis Gray.

It is recommended that the remaining stones that were once used for interpretive plaques be reused with new plaques. The design, images and text must be developed to include the historic research from this study and appropriately combined with an overall interpretive plan. This plan may include a visitor's center on this site, which would be best located off Fort Ave. near the proposed parking area or at the Fort Pickering site, possibly in an existing building. The landscape setting of Fort Lee has historically been part of the Salem Willows Park. As one viewed the fort from the park, it was surrounded by grass fields. Removal of the vegetation and the portion of Memorial Drive that runs between the baseball field and Fort Lee is suggested to restore this dramatic fort setting.

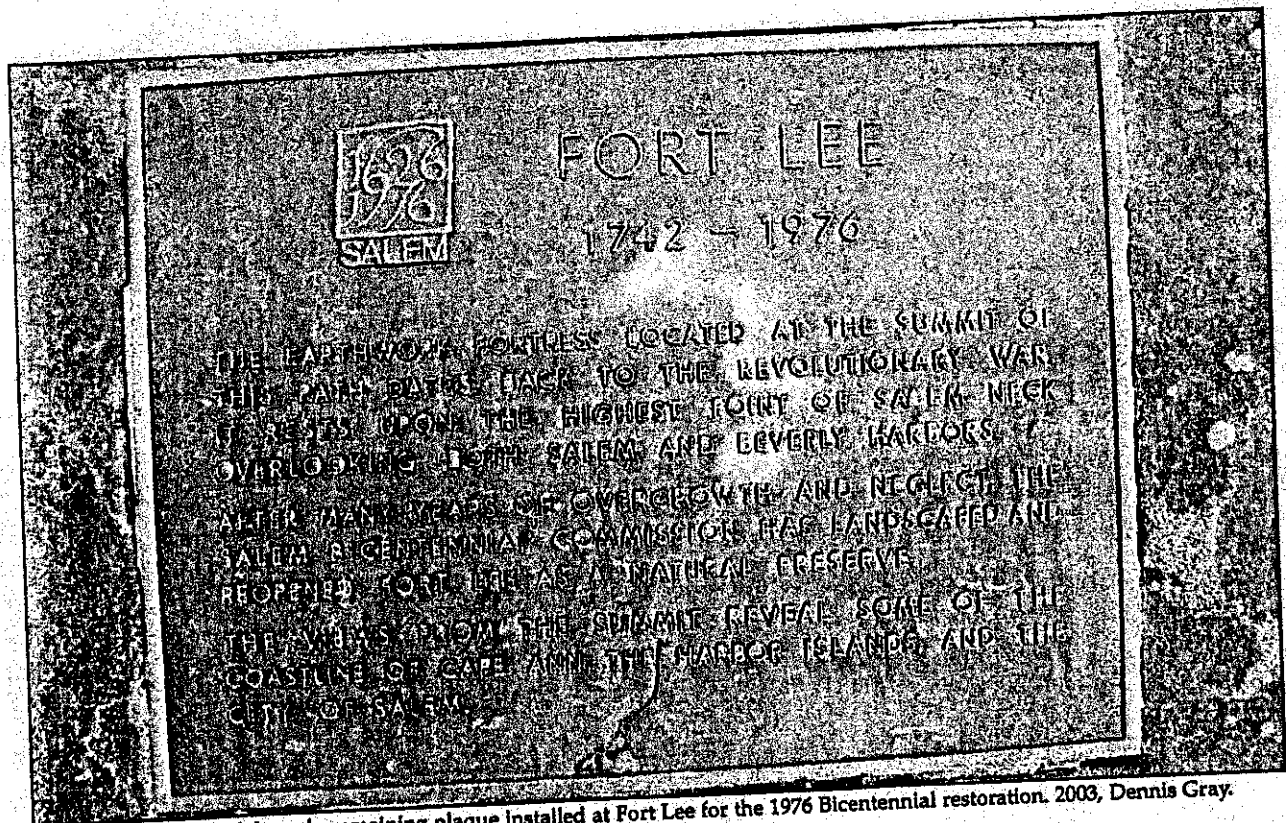
Fig.29: Photograph of the only remaining plaque installed at Fort Lee for the 1976 Bicentennial restoration. 2003, Dennis Gray.

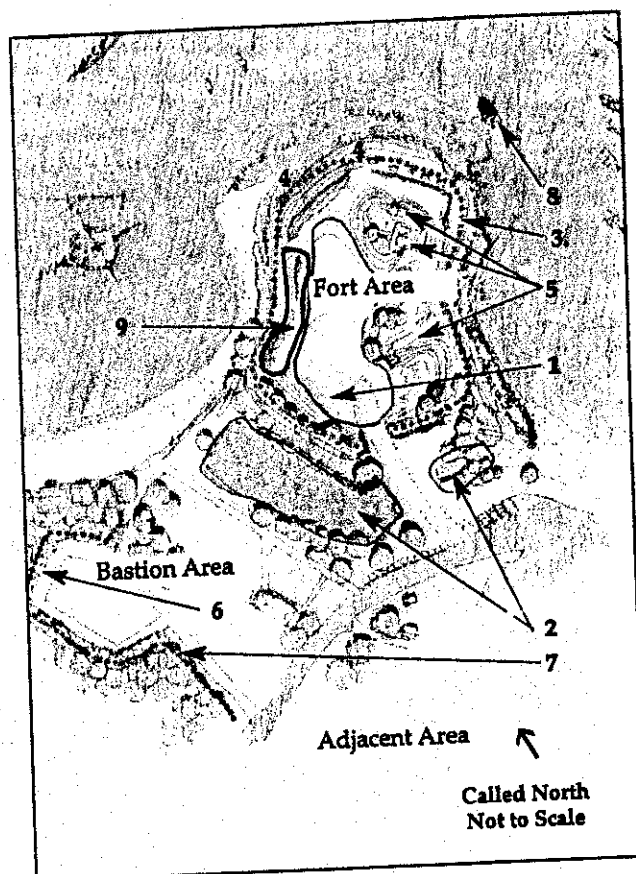
Fig. 31: Plan of existing features

The remaining visible and historic features that have been confirmed by the archaeological consultants are (see Figure 31):

1. The parade area
2. Wet Ditch
3. The ramparts (red dotted line)
4. Gun embrasures
5. Three bomb-proof magazines
6. Igloos for munitions storage
7. The remains of the bastion (red dotted Line)
8. The lighthouse
9. The terreplein

Figure 31 above shows the locations of the existing features. The conditions and recommendations for the masonry features are presented in a separate section below. This section presents the landscape features conditions. The stages of fort development are shown in Fig. 32 thru 34 giving approximate locations for the 1648, 1794 and 1864 fortifications. Figure 35, the Crane & Morrison Archaeology Existing Survey Plan of Basic Topographic Features shows the present fort plan. These plans are presented as a reference for understanding the design evolution of the fort and approximate locations of remaining features.

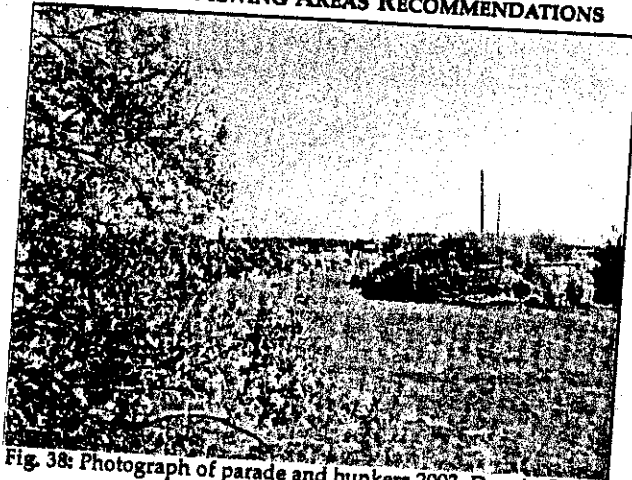
Fig. 38: Photograph of parade and bunkers 2003. Dennis Gray

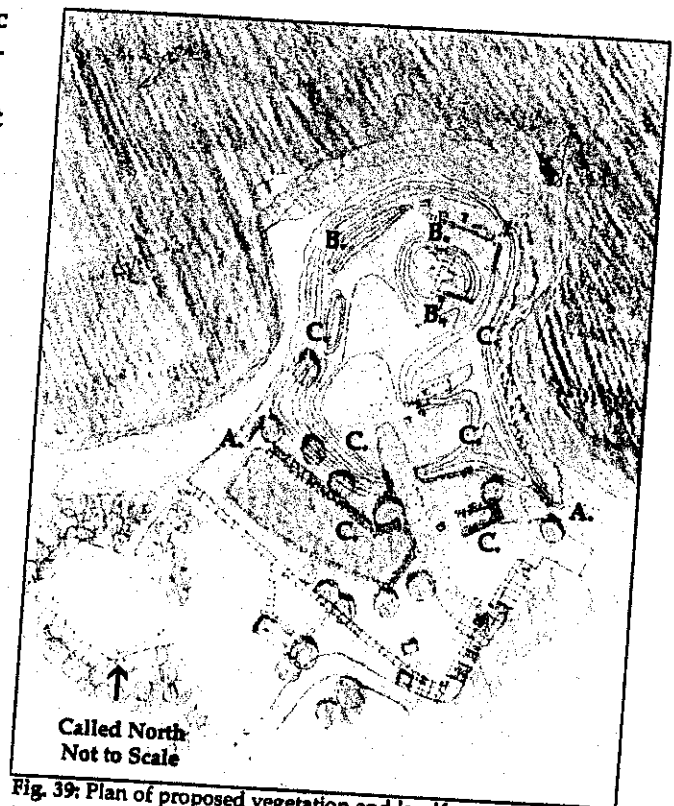
Fig. 39: Plan of proposed vegetation and landforms . A. Install temporary barriers to prevent erosion. B. Regrade area to conform with restoration plan. C. Remove vegetation to expose remaining features.

1. Remove vegetation as required by the final restoration plans.
2. Regrade areas to conform with approved final restoration plan.
3. Excavate to stabilize soil materials and make repairs to structures, foundations, and waterproofing materials as required.
4. Install new drainage systems or repair existing systems.
5. Install vegetative materials for ground cover and stabilization.

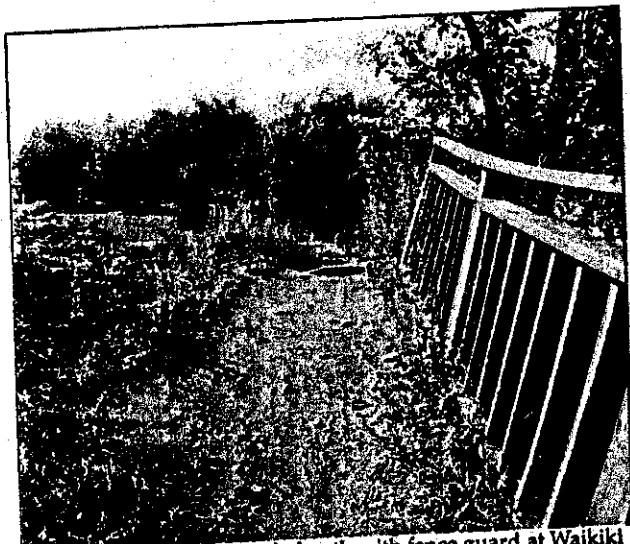
Walking paths have been created through visitor's use of the site. The paths do not have ground cover and are causing earth erosion. In some locations the grade has eroded because of surface runoff and the original earthen ramparts (the flat-

Fig. 40: Photograph at eroded path with fence guard at Waikiki Beach 2003. Dennis Gray.

topped formations that contrast with the natural terrain) have lost their identifying shape. Treatment includes cutting, filling, grading, and reshaping existing ramparts and ultimately abandoning the existing paths and creating new more stable paths leading to the viewing areas and other accessible areas. A small viewing area exists on the Salem Harbor side with four benches. This area gives excellent views and should be maintained. Paved parking for Winter Island and Fort Pickering exists to the south of the fort although no accessible or designated parking is provided for the fort.

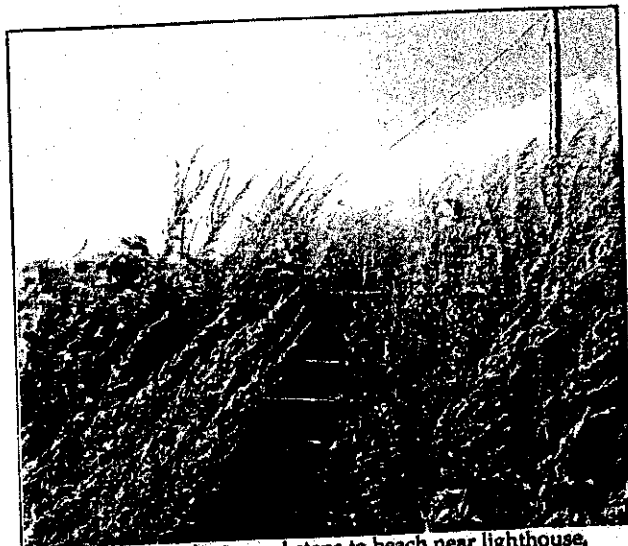
Fig. 41: Photograph at wood steps to beach near lighthouse, 2003. Dennis Gray.

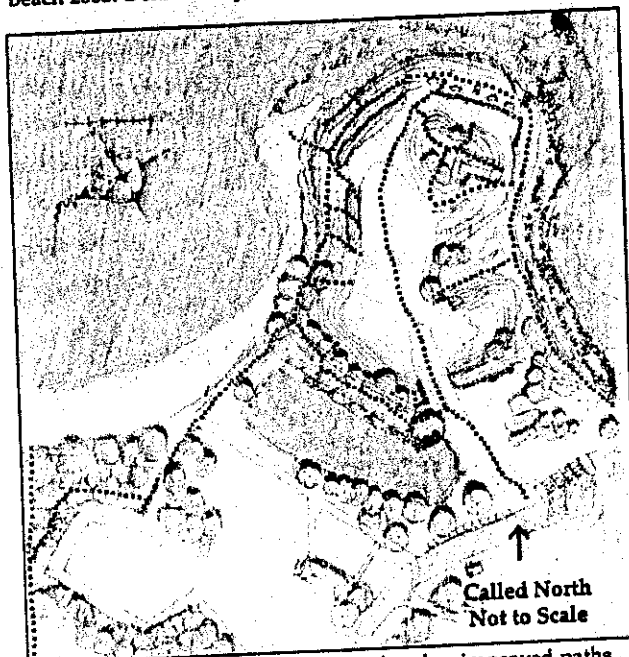
Social paths have been created on top of the remaining ramparts and at various other locations. Over time, these paths have damaged the fort grounds and in some locations are hazardous. These walks consist of compact earth and follow

Fig. 42: Plan of existing unsanctioned and unimproved paths shown in red.

It is recommended that formal paths be construct-

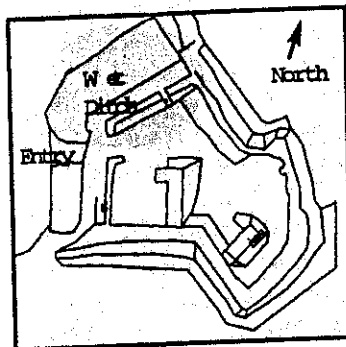
Condition is sound and largely original. The current water level is several feet higher than the level in historical photographs. The portion under the causeway leading into the fort is a jumble of stone and soil fill that is a 1940's alteration that replaced the original bridge. The original rip rap bank appears to remain beneath it. The causeway

Fig. 48: Current appearance of north rampart, north moat, and entry to fort (extreme right). The dry laid stone rip rap on the edge of the moat and the stone wall visible at the end of the moat are largely intact to their original appearance and are in serviceable condition. The north rampart is completely obscured by vegetation, but has also lost all its detailing except its general mass. See Fig. 49 below for c. 1860's appearance of this view.

Recommendations - North Wet ditch Rip Rap

Retain both rip rap and causeway masonry as is.
No substantial repairs appear needed.

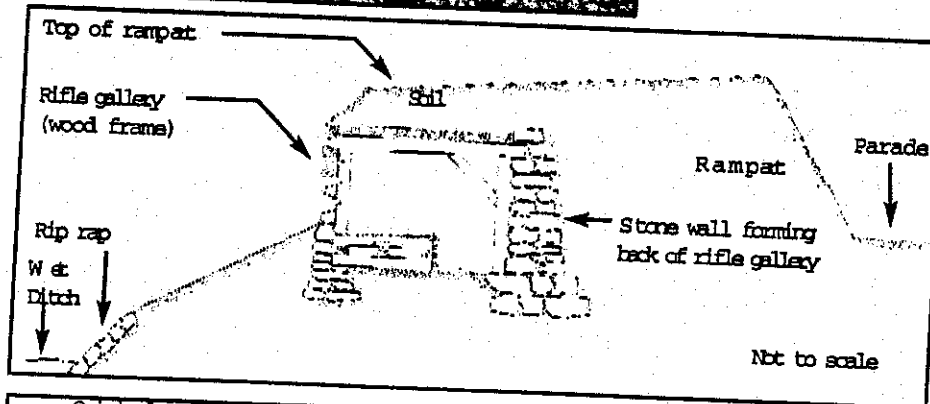
Fig.51: Conjectural section of original rampart with wood frame rifle gallery overlooking moat (based on 1830 drawing by West Point Cadet Thomas J. Lee from manuscript collection of Finch & Rose). The rifle gallery was covered with soil to make it bomb proof.

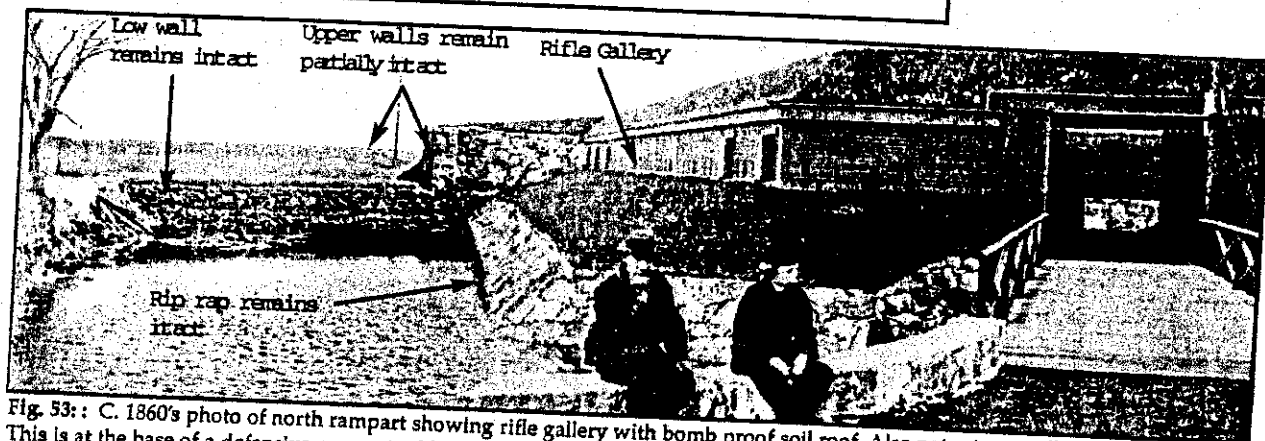
Fig. 53: C. 1860's photo of north rampart showing rifle gallery with bomb proof soil roof. Also note stone wall visible thru gate. This is at the base of a defensive rampart within the parade, and illustrates the original neat finish of the stone walls associated with the ramparts. Photo is a composite picture combining a c. 1900 photo on the left with the c. 1860's fort photo. Both photos courtesy of PEM.C.

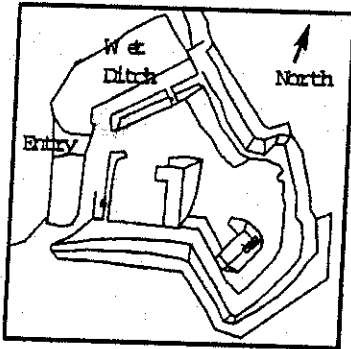
This dry laid wall of roughly dressed massive stones with tight chinking remains stable and reasonably plumb, but is missing some chinking and a few smaller stones. The right hand section of it in Figure 54 is the most intact example of the original dry stone wall construction remaining at the

Fig. 55: Main entry wall at north Rampart (west face) showing voids to be chinked, especially on left side. The right side should be used as a model for the repair, rechinking and rebuilding of other dry stone walls.

fort. It should be used as a model for rebuilding and repair of the other dry stone walls at the fort. Soil erosion at the wall's margin at the parade side of the rampart threatens to undermine the cap stones. Some graffiti is present. The wall turns the left corner to face the wet ditch where its condition becomes more disheveled. It then makes another turn and becomes largely buried in the soil of the collapsed rifle gallery roof.

Recommendations – North Rampart Entry Wall

- West Face: Chink voids in joints to match existing chinking, and fill large void on left side with a single stone plus chinking. Restore soil cover to parade side flank. Remove graffiti.
- Wet ditch Face: Rebuild with added chinking to match character of west face. Restore soil cover to top.

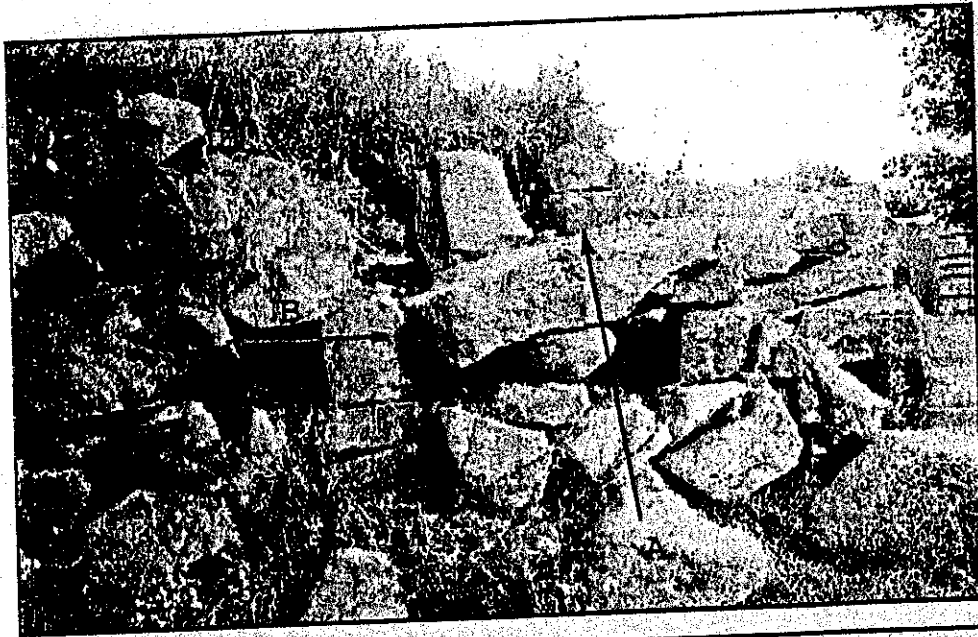
Fig. 58: Rifle gallery wall at entry corner - current view. Rock marked "A" has fallen or been pushed off the wall since 1998 (Arrow marks 1998 position). Soil behind corner with entry flank wall is also deeply eroded and will eventually undermine the corner of the entry wall. At minimum this section of wall should be rebuilt and the grade behind it restored to the top of the walls in order to stabilize this corner. Gap at B may be former chimney and should be maintained in rebuilding.

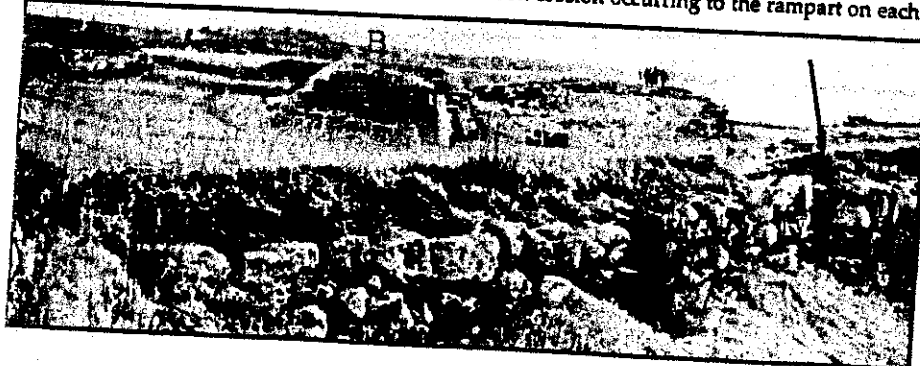
The typical condition of this wall is shown in fig. 50. Its appearance in 1942 is documented in fig. 61. The wall currently appears as an informal fieldstone wall without a uniform top and with occasional dislodged stones at the foot of the wall. It was not a visible part of the Civil War ramparts, but could be considered significant to the fort's 20th century appearance as a ruin. Other than its condition near the entry flank (Fig. 58 and 59) and

Fig. 61: C. 1942 photo looking over remains of north rampart rear rifle gallery wall to magazine B (B) and remains of west rampart. Arrow points to passage from parade to rifle gallery. Short term work to rifle gallery wall should aim to stabilize the wall to this condition. Photo was taken from position of "B" in Fig. 63. Photo, Salem Community Development Dept. (CD)

- Rebuild corners at rifle gallery passage, and at west end as required to stabilize the flanking walls and retain soil. Rebuild remainder only as required to stabilize erosion and secure random loose stones. Maintain general existing appearance of wall, using 1942 photo as guide for rebuilding the rifle gallery passage. Archeological testing is not required as long as the soil below grade will not be disturbed by the work.

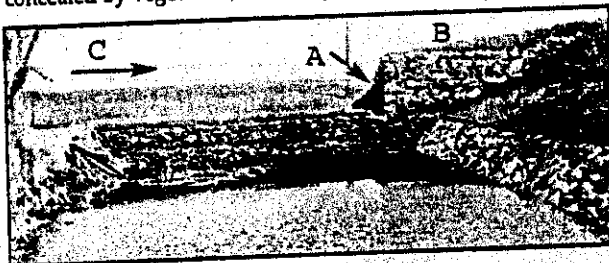
The walls retaining the end of the main rampart as it drops down to the spit of land between the wet ditch and the beach are illustrated in Fig. 62-64. They have lost considerable height and much of their original chinking. Based on Fig. 63 their original character was similar to the entry flank wall of the north rampart with moderately uniform but roughly dressed stone and much tight chinking. Wall "A" currently looks much less regular than

Fig. 63: C. 1900 photo of east end of wet ditch showing intact appearance of wall "A" in Fig. 62 and its return section "B". These walls were well chinked like the main entry flank wall in fig. 55. Photo courtesy PEM.

- Limited rebuilding and chinking of wall "A" fig. 62 & 63 and reset any loose stone. The extent of repair needed at wall "B" cannot be determined until the vegetation is removed.

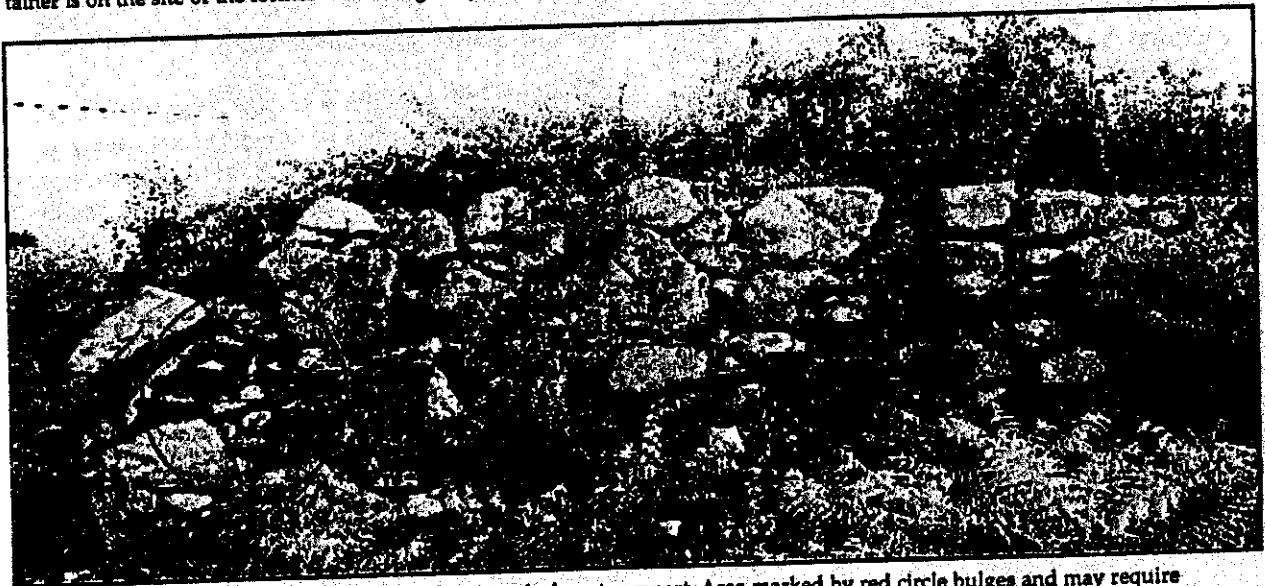
Fig. 66: Remains of rifle gallery rear wall at south end of west rampart. Area marked by red circle bulges and may require rebuilding. The rest of the wall needs chinking. Arrow points to location of beam end in fig.67. The slot once occupied by a chimney is marked "CH".

The entire wall should be rechecked to secure any loose stones. The northernmost portion of it bulges slightly and could potentially collapse. It warrants partial rebuilding to stabilize it. The wall is currently heavily obscured by vegetation.

- Remove existing vegetation from walls.
- Recheck to secure any loose stones (do not disturb remnants of wood beams).
- Partially rebuild the northern portion where it bulges as required to stabilize it.

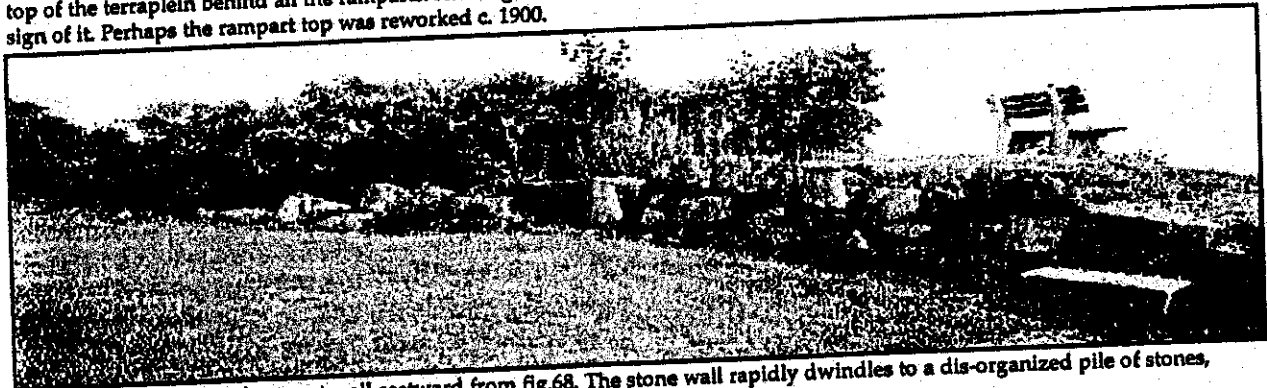
Fig. 69: Continuation of parapet wall eastward from fig.68. The stone wall rapidly dwindles to a dis-organized pile of stones, and then stops. A few random groups of stone occur further to the east of this section.

- Remove existing vegetation using care to not disturb any stones including those that appear to be lying at random.
- Rethink any loose or missing stones in the areas having well organized stone parapet walls.

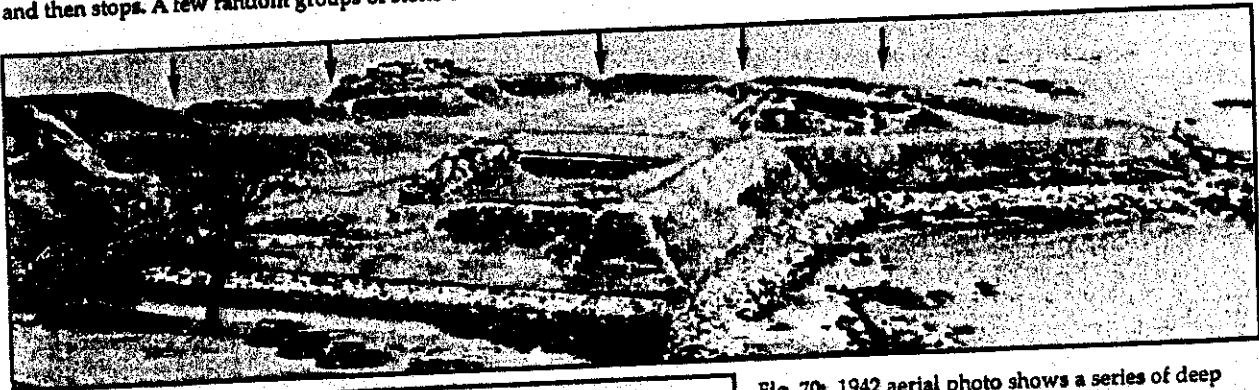
The last section of the east rampart shows no visible evidence of stone walls or parapets. It is more heavily eroded and obscured by vegetation than the other sections. In this and the previous section the deepest patterns of erosion running at right angles to the rampart roughly align to the embrasures on the 1864 plan.

Fig. 70: 1942 aerial photo shows a series of deep gullies across the east ramparts that correspond to the embrasures shown in the 1864 plan in fig. 71. Arrows marks typical gullies. Photo from City of Salem office of Planning and Community Development.

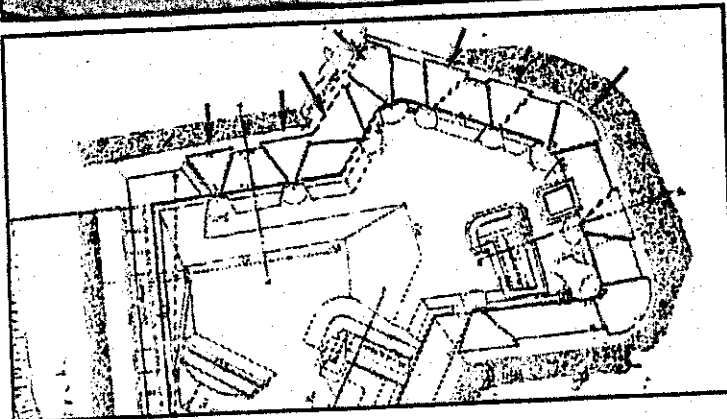
Fig. 71: Portion of 1864 plan of fort with east ramparts on top. Arrows marks typical embrasures that can be correlated to gullies visible in fig. 70. Plan from National Archives. Refer to Archeological Report for 1830 drawing of typical gun embrasure similar to ones on this plan.

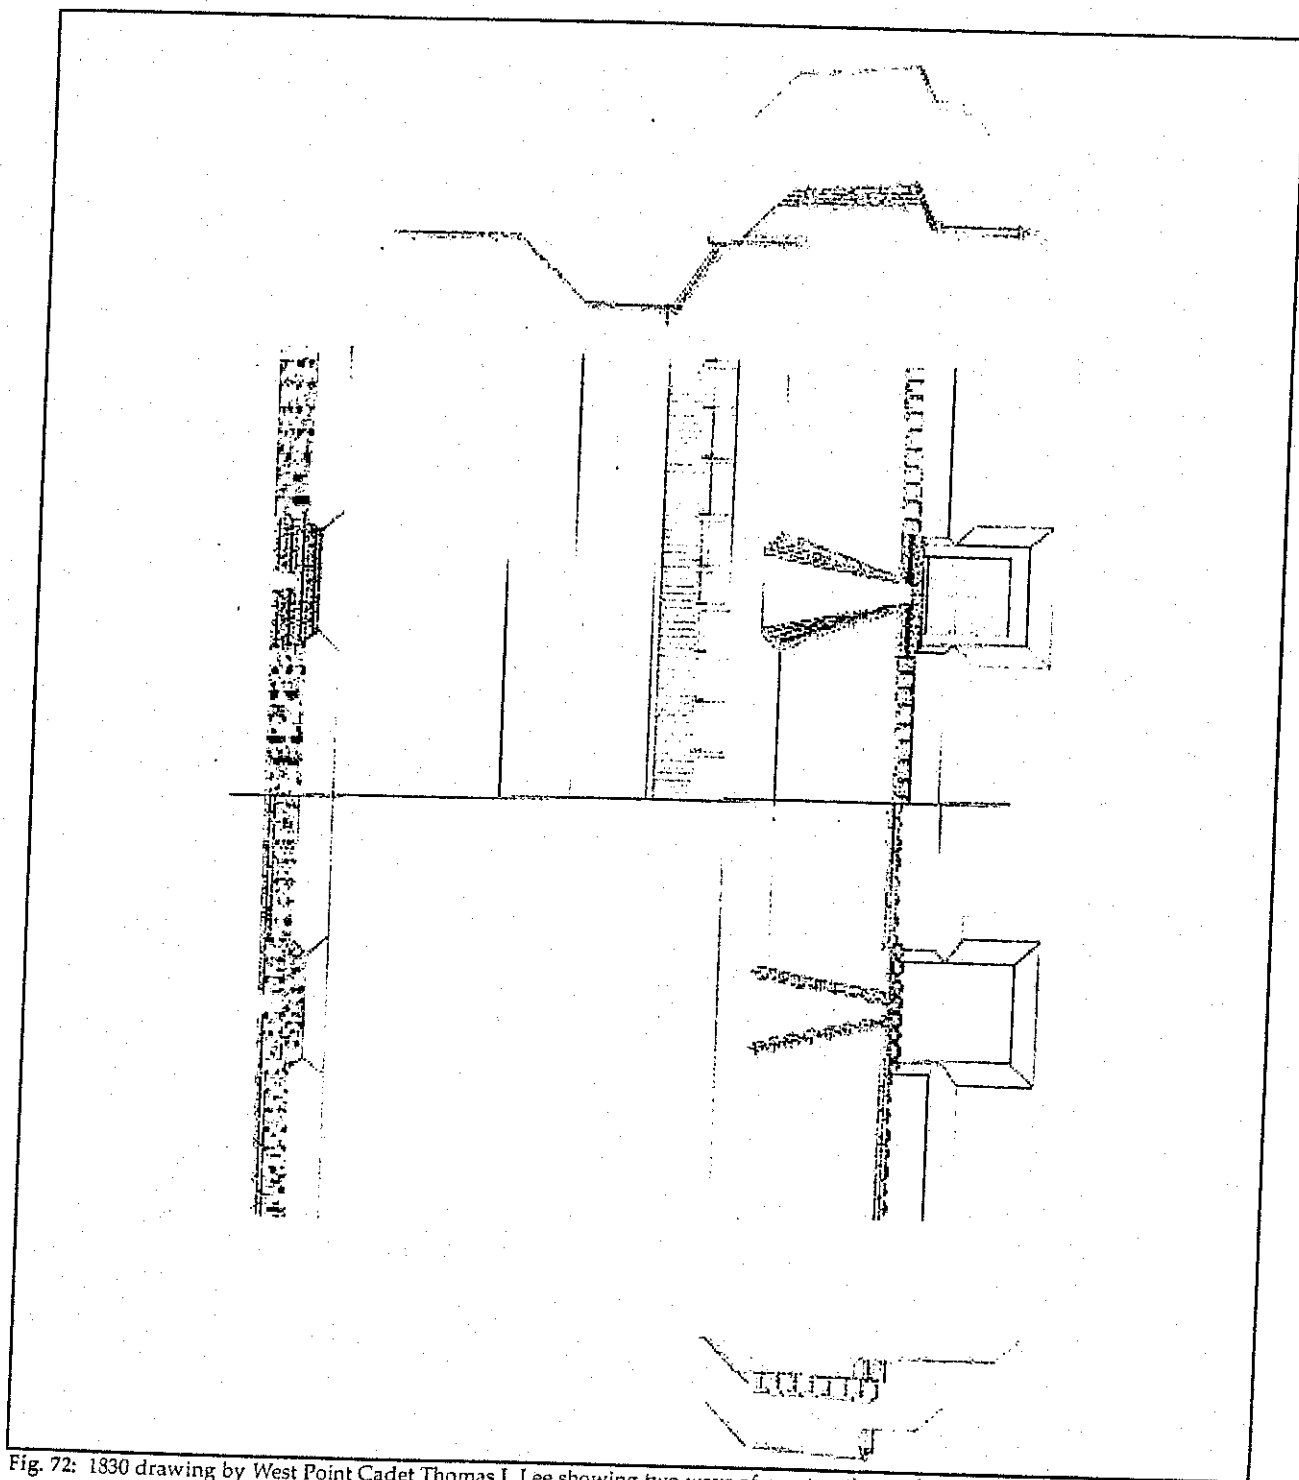
Fig. 72: 1830 drawing by West Point Cadet Thomas J. Lee showing two ways of constructing embrasures and gun emplacements. A long term interpretive goal is to reconstruct a typical embrasure, but more archeological and document research is needed in order to determine the construction details used at Fort Pickering to design and carry out a reconstruction. Drawing is from a portfolio of original drawings in Finch & Rose collection.

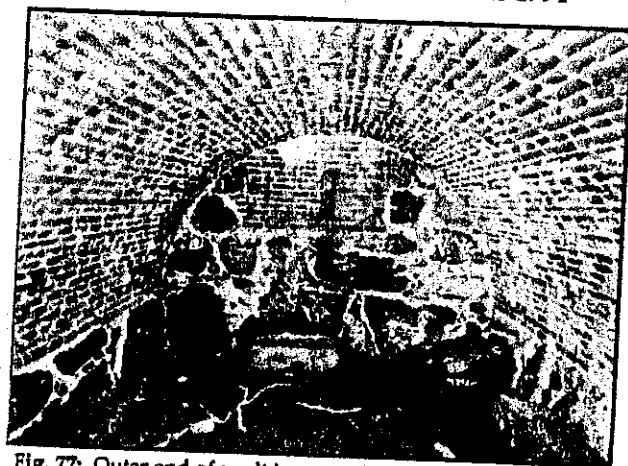
Fig. 77: Outer end of vault in magazine A with single ventilation slot in wall.

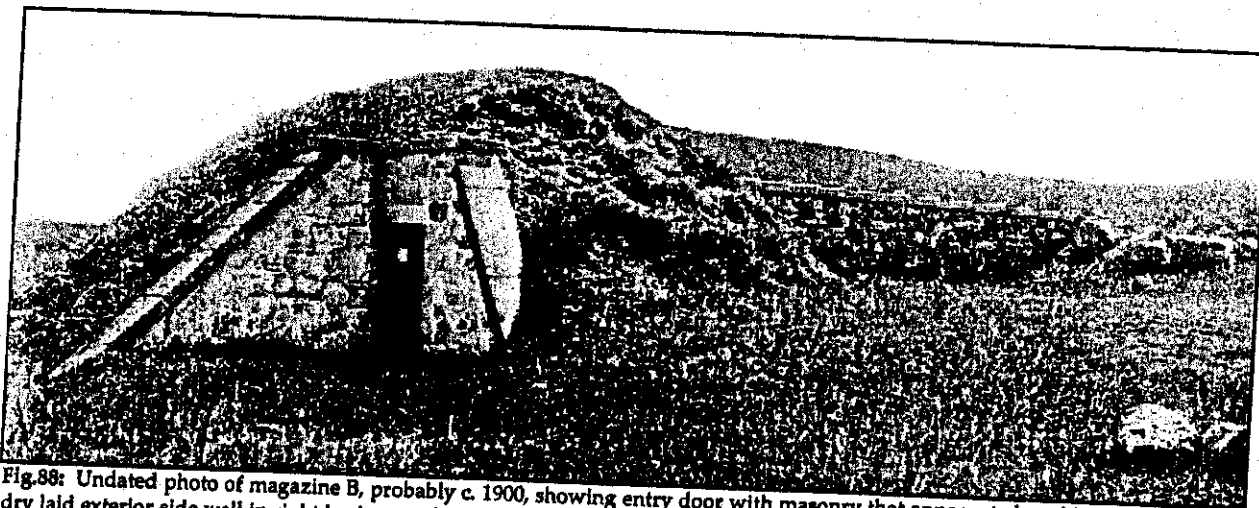
Fig.88: Undated photo of magazine B, probably c. 1900, showing entry door with masonry that appears to be whitewashed, and dry laid exterior side wall in right background. Note erosion is not a new problem. Photo courtesy PEM.

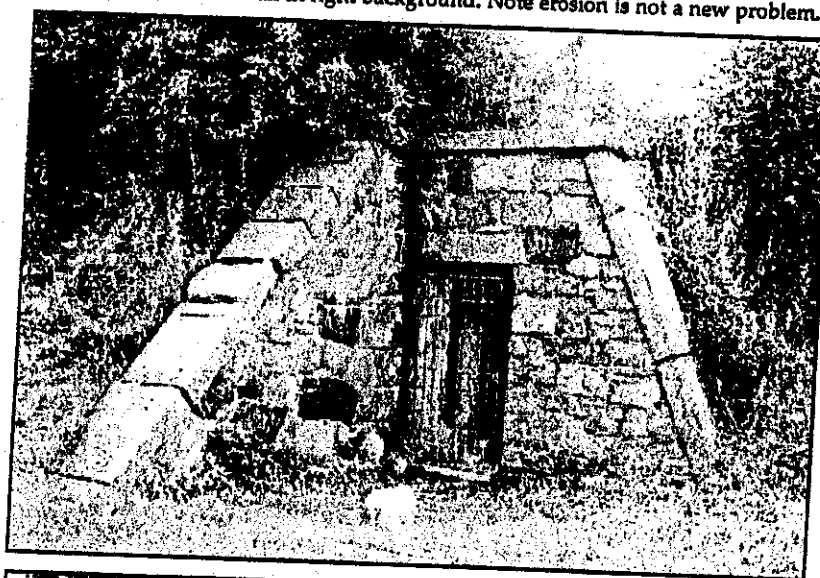
Fig.89: 2003 photo of entry to magazine B showed barred iron doors currently used on all three magazines.

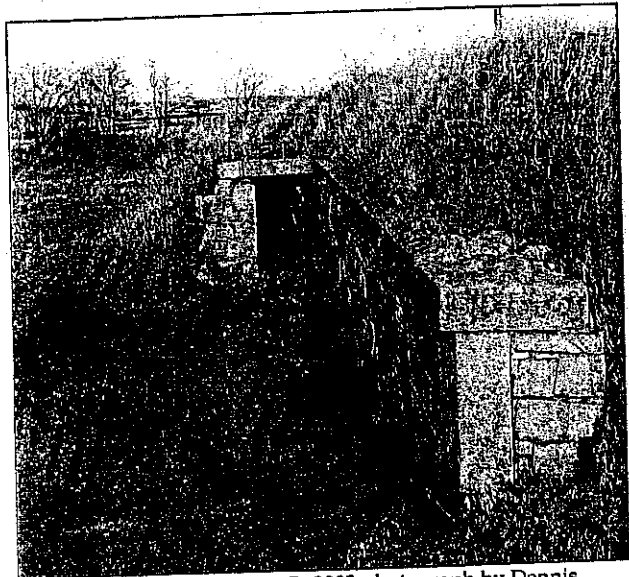
The exterior wall stone masonry at the entry is in generally sound, serviceable condition with only a few random open mortar joints. It appears to have been repointed a number of times with mortars that do not visually match each other. The joints between the capstones are largely void of mortar with remnants of previous pointing in some of them. The capstone joints and open wall joints should be cut and repointed as maintenance activity with mid-term priority. The 1:1:6 mortar indicated above for the brick should also be used for repainting the stone. The soil that has eroded away from the back side of the entry walls should be replaced.

Fig. 91: Entry to Magazine B. 2002 photograph by Dennis Gray.

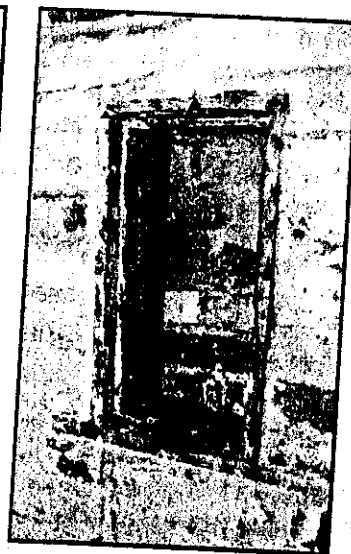
Fig. 93: Detail of ventilation slot with wood frame. Some slots had metal hardware cloth in these frames.

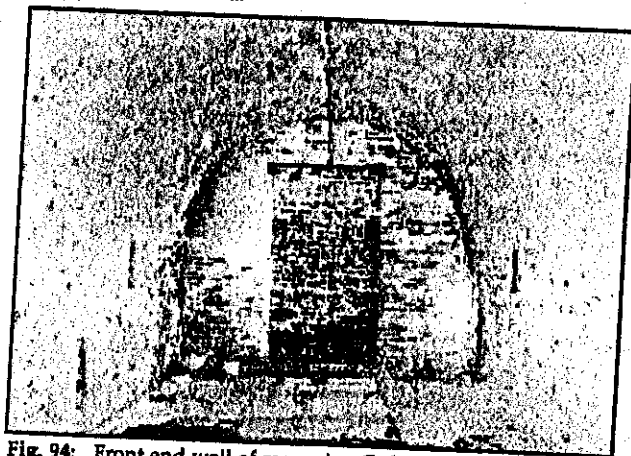
Fig. 94: Front end wall of magazine C showing remains of modern wood floor c. WWII.

- If the magazine is to be opened for limited public tours, consider restoring the wood floor in the magazine vault to match the existing WWII flooring, applying whitewash to the masonry, and redoing the electric lighting.

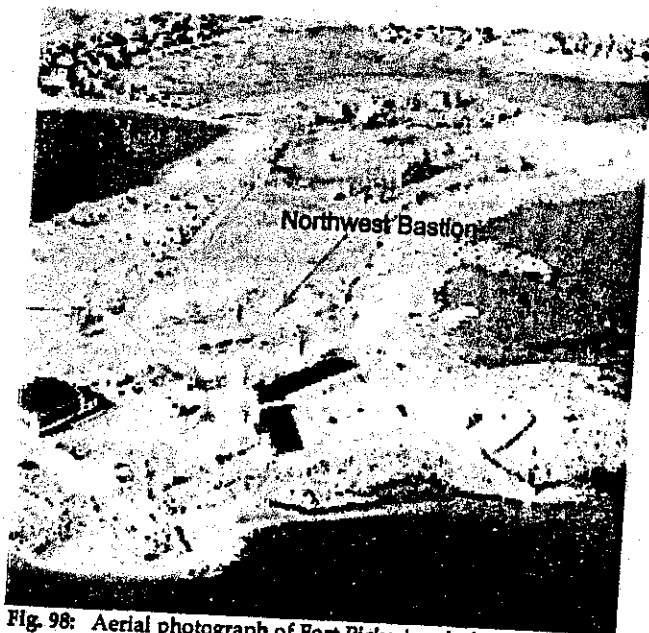
Fig. 98: Aerial photograph of Fort Pickering, before 1943, Winter Island Marine Park, City of Salem, MA.

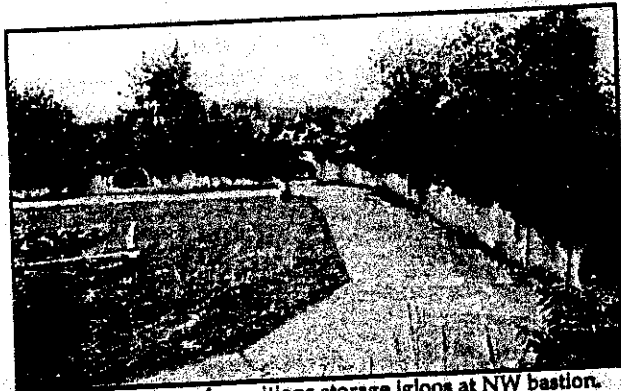
Fig. 99: Overview of munitions storage igloos at NW bastion.

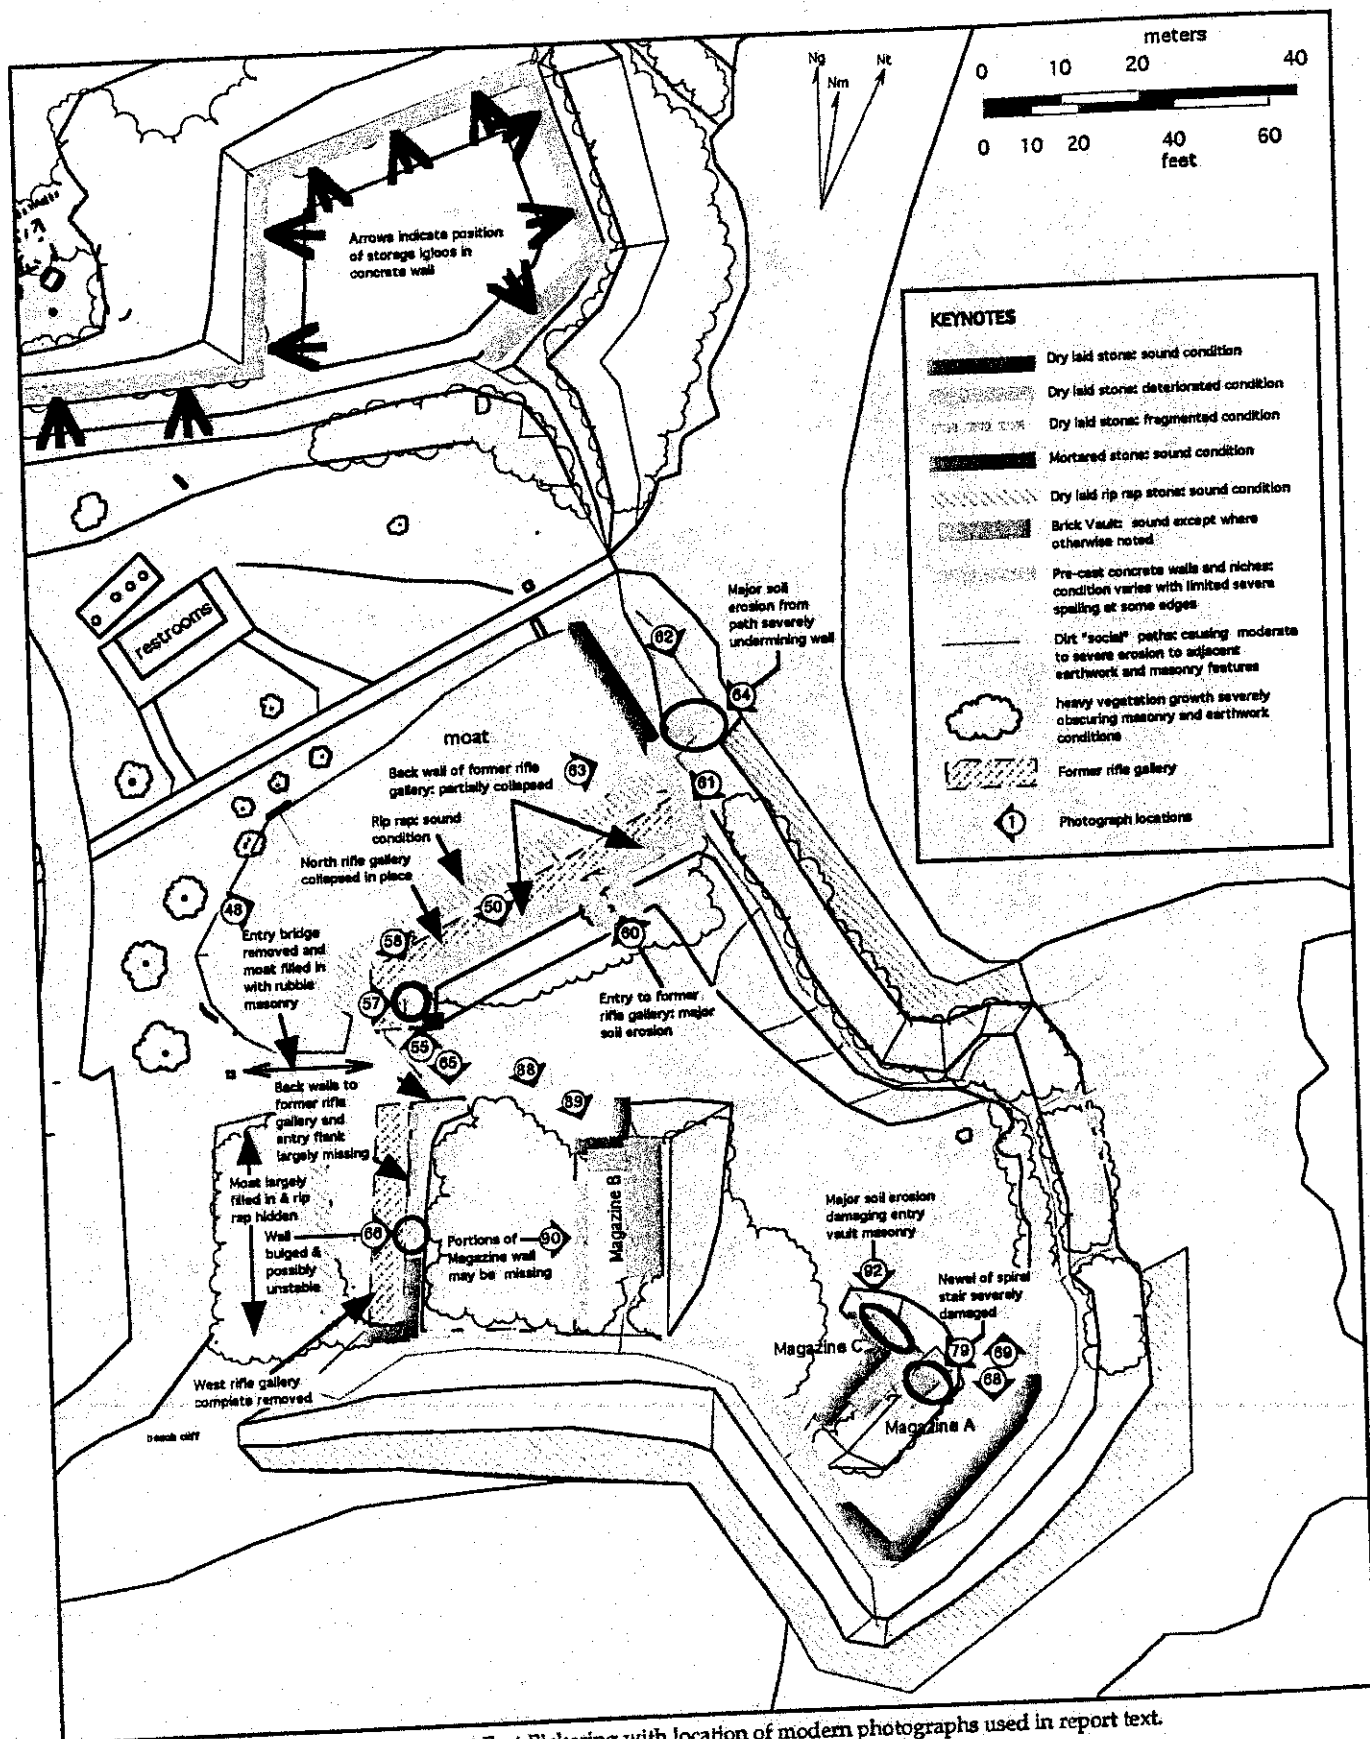
Fig. 115: Summary of existing conditions at Fort Pickering with location of modern photographs used in report text.
