# St. Joseph's Parcel Reuse Study

**2.7 Acre Site  
135 Lafayette Street  
Salem, Massachusetts**

**Prepared by  
Crosswhite Property Advisors  
6 Beacon Street Suite 215  
Boston, MA 02108**

**November 2005**

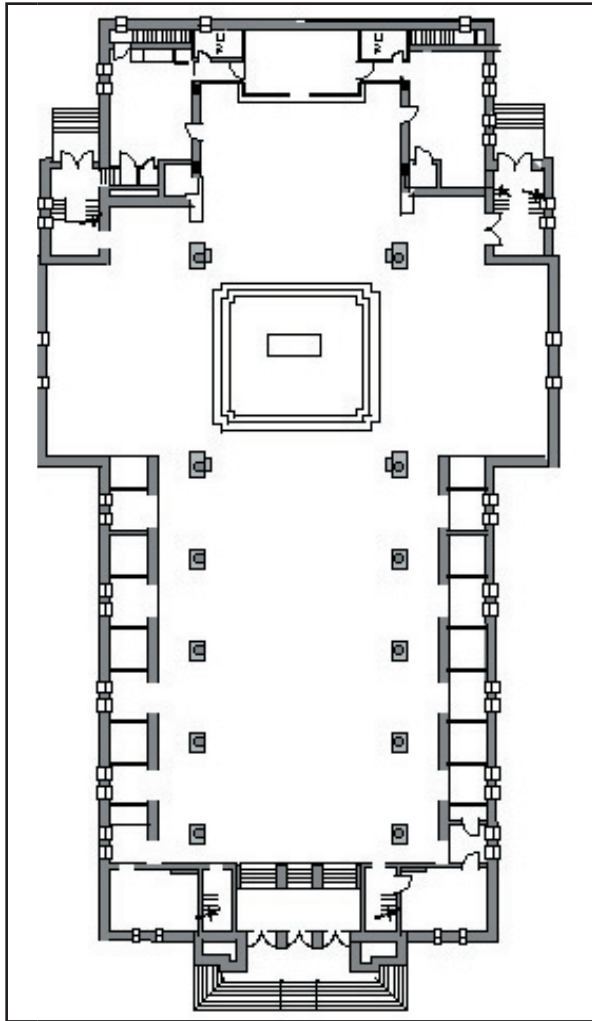
**Existing  
First  
Floor**

At every vertical corner of the building, a long, deep vertical crack has occurred approximately 4" from the corner on both faces. The face-brick (white glazed) has not demonstrated compatibility with either the brick or concrete back-up material.

The brick over the windows is supported by embedded steel lintels, of which the bottom flanges can be seen from the exterior. Stress lines can be seen in the form of horizontal cracks and movement in and near the joint in which the lintel sits, often for long stretches of wall such as the north and south elevations, which have repetitive closely spaced windows that share the same top elevation. The cause of the cracking and movement is most likely the corrosion of the steel lintels and subsequent rust jacking.

There are thermal cracks at the north and south facing walls to the east of the transept. These relatively short walls are rigidly attached via the roof structure to the longer walls on the west side of the transept. When thermal expansion and contraction occurs in the roof structure, it creates a "tug of war" between the two respective sections of, causing diagonal shear cracks to occur in the shorter ones.

The chimney near the northeast corner of the building is in a cracked and somewhat fragmented condition. While it remains serviceable at present, it will eventually need to be reconstructed.

The steel structure within the tower is rusting. *The steel structure will need to be cleaned and painted if the tower is to be retained.*

Water is entering the interior of the structure through the exterior envelope at several scattered locations, as is evident in staining on the interior surfaces of walls.

*Prior to any repairing of the corners of the face brick, an investigation and analysis will have to be performed to demonstrate that the ties between the backup brick and the face brick have retained their structural integrity.*

*To halt further damage to the building facade, veneer brick should be stripped off the existing lintels, which should then be removed and replaced with new, corrosion-resistant galvanized steel. If it is evident that the corrosion is only occurring on the outside face of a given steel lintel, it may be possible to remove the rust and corrosion-protect the steel from the outside. Cracks caused by rust jacking should be pinned, knitted back together or repointed as necessary, depending upon the situation.*

*Thermal effects of this nature are unavoidable in this type and scale of construction and can best be accommodated by the introduction of sawcut control joints in the brickwork that will allow the stresses caused by these movements to be relieved.*

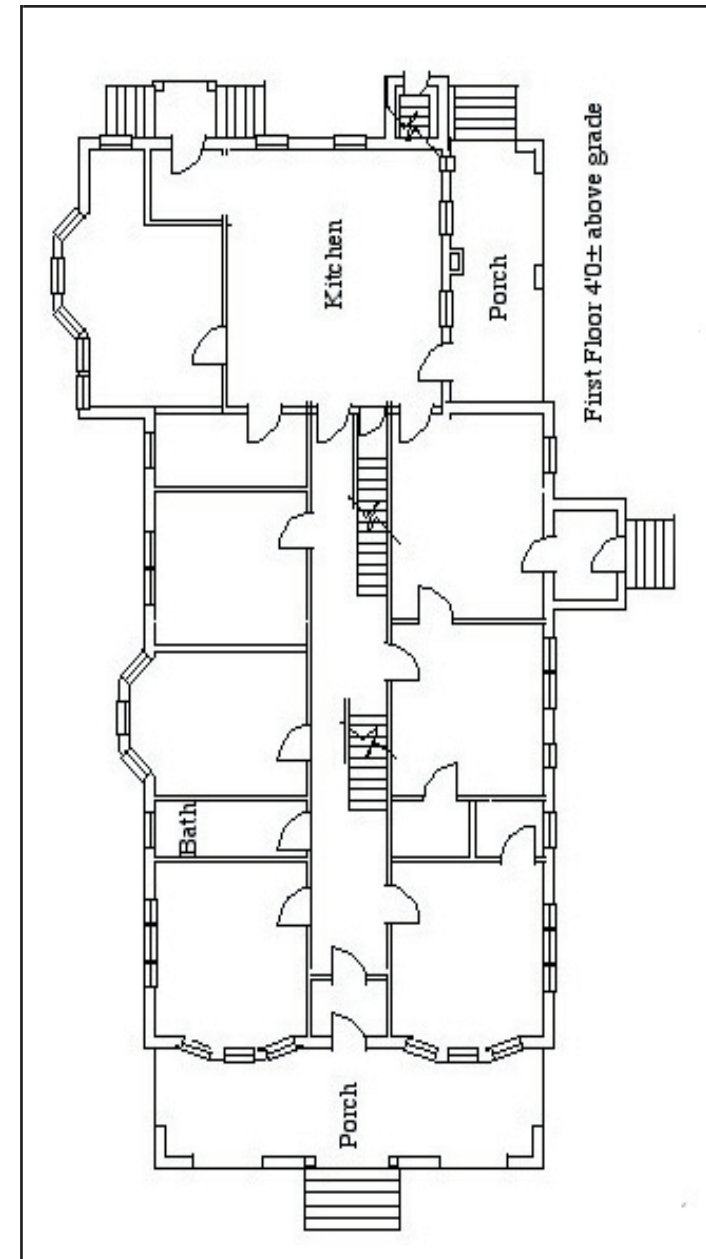
**Existing  
First  
Floor**

The exterior brick seems well fired and the mortar appropriate for the brick. That being the case, we have still noted significant damage (most likely due to the use of concealed headers) which is described below.

This condition specifically occurs on all three sides of the west facing (front) porch and entry steps. The piers at the bottom of the steps show significant movement as well as cracks in the lower concrete foundation wall. The south-east porch (south wall), south facing porched entrance canopy housing stairs up to the first floor, and the north facing porch have also all incurred movements due to the instability of the brick banding.

The brick over the windows is supported by embedded steel lintels, of which the bottom flanges can be seen from the exterior. Most of the steel lintels are currently deflected (sagging in the middle), and stress lines can be seen in the form of horizontal cracks in the joint that the lintel sits in, or step cracks originating at the top corner of the window and projecting diagonally upward.

The cause of the sagging of the lintels and adjacent cracking is directly attributable to corrosion of the steel lintel and subsequent rust jacking.

One of the cast stone units in the north façade's string course has spalled and is about to fall to the single-story roof below, possibly damaging it or rebounding onto the sidewalk. The spalled piece of stone should be removed and stored.

There are several cracks and spalls in the cast-in-place concrete steps *that should be repaired using standard concrete restoration methods such as adhesive-injecting cracks, exposing and corrosion-treating embedded steel (if any) and applying formed or trowel-grade restoration mortar to spalls.*

The ceilings in several of the interior spaces of the first, second and third floors have diagonal cracks, particularly near the southeast and northeast corners of the building. These are most likely to be from normal deflection and seasonal moisture changes in the wood construction in contrast with the unchanging masonry at the exterior. Damage is most severe at the roof scuttle stair at the east end of the third floor, where the plaster is water-stained. This

There is fairly extensive water damage to the finishes at the third floor, within the west half of the north wall. This corresponds to eroded mortar joints and some diagonal cracks in the exterior masonry, and some rust staining on the cornice. The masonry should be repointed and the crack repaired. The roof edge flashing should be checked for leaks.

The exterior foundation brickwork of the north wall is efflorescing in the basement, suggesting infiltration of water. The mortar and the brick units themselves still look sound. *Restoration of the exterior masonry would be required to alleviate this problem.*

*The resultant bowing of the lower bricks caused by the redistribution of support is in and of itself a potentially unstable arrangement that will increase in magnitude as mortar joints naturally weather and erode losing their tensile strength. The outer wythe (10 courses) of the single story segments of wall between the belt course and the foundation would need to be sequentially disassembled and rebuilt using galvanized or stainless steel brick anchors to stabilize the projecting bands.*

*To halt further damage to the facade of the building, veneer brick should be stripped off at the lintels and the lintels should be removed and replaced with new galvanized steel. If it is evident that the corrosion is only occurring on the outside face of the steel lintel, it may be possible to remove the rust and corrosion and protect the steel from the outside. Cracks caused by rust jacking should be individually assessed, and pinned, knitted back together or repointed as necessary.*

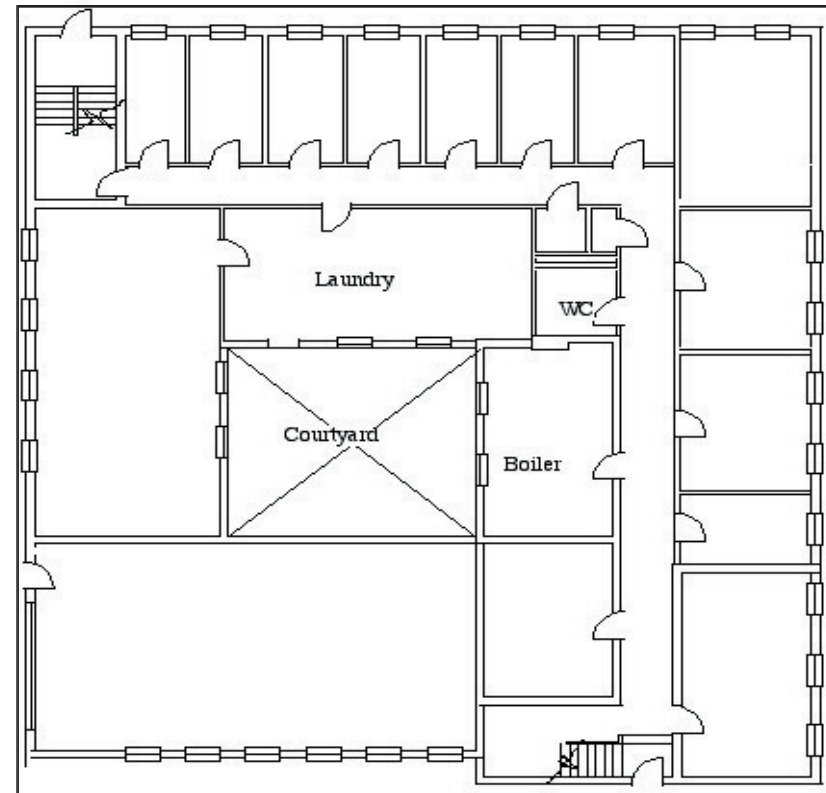
Existing First Floor

There is a large garage door opening on the west facing façade of the building, the masonry over which is supported by a steel W-flange beam with a full-wall thickness steel plate welded to the bottom flange (visible from the opening). The top surface of the plate is rusting and jacking itself downward away from the beam.

*The repair would include: shoring of the garage door opening, removal of the bottom plate and subsequent repair and corrosion-protection of the beam flange and replacement of the bottom plate using galvanized steel.*
