Charter Street Cemetery, Salem MA

# Charter Street Cemetery, Salem MA

The initial assessment identified 23 priority 1 and 1.5 markers to be conserved and are listed in the table to the left. Upon excavating markers C7.2 and J10.1 their condition was found to be un-restorable.

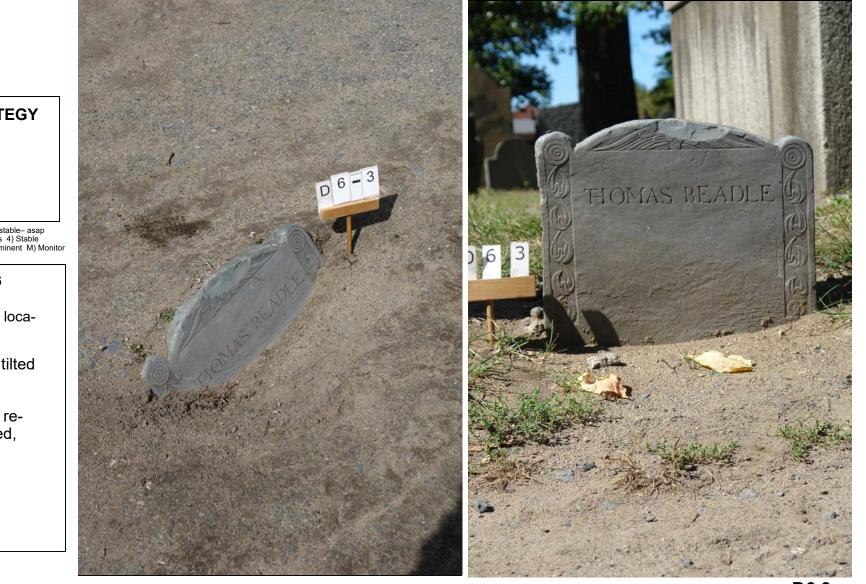
10

**Charter Street Cemetery** Cemetery: NAME ON MARKER **Thomas Beadle** Footstone? Marker Type: Death Date: Condition of Inscription: Partially Decipherable Material: Slate **EXISTING CONDITIONS** CONSERVATION STRATEGY Tilted Reset plumb-off pathway Possible new below base In pathway 1) Hazardous, immediate action 2) Unstable- asap **CONSERVATION PRIORITY 1** 3) Ongoing deterioration, treat 2-5 years 4) Stable A) Artistic H) Historical P) Visually prominent M) Monitor Date(s) of treatment 6/6/2016 TREATMENT Note: Existing location in pathway is hazardous. New setting location agreed by Town Staff Planner and Landscape Architect. 1. Marker carefully excavated removing the soil around tilted markers to an appropriate depth. Marker appears to be sound. 2. Setting area excavated to sufficient depth and stone reset plumb at appropriate height and level onto gravel bed, aligned with adjacent markers. 3. Area backfilled around marker with tamped sand and gravel

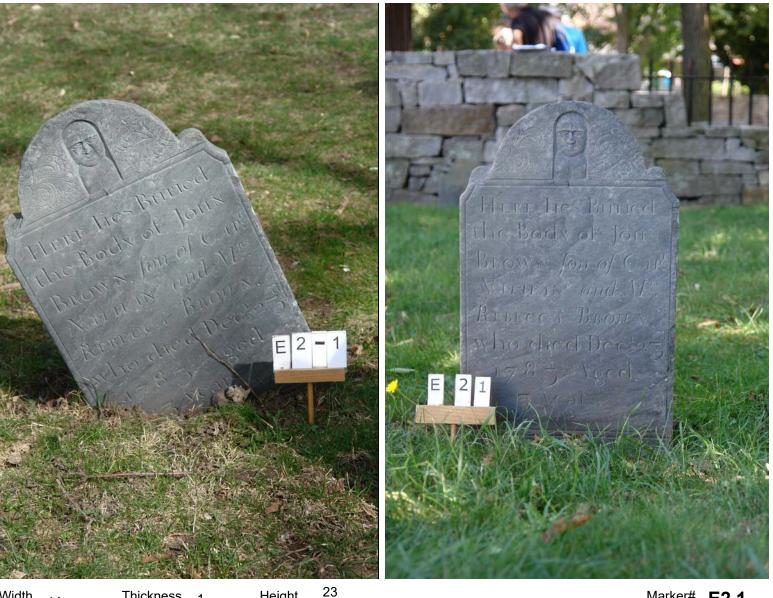
**Charter Street Cemetery** NAME ON MARKER John Brown 12/23/1783 Marker Type: Death Date: Headstone Condition of Inscription: Legible Material: Slate **EXISTING CONDITIONS** CONSERVATION STRATEGY Reset plumb Possible new below base 1) Hazardous, immediate action 2) Unstable- asap **CONSERVATION PRIORITY** 1.5 3) Ongoing deterioration, treat 2-5 years 4) Stable A) Artistic H) Historical P) Visually prominent M) Monitor TREATMENT Date(s) of treatment 6/6/2016 1. Marker carefully excavated removing the soil around tilted markers to an appropriate depth. Marker appears to be 2. Setting area excavated to sufficient depth and stone reset plumb at appropriate height and level onto gravel bed, aligned with adjacent markers. 3. Area backfilled around marker with tamped sand and 4. Disturbed areas re-graded with existing topsoil and sod.

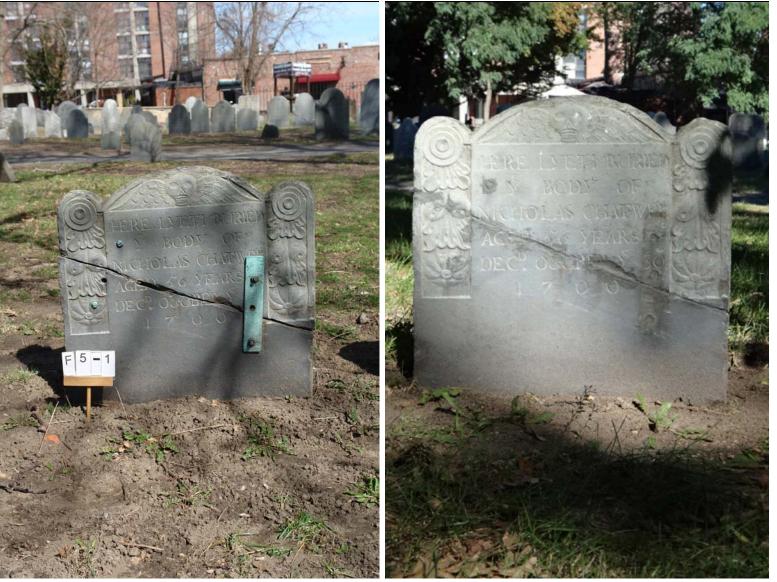
20

#### **Charter Street Cemetery** Cemetery: NAME ON MARKER Nicholas Chatwel (?) 10/30/1700 Death Date: Marker Type: Headstone Condition of Inscription: Decipherable Slate Material: **CONSERVATION STRATEGY EXISTING CONDITIONS** Metal strap **Remove metal strap** Fractured Attach fragments with structural adhesive

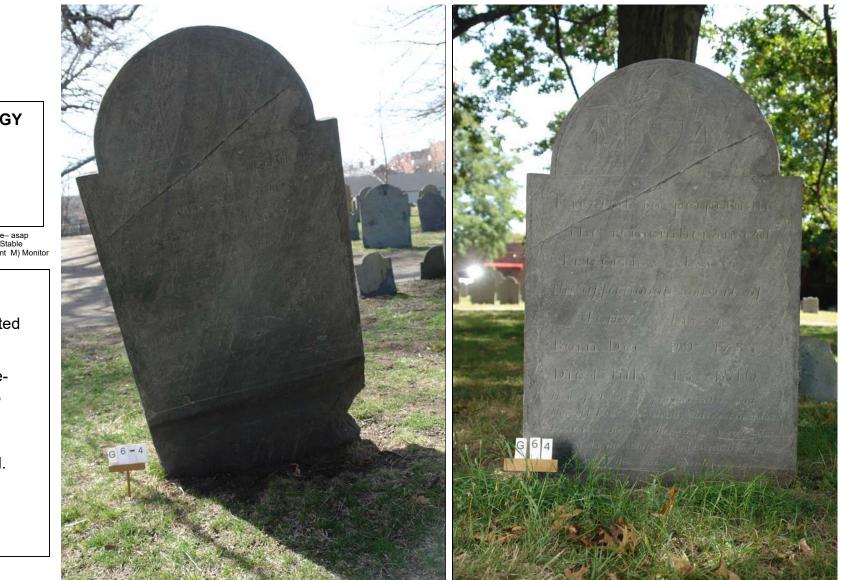
41

#### **Charter Street Cemetery** Cemetery: NAME ON MARKER **Priscilla Jayne** Headstone 7/18/1810 Death Date: Marker Type: Condition of Inscription: Legible Material: Slate **EXISTING CONDITIONS** CONSERVATION STRATEGY Tilted **Reset plumb** Possible new below base 1) Hazardous, immediate action 2) Unstable- asap **CONSERVATION PRIORITY 2** 3) Ongoing deterioration, treat 2-5 years 4) Stable A) Artistic H) Historical P) Visually prominent M) Monitor Date(s) of treatment 6/29/2016 TREATMENT 1. Marker carefully excavated removing the soil around tilted markers to an appropriate depth. Marker appears to be sound. 2. Setting area excavated to sufficient depth and stone reset plumb at appropriate height and level onto gravel bed, aligned with adjacent markers. 3. Area backfilled around marker with tamped sand and gravel 4. Disturbed areas re-graded with existing topsoil and sod.

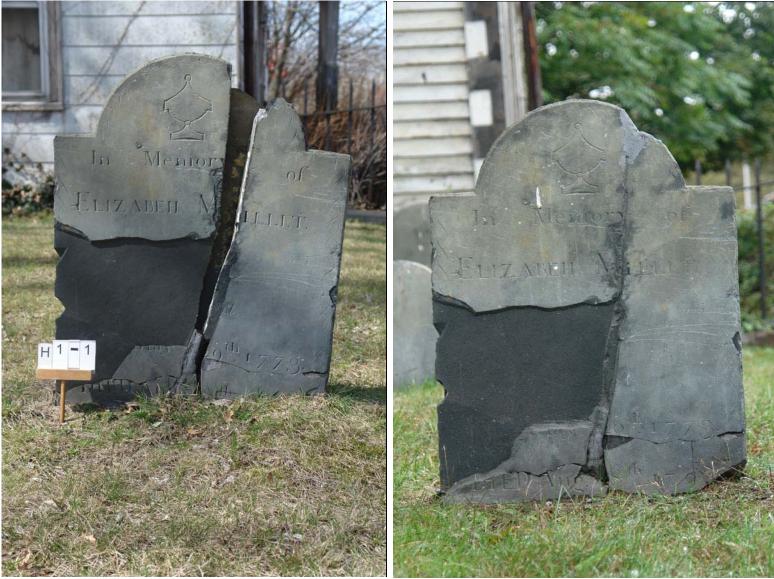
#### Comments: Adhesive repair and reset in 1995

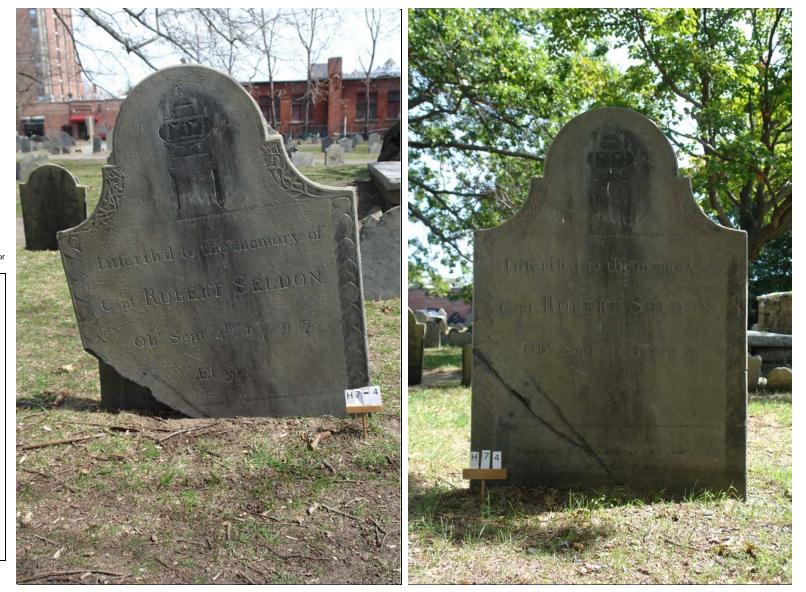
**Charter Street Cemetery** Cemetery: Capt. Robert Seldon NAME ON MARKER Marker Type: Headstone 9/4/1797 Death Date: Condition of Inscription: Legible Material: Slate **EXISTING CONDITIONS** CONSERVATION STRATEGY Tilted Reset plumb Attach fragments with structural Fractured adhesive Possible new below base 1) Hazardous, immediate action 2) Unstable- asap **CONSERVATION PRIORITY** 1 3) Ongoing deterioration, treat 2-5 years 4) Stable A) Artistic H) Historical P) Visually prominent M) Monitor Date(s) of treatment 6/27-9/20/2016 TREATMENT

1. Marker and fragment carefully excavated and inspected for soundness. Area probed for buried or overgrown fragments. 2. All mating edges of fragments cleaned with water and failed adhesives removed with hand tools.

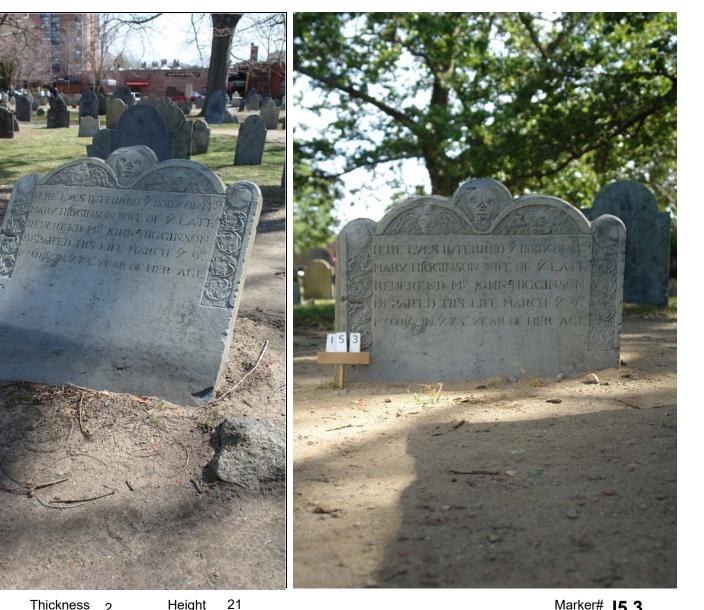
**Charter Street Cemetery** Cemetery: Mary Higginson NAME ON MARKER Death Date: 3/9/1708/9 Marker Type: Headstone Condition of Inscription: Legible Material: Slate **EXISTING CONDITIONS CONSERVATION STRATEGY Reset plumb** Tilted Possible new below base 1) Hazardous, immediate action 2) Unstable- asap **CONSERVATION PRIORITY 1.5** 3) Ongoing deterioration, treat 2-5 years 4) Stable A) Artistic H) Historical P) Visually prominent M) Monitor Date(s) of treatment 6/27/2016 TREATMENT 1. Marker carefully excavated removing the soil around tilted markers to an appropriate depth. Marker appears to be sound.

2. Setting area excavated to sufficient depth and stone reset plumb at appropriate height and level onto gravel bed, aligned with adjacent markers.

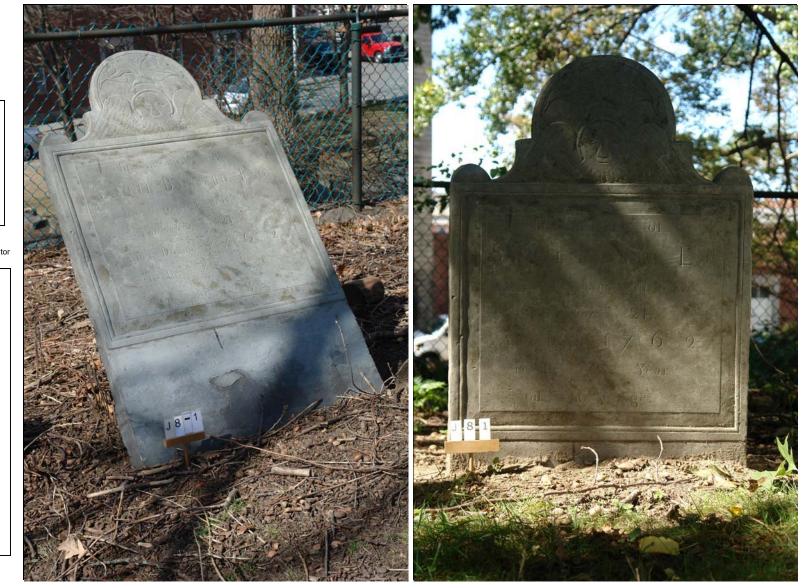
#### Cemetery: **Charter Street Cemetery** NAME ON MARKER Samuel Barnard 11/21/1769 Marker Type: Headstone Death Date: Condition of Inscription: Legible Material: Slate **EXISTING CONDITIONS CONSERVATION STRATEGY** Tilted Reset plumb Possible new below base 1) Hazardous, immediate action 2) Unstable- asap **CONSERVATION PRIORITY 1.5** 3) Ongoing deterioration, treat 2-5 years 4) Stable A) Artistic H) Historical P) Visually prominent M) Monitor TREATMENT Date(s) of treatment 6/27/2016 1. Marker carefully excavated removing the soil around tilted markers to an appropriate depth. Marker appears to be sound. 2. Setting area excavated to sufficient depth and stone re-set plumb at appropriate height and level onto gravel bed, aligned with adjacent markers. 3. Area backfilled around marker with tamped sand and gravel 4. Disturbed areas re-graded with existing topsoil and sod.

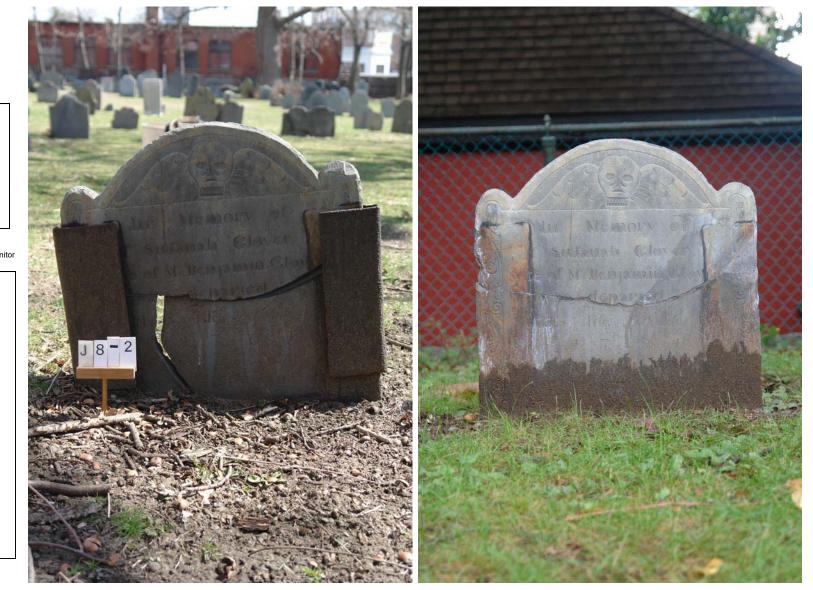
#### Susanah Clover NAME ON MARKER 12/16/1761 Death Date: Marker Type: Headstone Condition of Inscription: Legible Material: Slate **EXISTING CONDITIONS** CONSERVATION STRATEGY **Remove metal supports** Fragmented Structural adhesion Tilted **Reset plumb** Metal supports Possible new below base 1) Hazardous, immediate action 2) Unstable- asap **CONSERVATION PRIORITY 1.5** 3) Ongoing deterioration, treat 2-5 years 4) Stable A) Artistic H) Historical P) Visually prominent M) Monitor TREATMENT Date(s) of treatment
