Winter Island Barracks Building Re-Use Feasibility Study

SALEM, MASSACHUSETTS

Submitted to:
City of Salem

Submitted by:
Vine Associates, Inc.

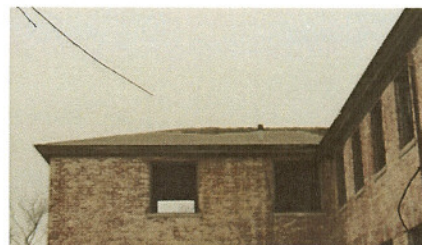
Roof South Side EL

Roof: The building's roof design is a shallow hip (circa 7 1/2 in 12) covered with slates. Ornamental brick chimneys are positioned about 30 feet from the north and south ends.

The entire roof needs to be replaced. Currently water enters through the roof and freezes in the joints between the concrete floors and the walls causing damage to the structure.

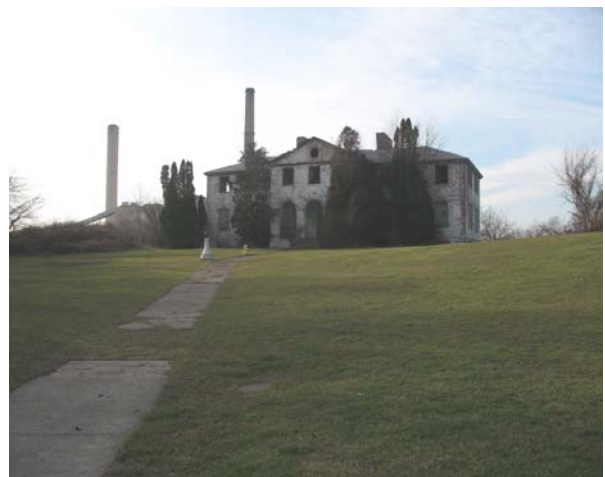
View of East Lawn

The site appears to be relatively free of encumbrances to further development. The sloping terrain lends itself to molding and the vegetation is unremarkable.
