Greenlawn Chapel, Salem, Mass.

City of Salem- Dickson Memorial Chapel Restoration 2016
Department of Planning and Community Development
By: Erin Schaeffer, Staff Planner

Phase I: Municipal Restoration
2016-2017

Existing Conditions and Project Scope

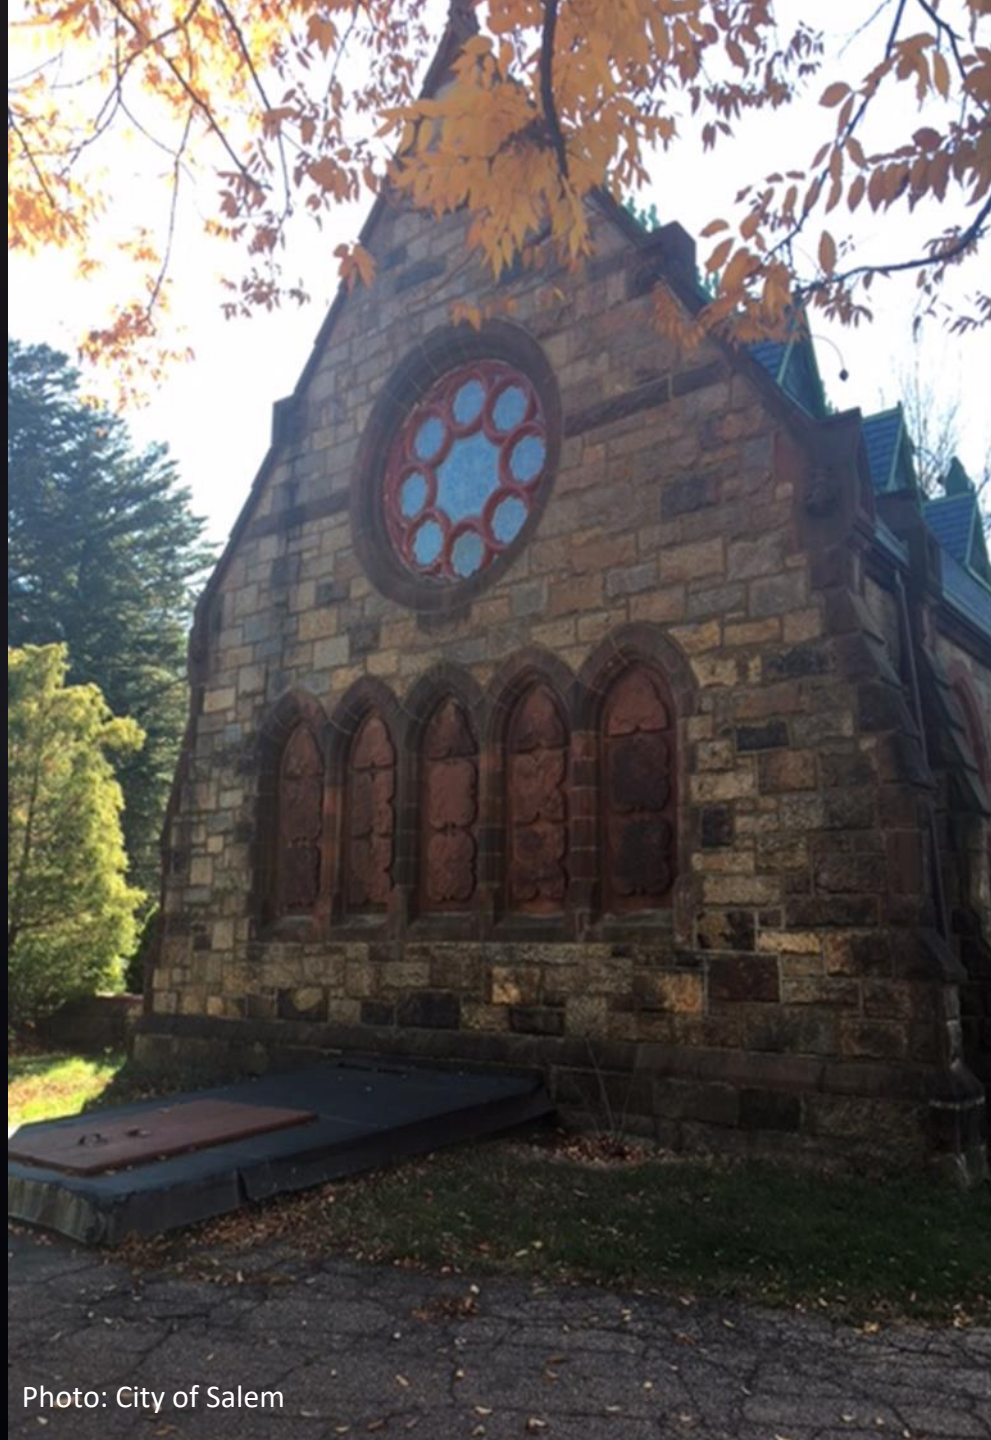
Existing Conditions- East Rose Window

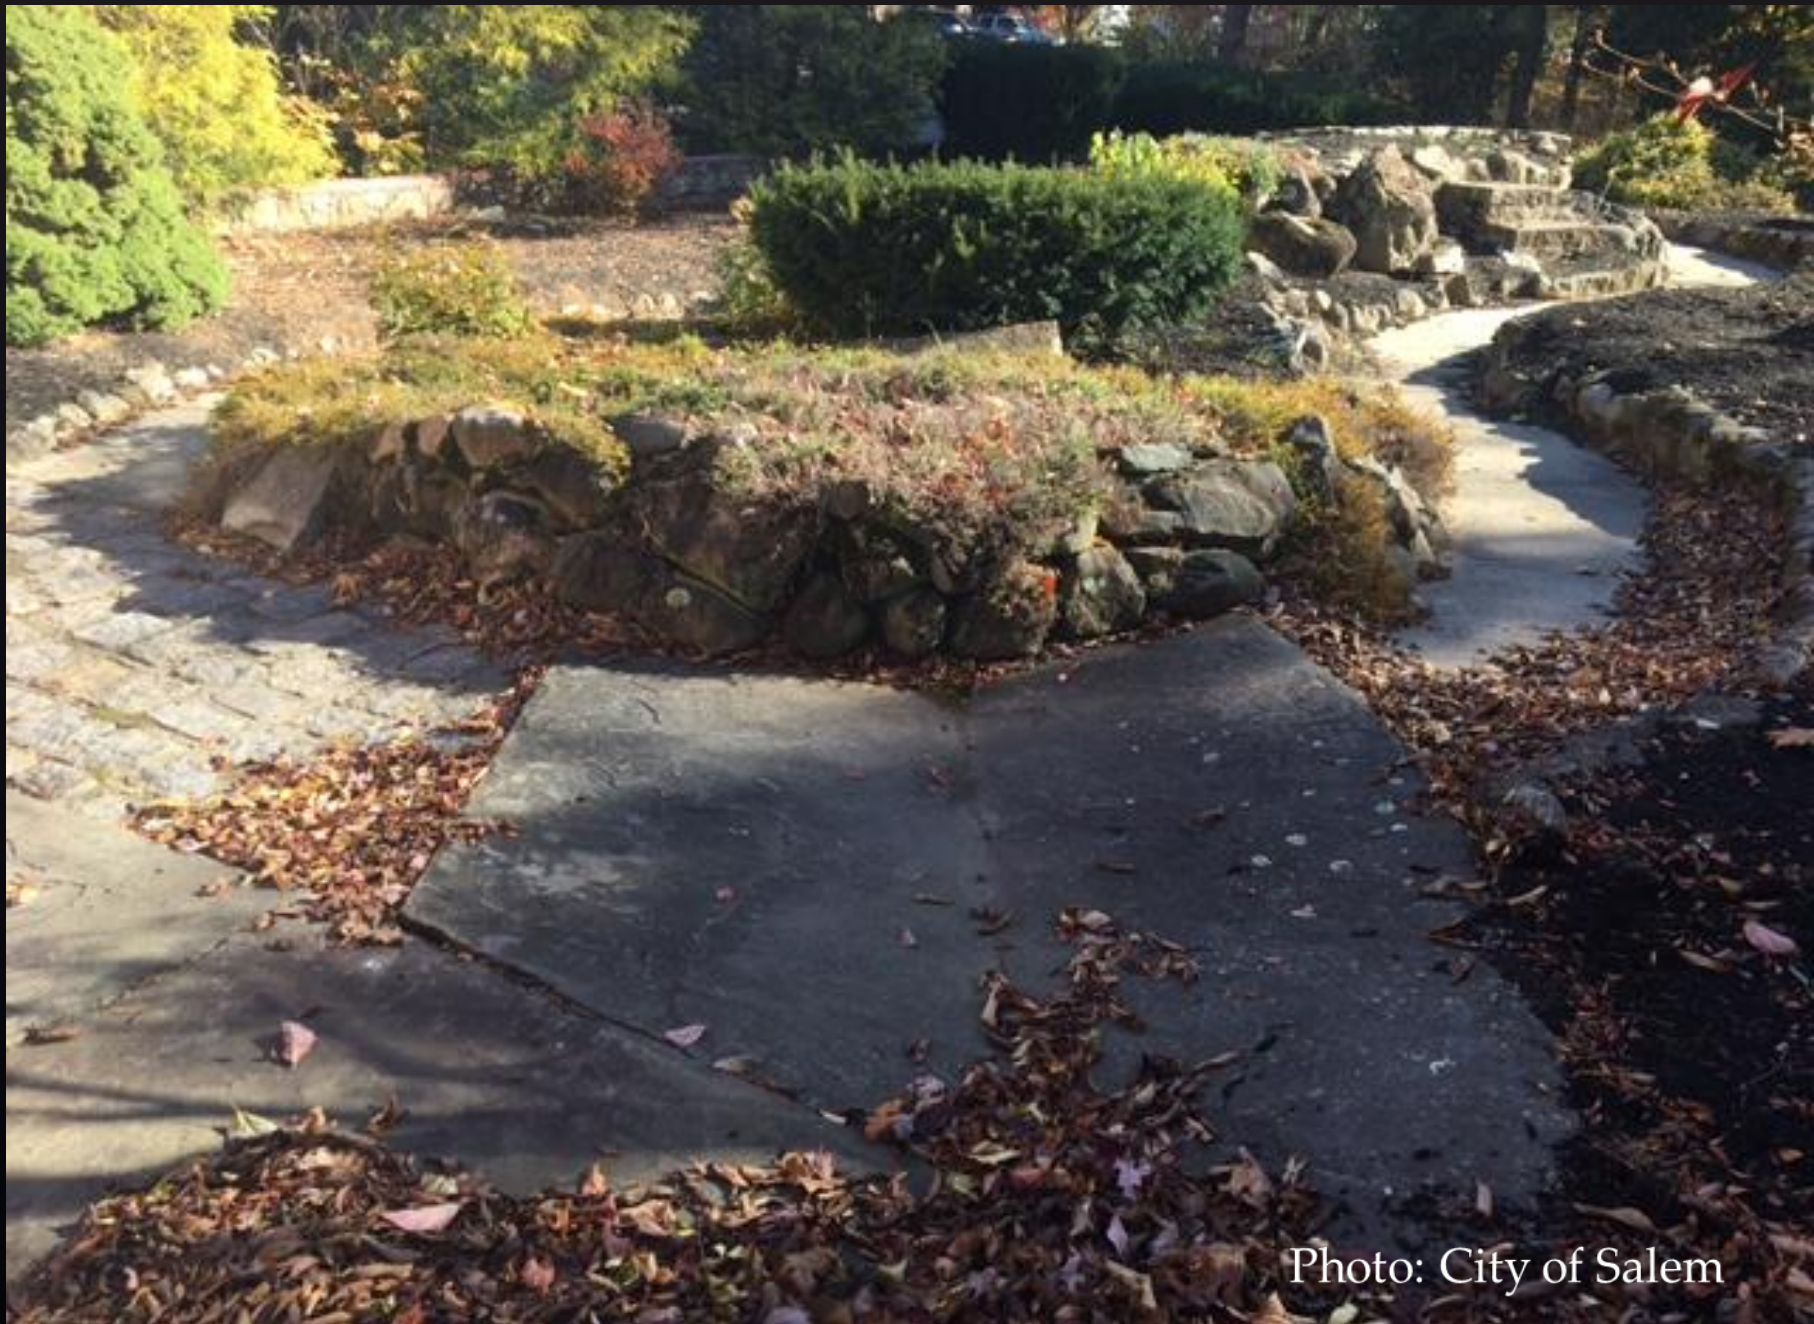
Existing Conditions- Gutters and Downspouts South Façade Alternate #2

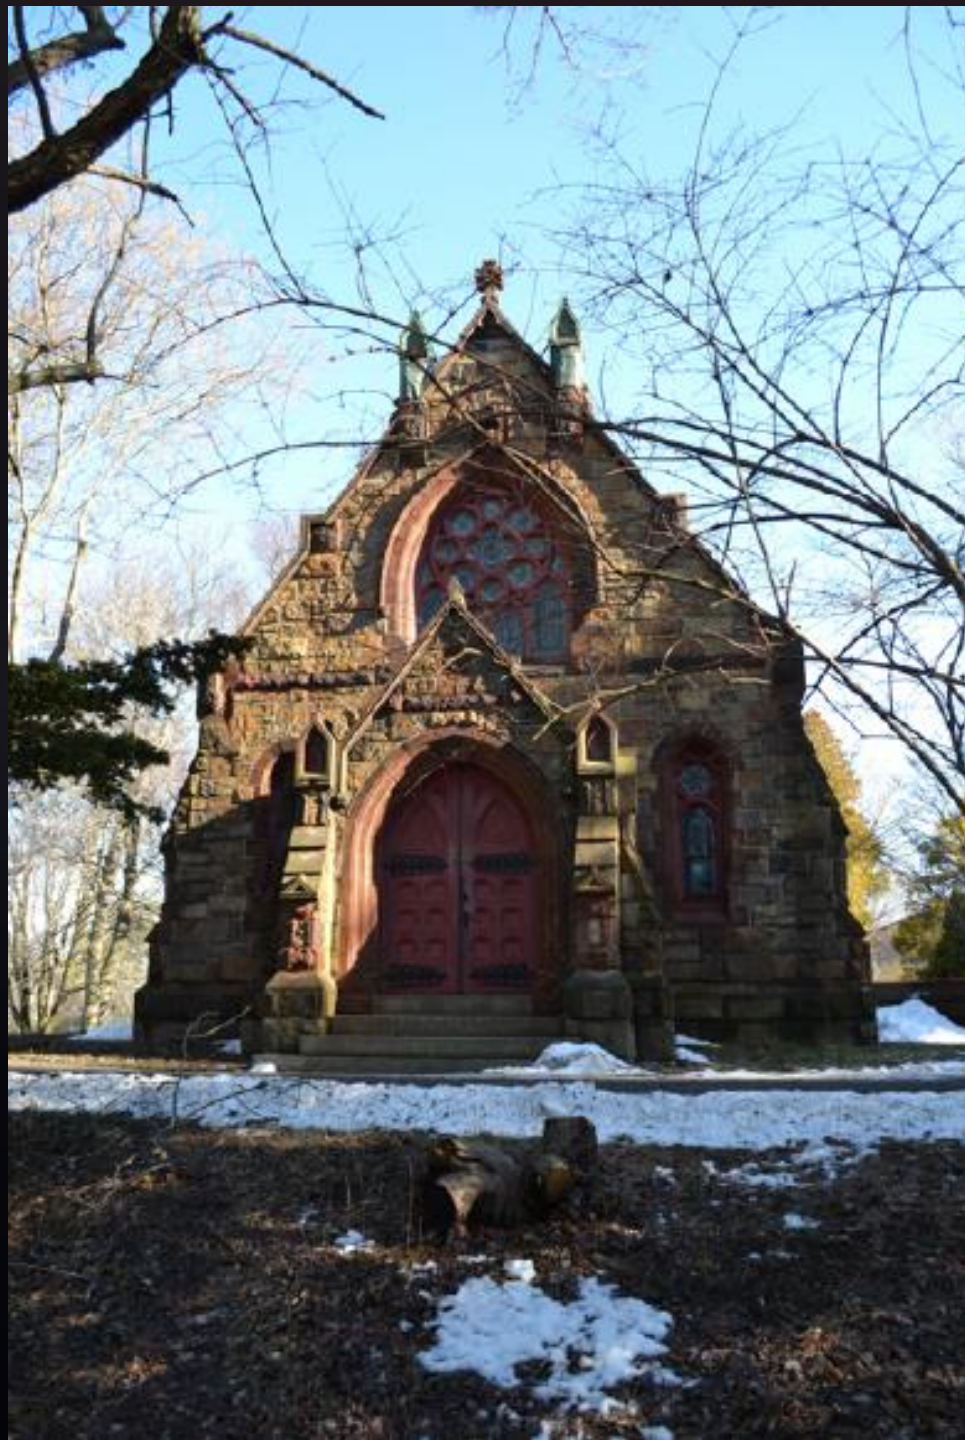
S2.1

ITEM #1: ERODED MORTAR JOINTS- MUST BE CUT AND POINTED

ITEM #2: DEEPLY ERODED MORTAR JOINTS, MUST DEEPLY CUT AND POINT, RE-SET STONES THAT LOOSEN DURING CUTTING

ITEM #3: BULGED OR SHIFTED FLAT MASONRY, MUST BE REMOVED AND RE-SET

ITEM #4: BULGED OR SHIFTED PROJECTING MASONRY, MUST BE DISMANTLED AND RECONSTRUCTED FROM 3-SIDES

ITEM #5: DAMAGED INTERIOR MASONRY UNITS, MUST BE REPLACED

ITEM #6: EFFLORESCENT DEPOSITS, SIGN OF DAMNNESS OR LEAKAGE

ITEM #7: CRACK THROUGH MORTAR JOINTS, EXCAVATE, POINT AND GROUT, RE-SET STONES ALONG CRACK THAT HAVE LOOSENED

ITEM #8: CRACK THROUGH UNIT, REPLACE OR REPAIR
