Re: Preliminary Design Summary Letter  
Columbus Avenue Seawall Reconstruction Project (EEA #258-2020-3)  
Salem, Massachusetts

GZA GeoEnvironmental, Inc. (GZA) is pleased to submit this summary letter of preliminary design progress for the Columbus Avenue Seawall Reconstruction Project to the City of Salem (Client). The summary letter is provided in accordance with our agreement for design and permitting services for the above-referenced project, dated January 22, 2020. This summary letter is subject to the Limitations indicated in **Attachment A**. Elevations provided are referenced to the North American Vertical Datum 1988 (NAVD88).

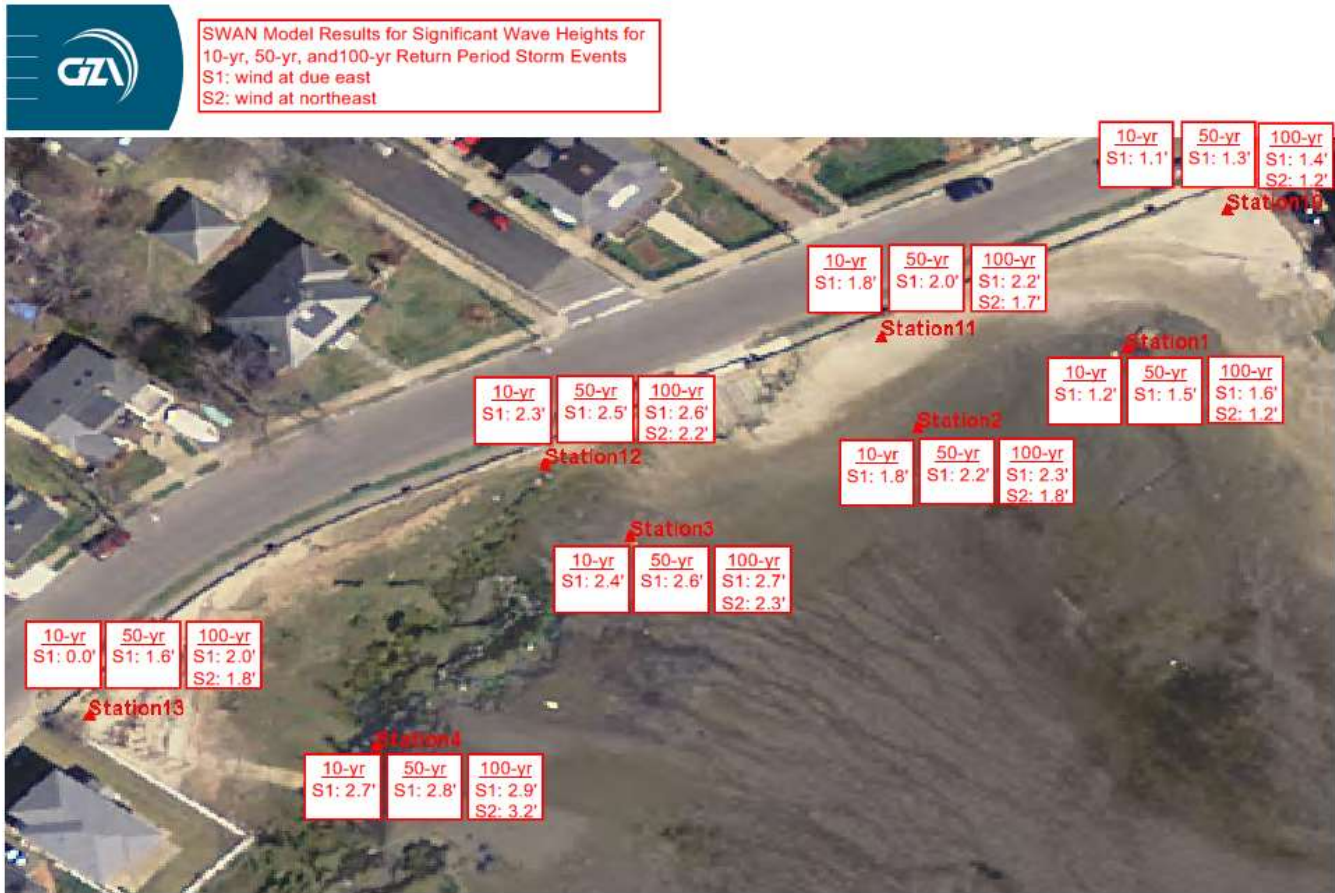
Figure B-24: Output Stations 10 to 13 adjacent to the CAS for SWAN Model Results.

The simulated wave heights indicated significant wave attenuation within Juniper Cove from about 10 feet at the Cove inlet to about 1.4 feet to 2.6 feet at the seawall for the predicted 100-year recurrence interval flood event. Waves along the seawall range from approximately 1.4 feet to 2.6 feet in height for the 100-year storm event. Comparatively, for the 10-year storm event, waves along the seawall range from no waves at the southwest corner to approximately 2.3 feet towards the center of the seawall. **Figure B-24** shows the SWAN model results for the significant wave heights at various output stations along the existing seawall and just seaward of the seawall for the 10-year, 50-year, and 100-year recurrence interval events.

Generally, the largest predicted waves occur towards the center of the seawall and the smallest predicted waves occur at the northeast corner, likely due to the topographic difference and natural sheltering. Although significant wave attenuation occurs within the Cove, the wave heights would still likely overtop the existing seawall based on the existing conditions.

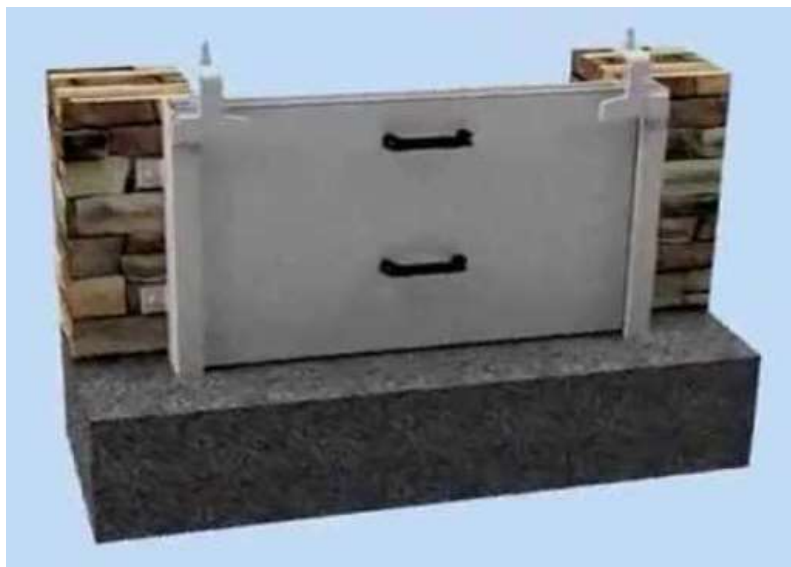
**Figure 3: Example Stop-Log Type Removable Flood Barrier**

The existing seawall has an approximate 20 linear foot opening for the beach access granite block landing. It is our understanding that during the off-season and during storm events the opening is blocked using sandbags and concrete blocks. The proposed project will incorporate the design of removable flood barriers for increased protection and resiliency against waves and flooding events. The design will likely consist of permanent fixed end steel channel brackets with removable stop-log type beams, with consideration for a mid-span support or lateral brace anchors. The flood barriers will be designed based on the anticipated metocean and wave conditions as previously discussed. See example flood barrier, **Figure 3**.

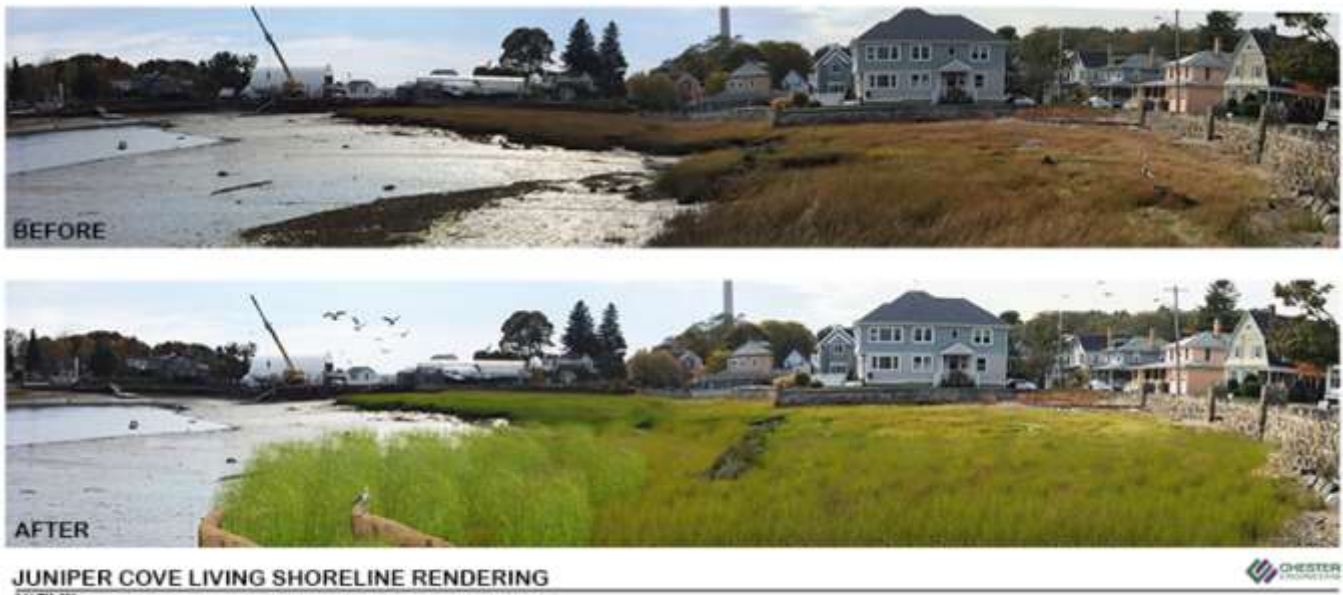
**Figure 4: Living Shoreline Salt Marsh Enhancement Rendering by Chester Engineers**

The proposed salt marsh enhancement design aims to stabilize the shoreline and reduce erosion, attenuate waves, and provide habitat for plant and animal species. The conceptual design was originally developed by Chester Engineers, Inc. in 2016 as part of a Salem Living Shoreline Project – Conceptual Designs report. Refer to the rendering by Chester Engineers, **Figure 4**.

The proposed salt marsh enhancement includes new toe protection sills at the seaward edge, sand nourishment to meet the level of the existing remnant salt marsh and to fill voids within the existing marsh, and new salt marsh plantings for enhanced vegetative cover.

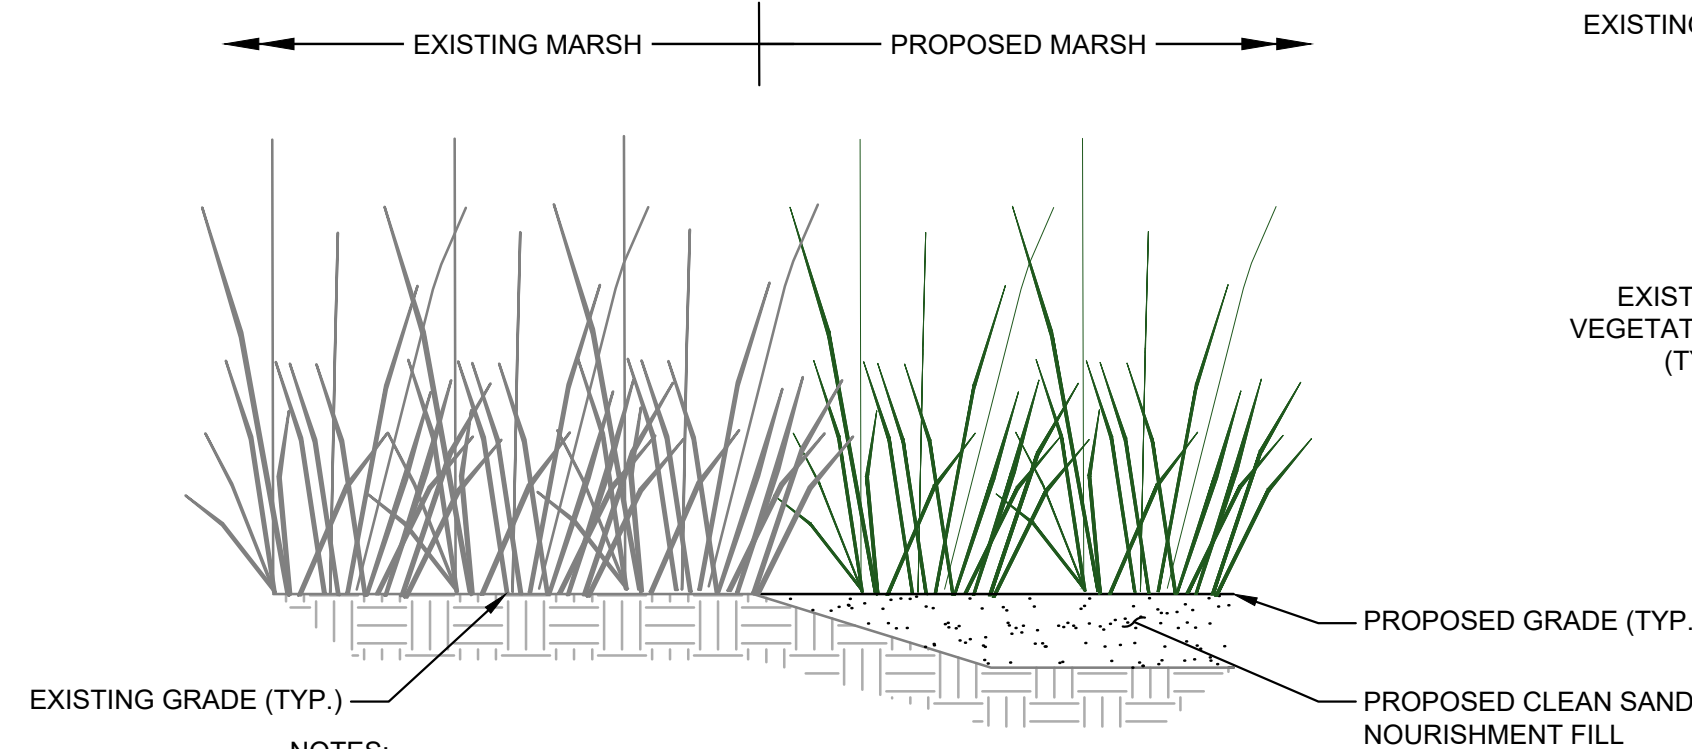
**TIE-IN WITH EXISTING MARSH DETAIL**

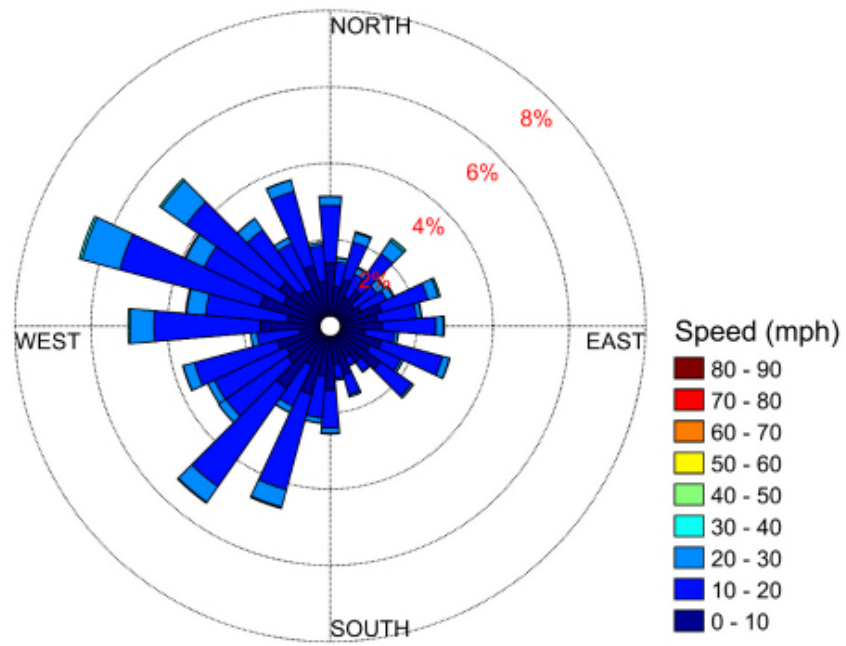
Figure B-12: Wind rose at the nearby Boston Logan Airport.

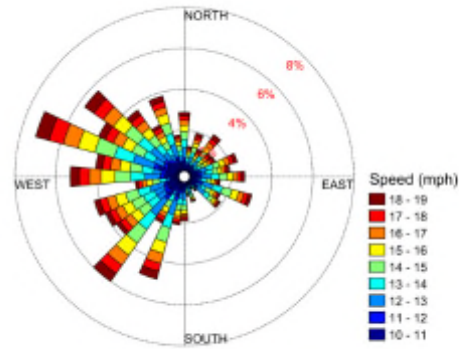
Figure B-13: Wind rose for various speed ranges at the nearby Boston Logan Airport.

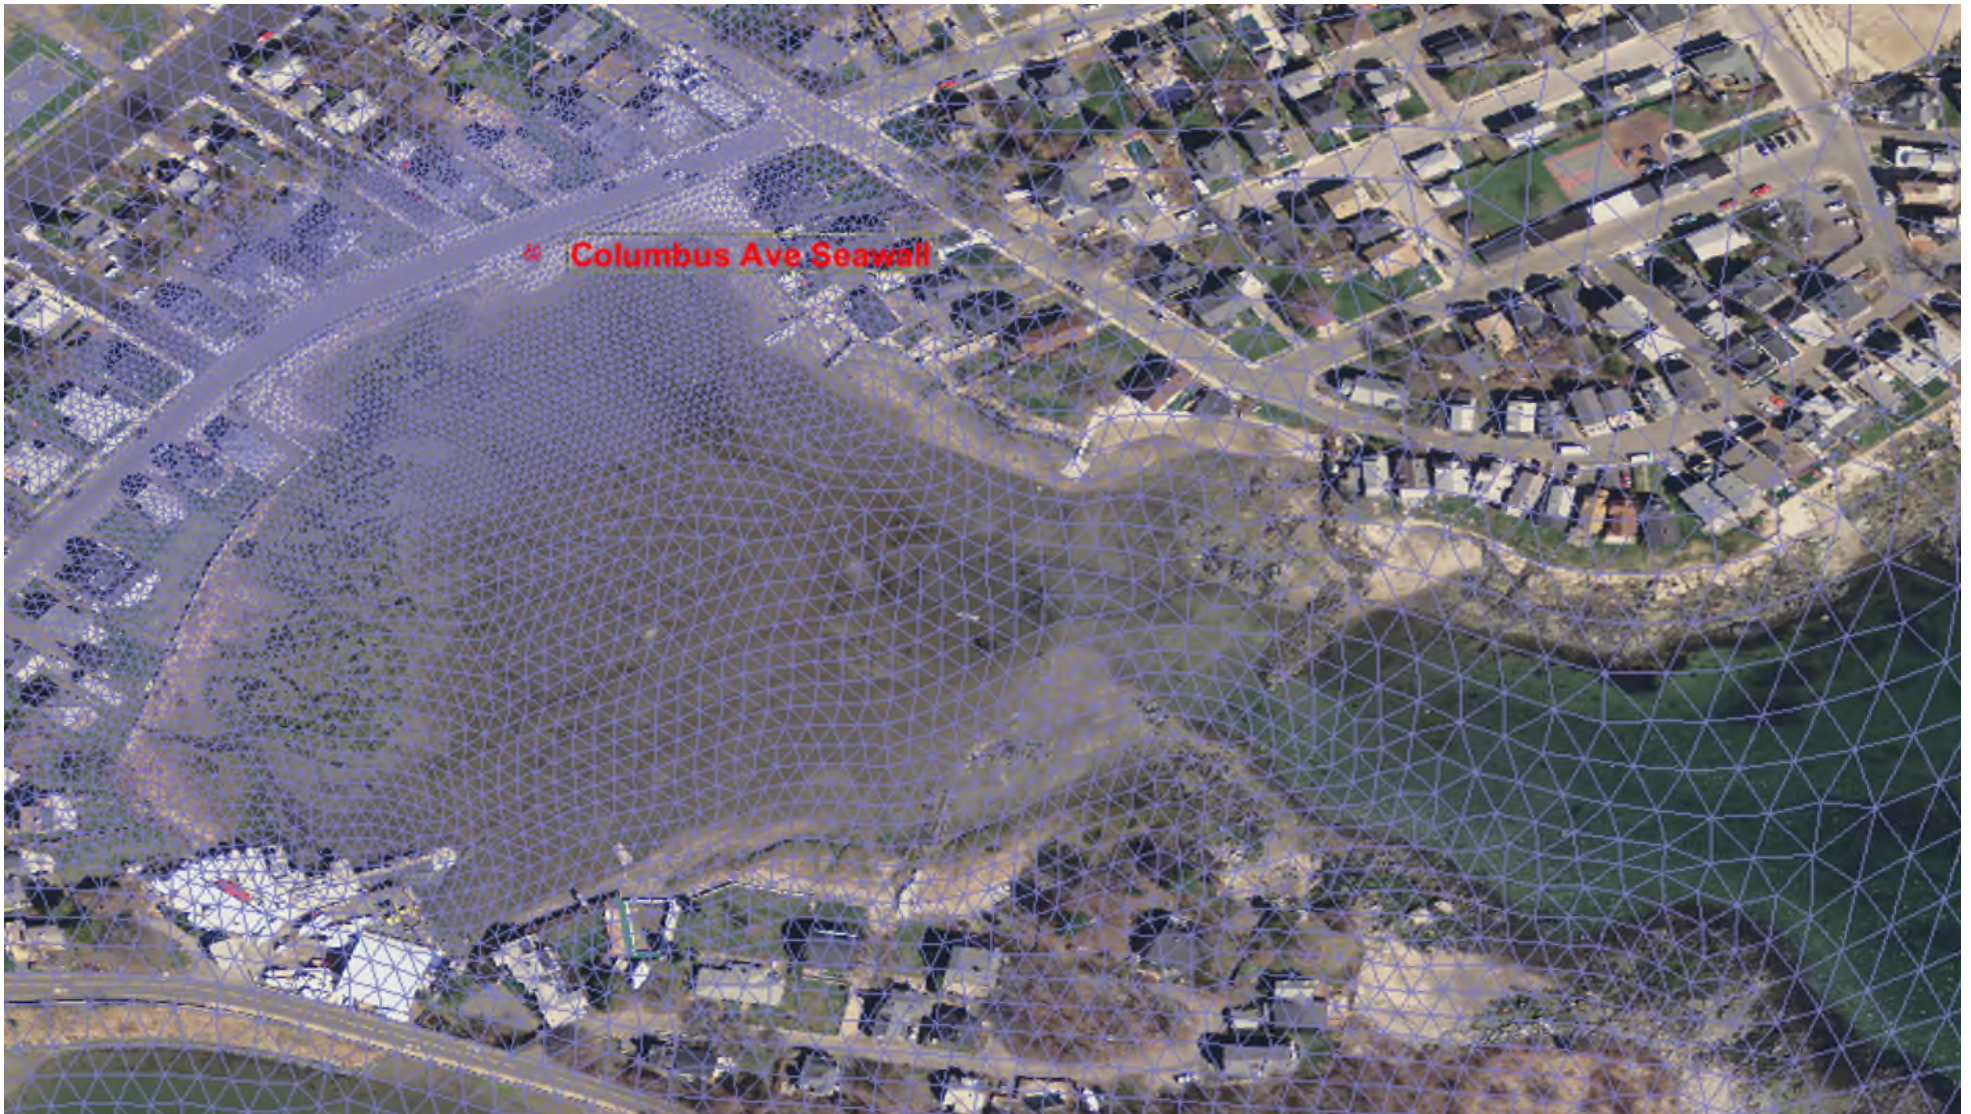
Figure B-16: SWAN model mesh – zoomed view.

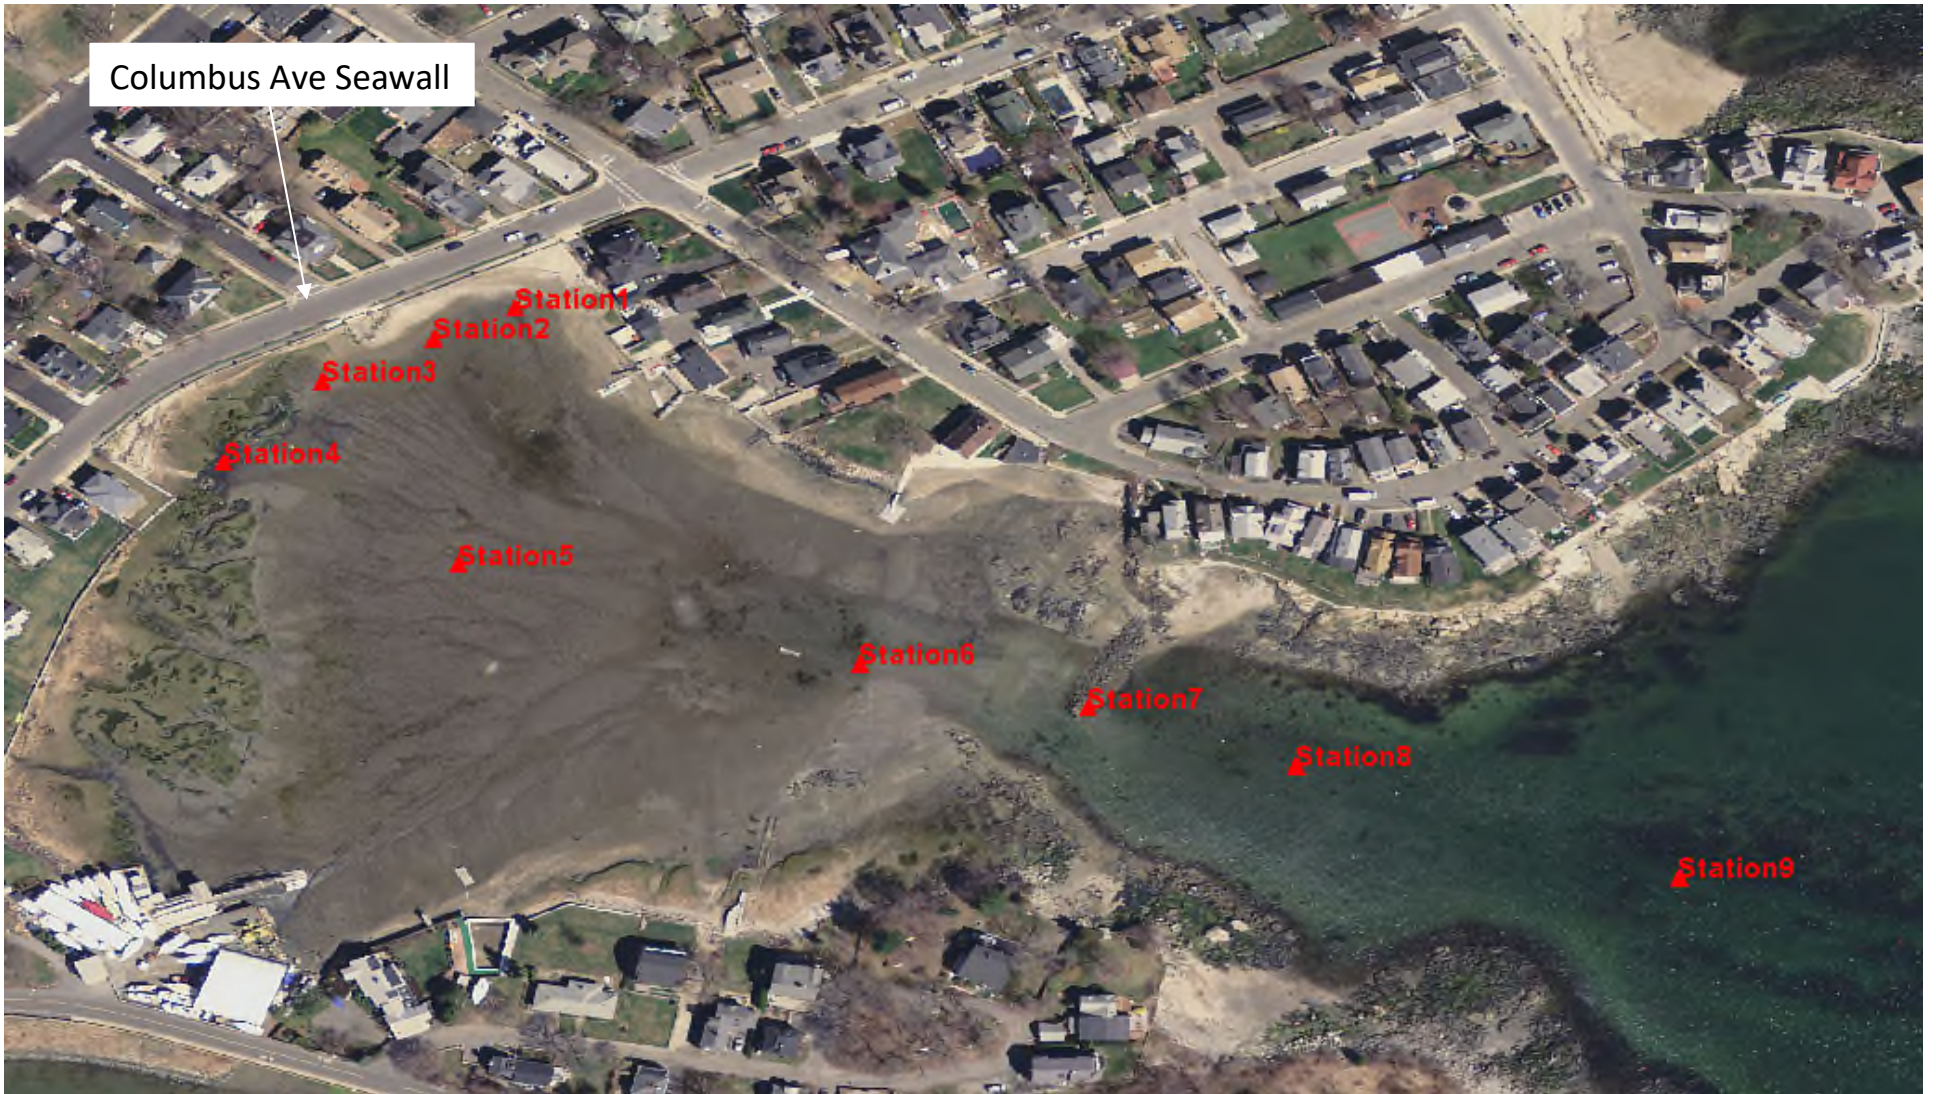
Figure B-23: Output Stations for SWAN Model Results.

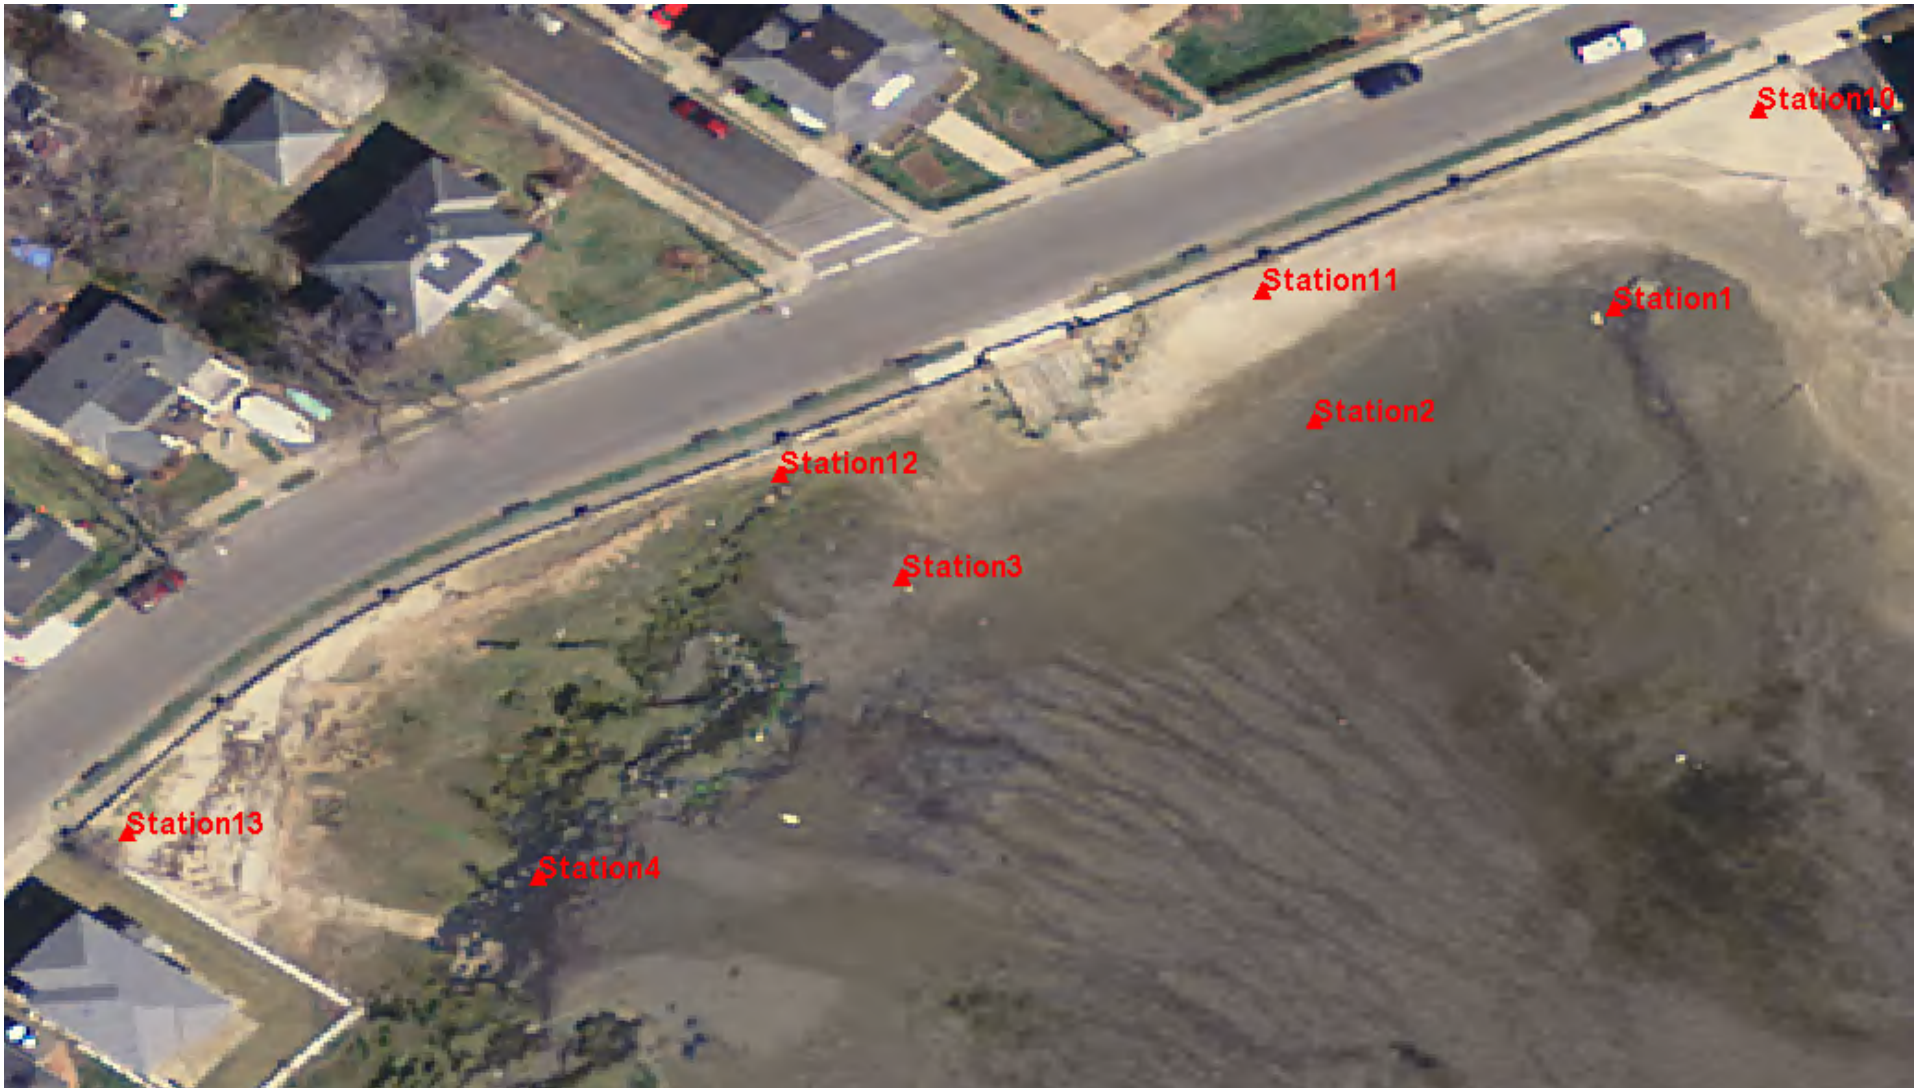
Figure B-24: Output Stations 10 to 13 adjacent to the CAS for SWAN Model Results.

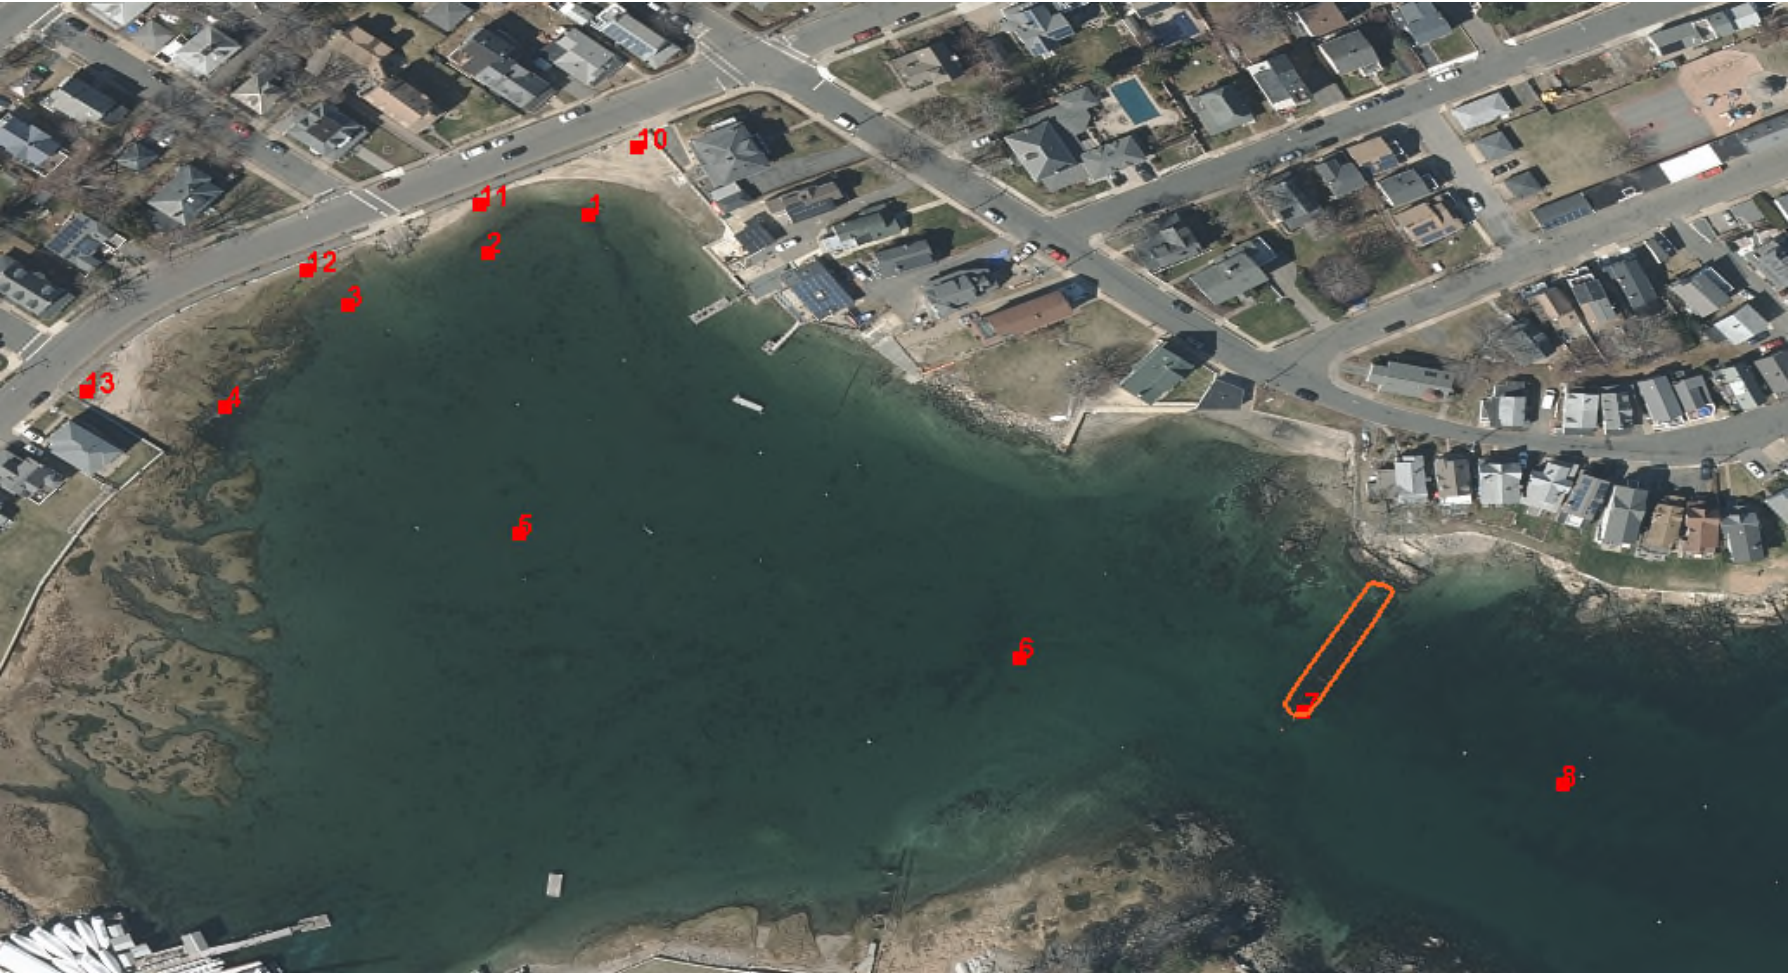
Figure B-25: Output Station ID and location of the breakwater (orange color).

Significant wave heights were estimated using the SWAN model for increased breakwater heights (**Figures B-25 through B-33**). If the breakwater crest was raised 5 feet to elevation 5 feet NAVD88, the 100-year flood wave height at the seawall would be reduced by approximately 0 feet to 0.4 feet. The small reduction of wave height is likely because there would be a water depth of 5 feet above the breakwater under 100-year flood event of elevation 10 feet NAVD88, which does not cause significant wave breaking. If the breakwater height is increased to elevation 10 feet NAVD88 the wave heights at the seawall would be reduced by approximately 0.5 feet to 1.4 feet for the 100-year recurrence interval flood event. Refer to **Tables B-8, B-9, and B-10** for results of various output stations.

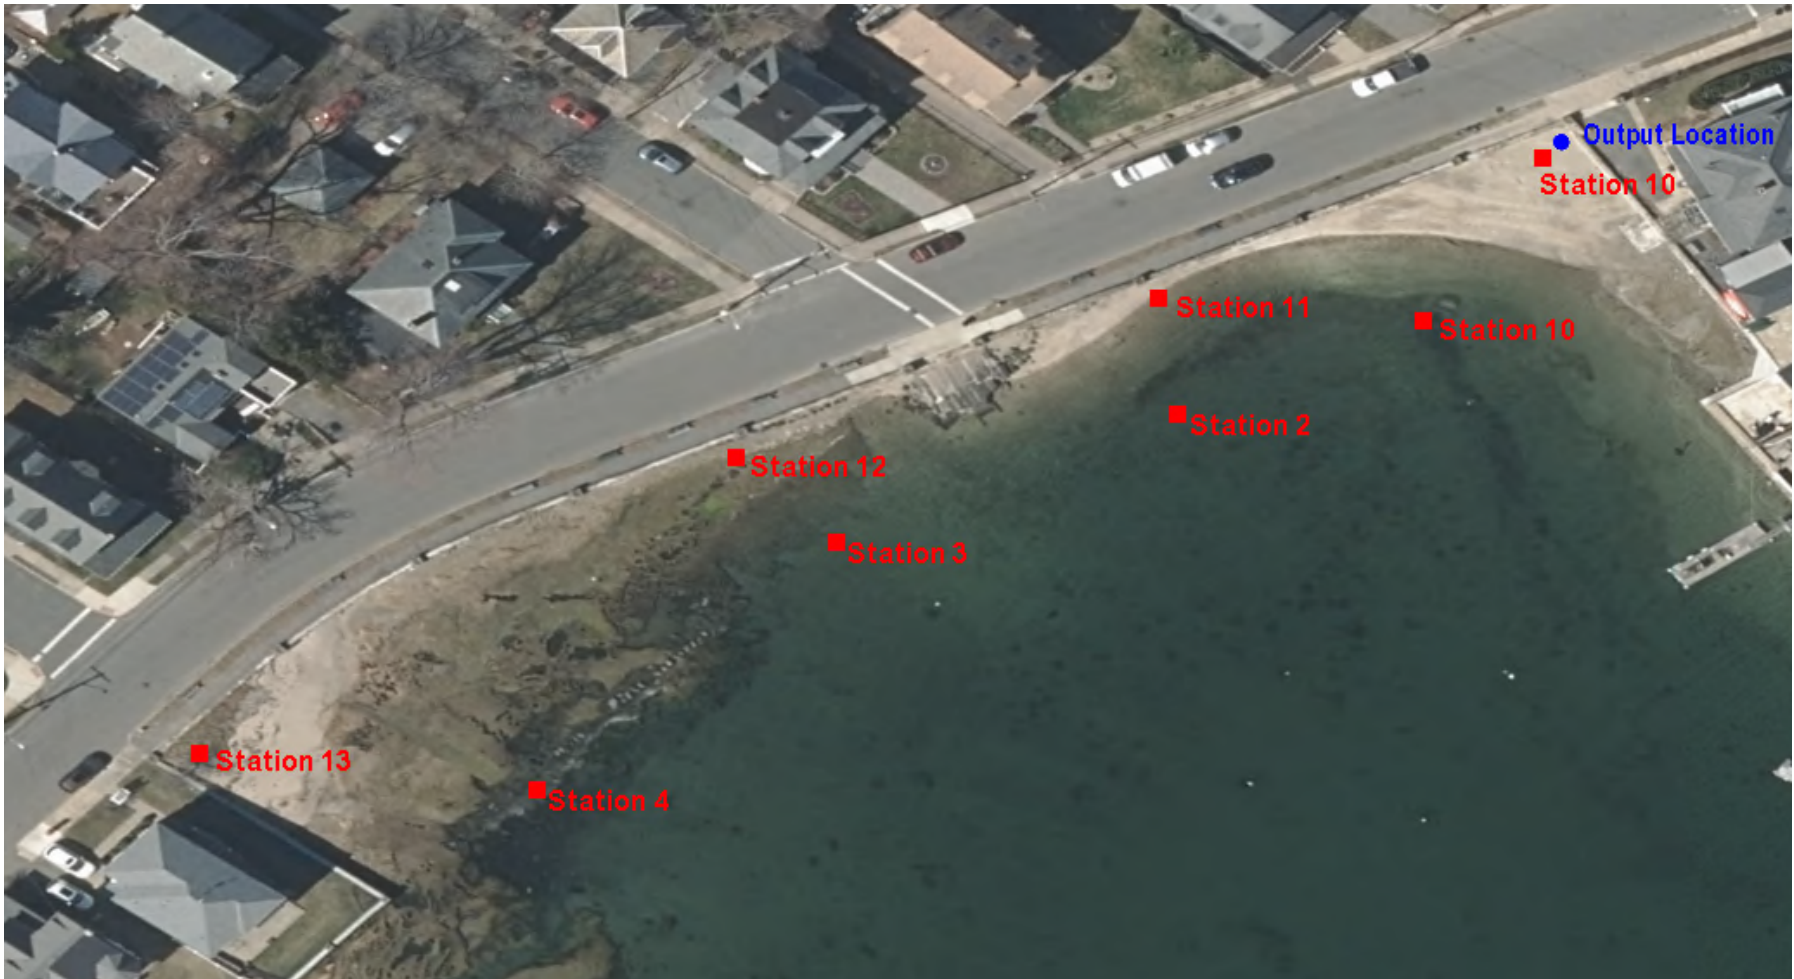
Figure B-34: Wave Runup / Overtopping - Location of output station.

1. See **Figures B-34** through **B-38** for results of runup and overtopping analysis;
2. Calculated based on EurOtop Manual (2018);
3. Estimated simply by stillwater elevation plus 70% of significant wave height;
4. Height of wall located on neighbor properties was not increased in modeling.
