RE: *St. Joseph's Residential Development, 135 Lafayette Street, Salem, MA  
MHC # 47465*

# 1. St. Joseph's Parcel Re-Use Study

On December 1, 2004, we visited the four-building St. Joseph's Church Complex in Salem to perform an interior visual inspection of the buildings' structures. We followed up with visits on December 8 and 9 to inspect the exterior of the buildings. The following is a summary of our findings and recommendations.

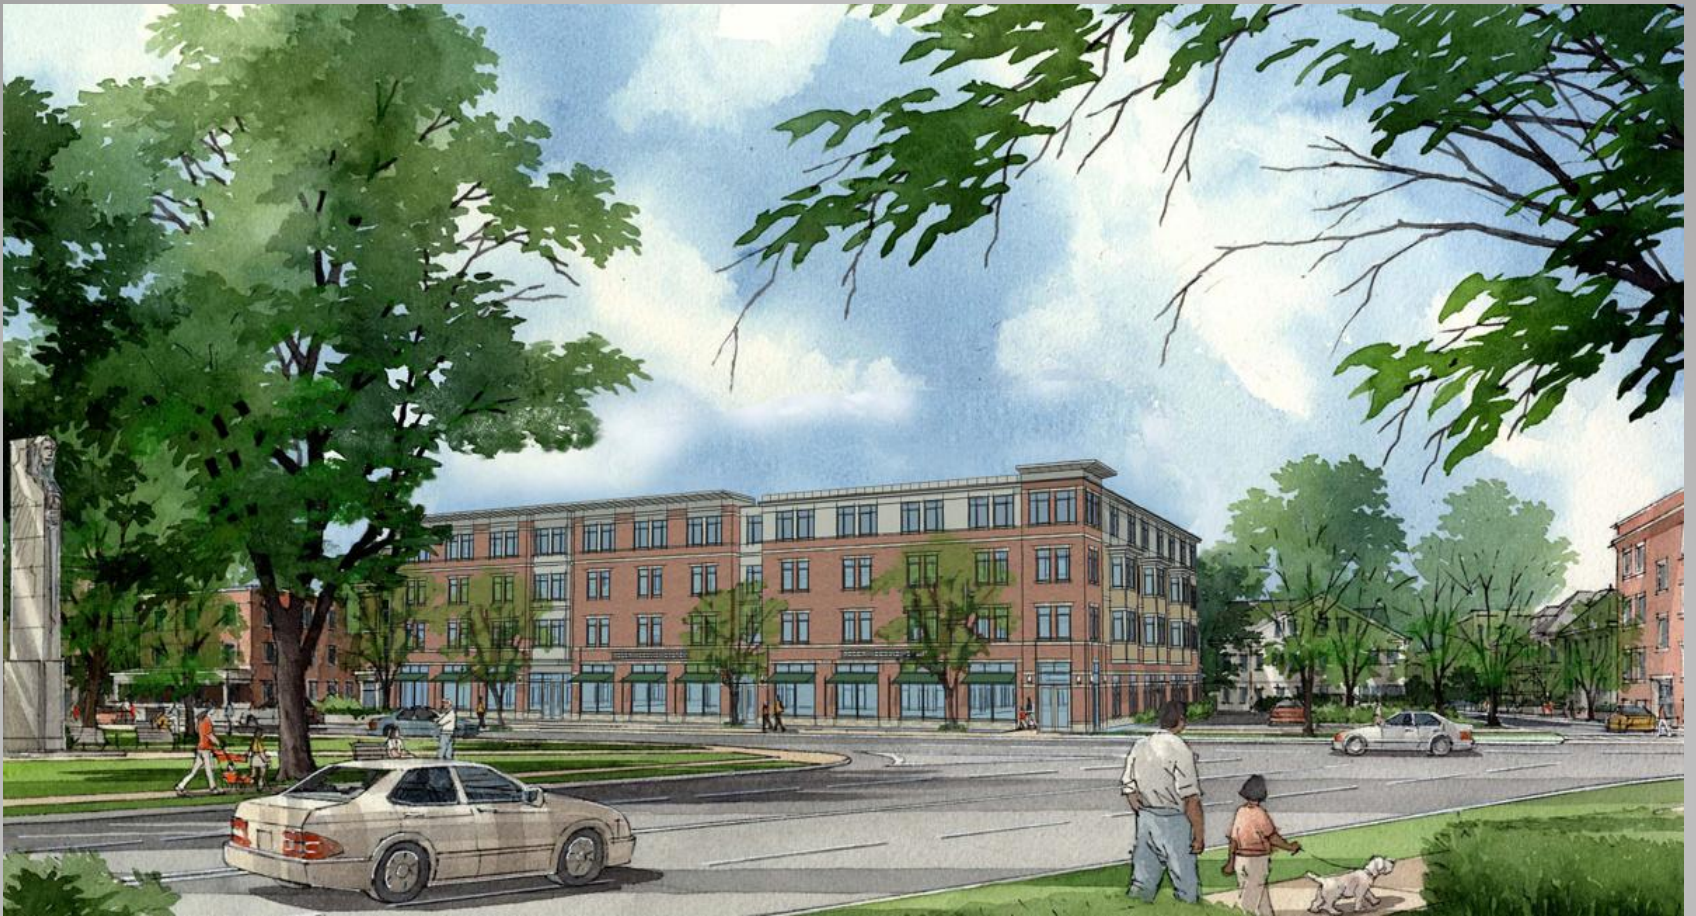
**2011 Concept: 4 stories, 51 units,  
clean design, eliminates plan for  
drive-through and large retail**

With significant input from members of the City's Design Review Board, the final September 2010 design replaced the mansard roof with a strong 4<sup>th</sup> story cornice line, set back the southern half of the Lafayette Street façade to break up the building and added bays along the south Dow Street façade to mimic the more residential buildings in the blocks to the south. The proposed building is in keeping with the recommendation of Historic Salem for a four-story building on the site. Its western elevation fronts on Lafayette Park and Lafayette Street/MA 114, a high-traffic corridor that is a gateway to Downtown Salem. As suggested by members of the Design Review Board, the new building is of brick construction, matching the materials of the existing rectory and school and a majority of the building stock throughout the neighborhood. It also restores the street wall along Lafayette which was lost when the school building formerly located at the corner of Lafayette and Dow was demolished in 1982. Eliminating the asphalt parking lot frontage along such a prominent entrance corridor to the City is an improvement to the neighborhood as well.
