COLUMBUS AVENUE SEAWALL

PROJECT REVIEW MEETING FEBRUARY 3, 2021

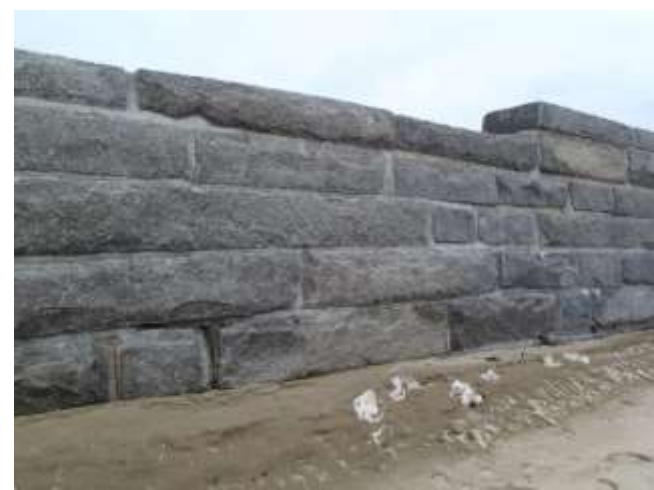
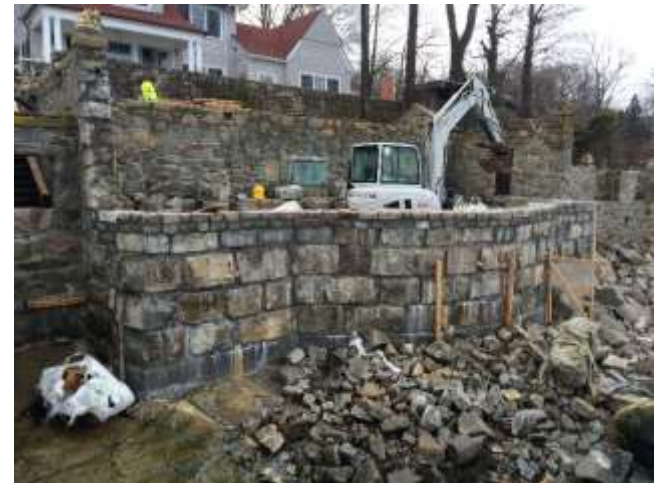
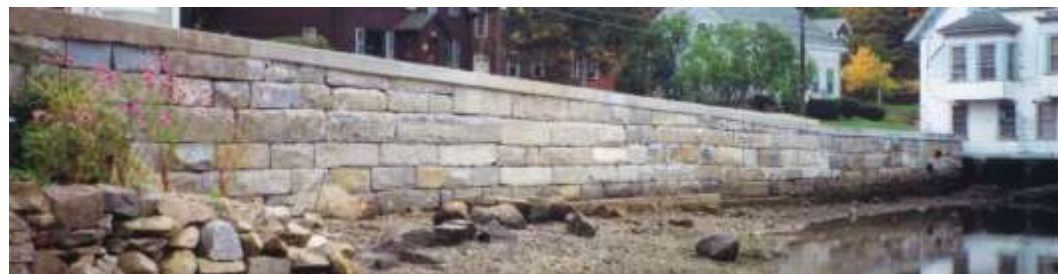
➤ Alt No. 2B – Reconstruct with Large Cut Granite Stone

- Medium upfront cost
- Increased flood protection
- Aesthetics- stone masonry

- Routine maintenance/upkeep
- Material availability

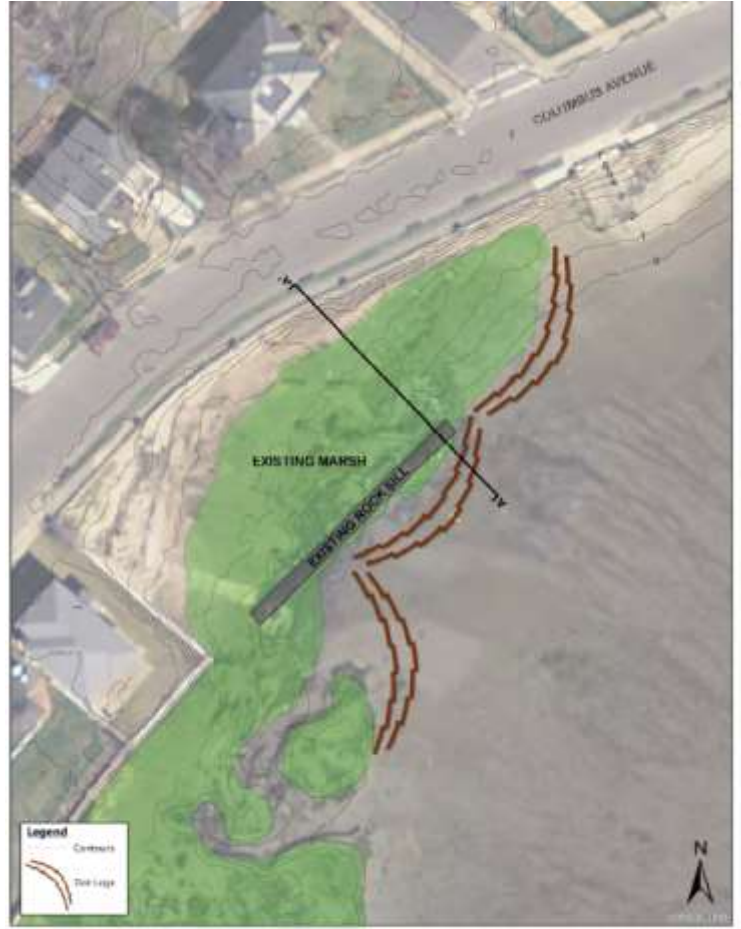
JUNIPER COVE - SALEM, MA
 Design Layout Concept
 Contours referenced to NAVD88 (feet)

Living Shoreline – Marsh Enhancement Area

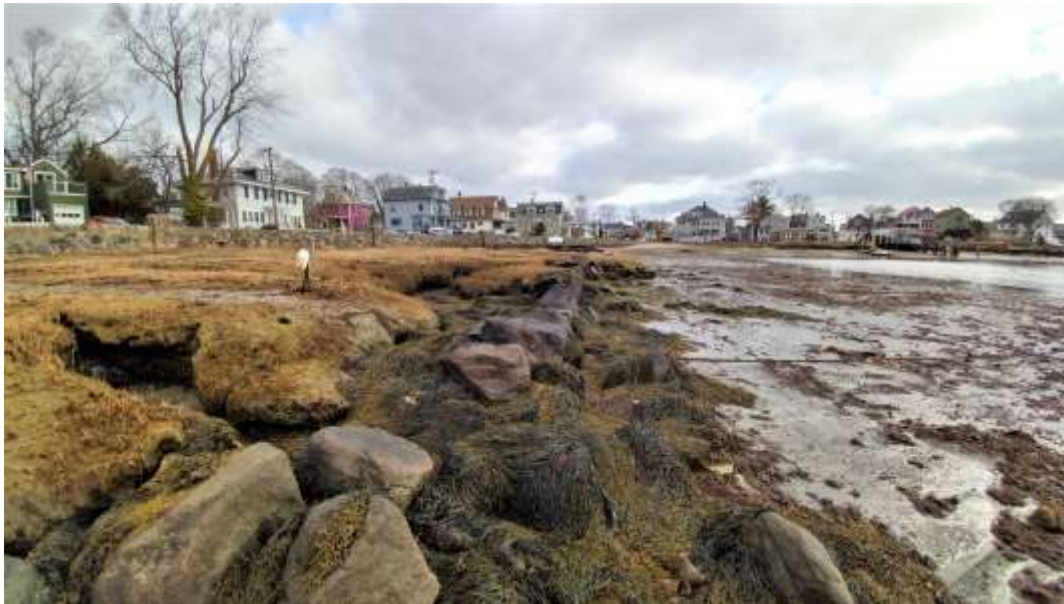
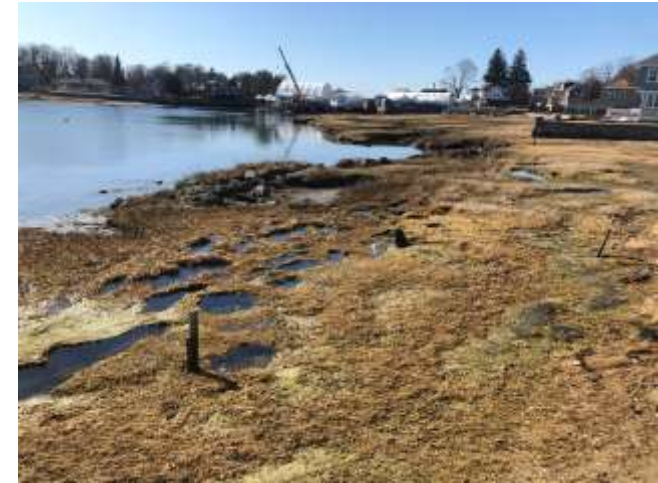
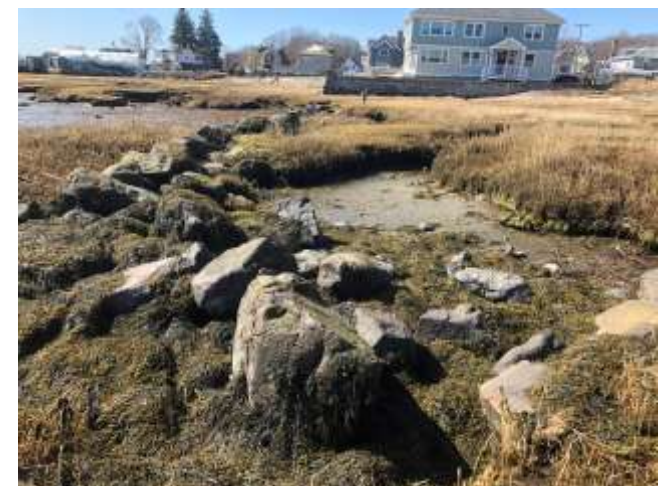
- Partly desiccated with “pockmark” voids throughout
- Erosion and undermining along seaward edge

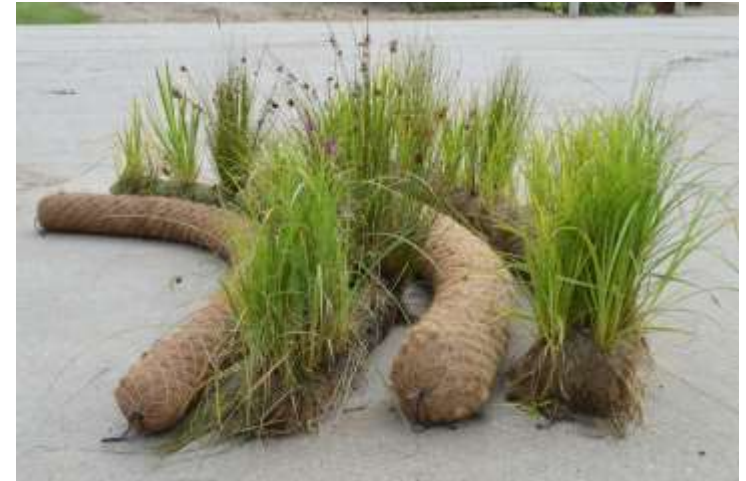
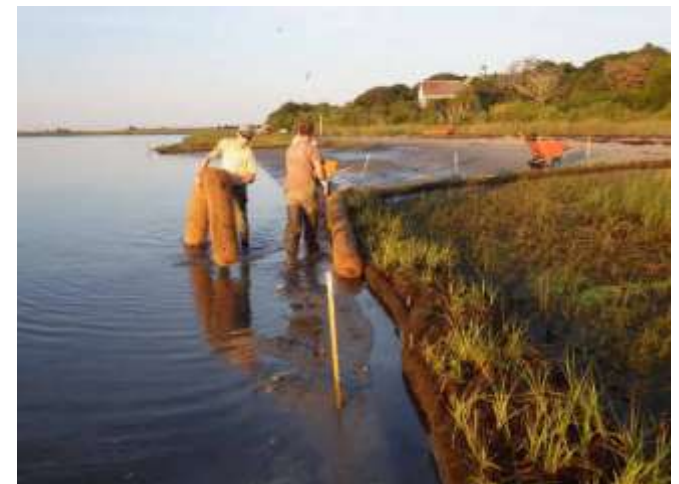
➤ Toe Sill – Coir Roll

- Natural and biodegradable material
- Promotes vegetation growth – plant directly into coir roll
- Absorbs wave energy with minimal reflection
- Easy installation

- Temporary protection (2-5 years)
- Minimal protection against waves and ice impacts
- Additional maintenance (resetting, anchoring, or replacement)

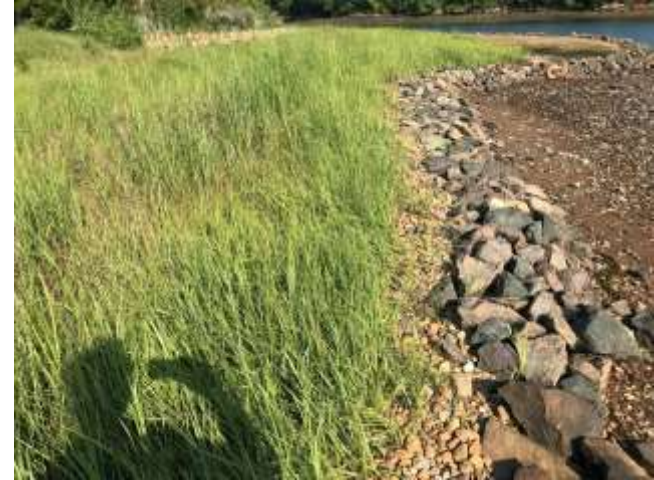
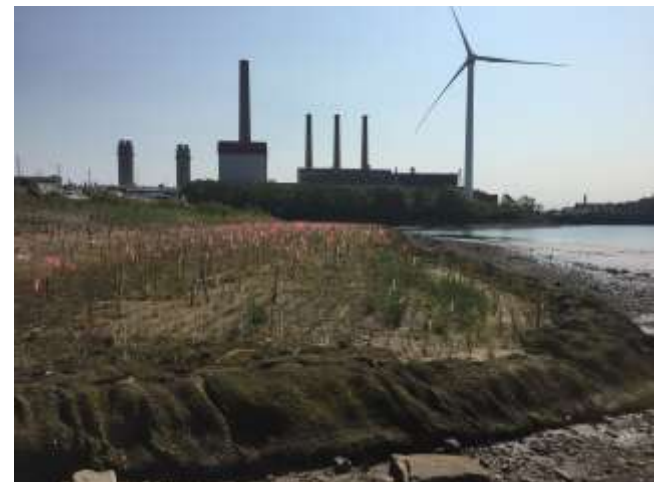
➤ Toe Sill – Stone Sill

- Long-term protection
- Increased protection against waves and ice impacts
- Easy to moderate installation

- Less natural- hard armoring
- Possible wave reflection and scour

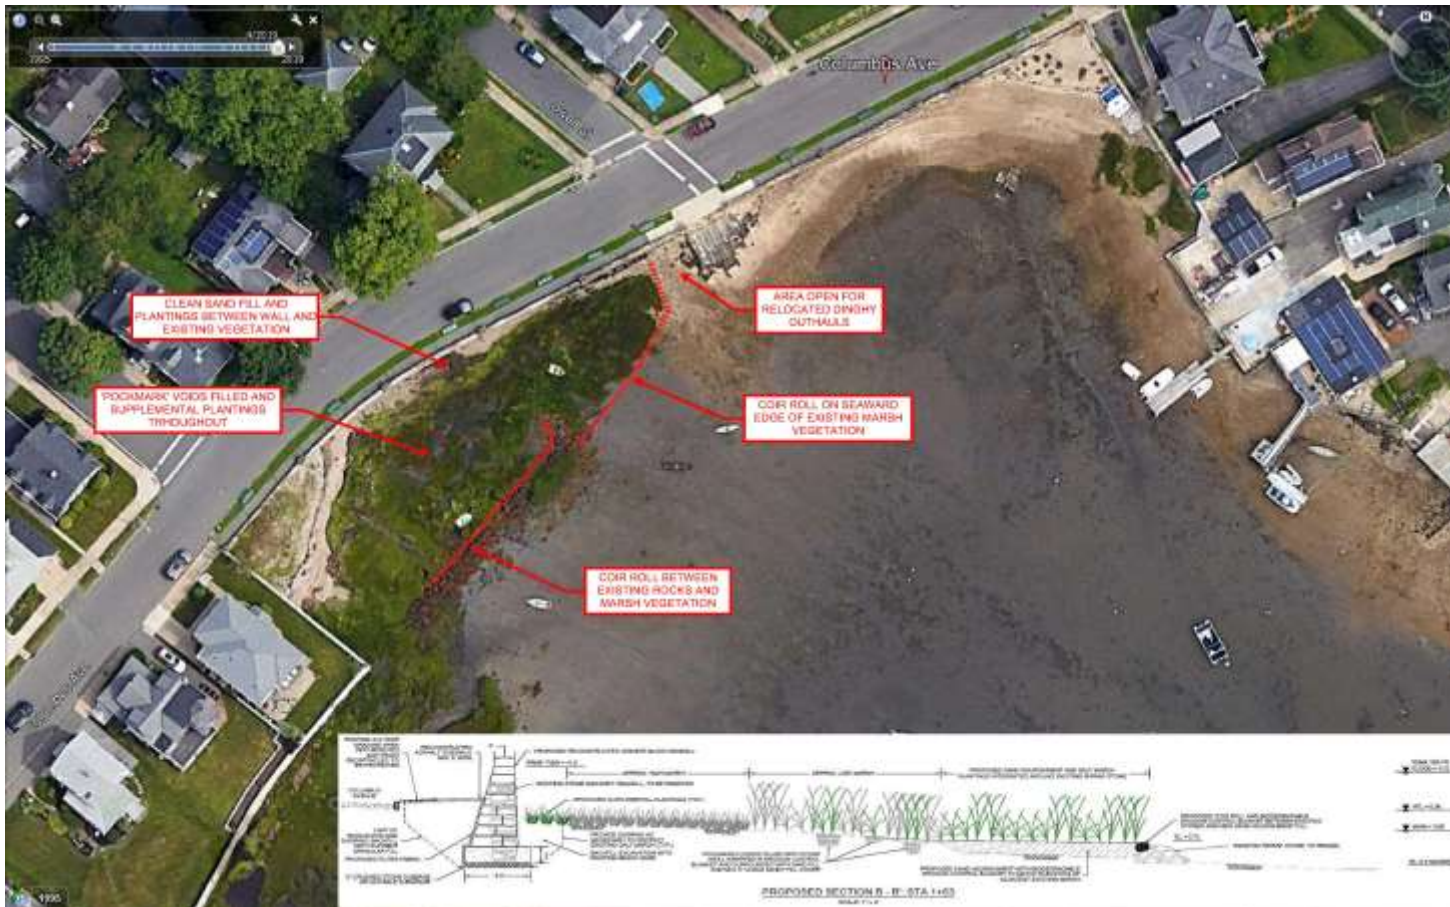
ALTERNATE DESIGN

Living Shoreline Design:

- Improve/Repair Existing
- Minimal Inter-Tidal Impacts

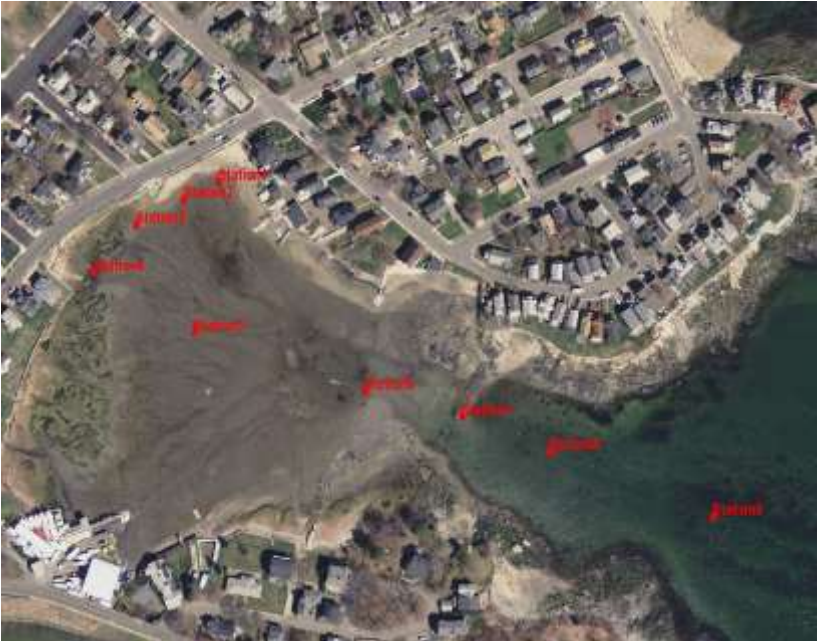
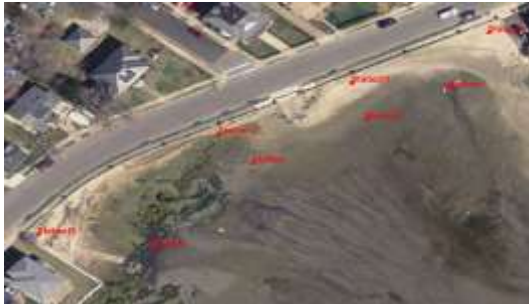
COASTAL MODELING – WAVE HEIGHTS SCENERIO 1

Stations	Scenario 1	Scenario 2
SWAN Model Output ⁴ of Significant Wave Height (ft)	Output Station 1	1.6	1.2
	Output Station 2	2.3	1.8
	Output Station 3	2.7	2.3
	Output Station 4	2.9	3.2
	Output Station 5	3.1	3.2
	Output Station 6	4.4	4.2
	Output Station 7	6.0	5.8
	Output Station 8	7.4	7.1
	Output Station 9	10.0	9.6
	Output Station 10	1.4	1.2
	Output Station 11	2.2	1.7
	Output Station 12	2.6	2.2
	Output Station 13	2.0	1.8

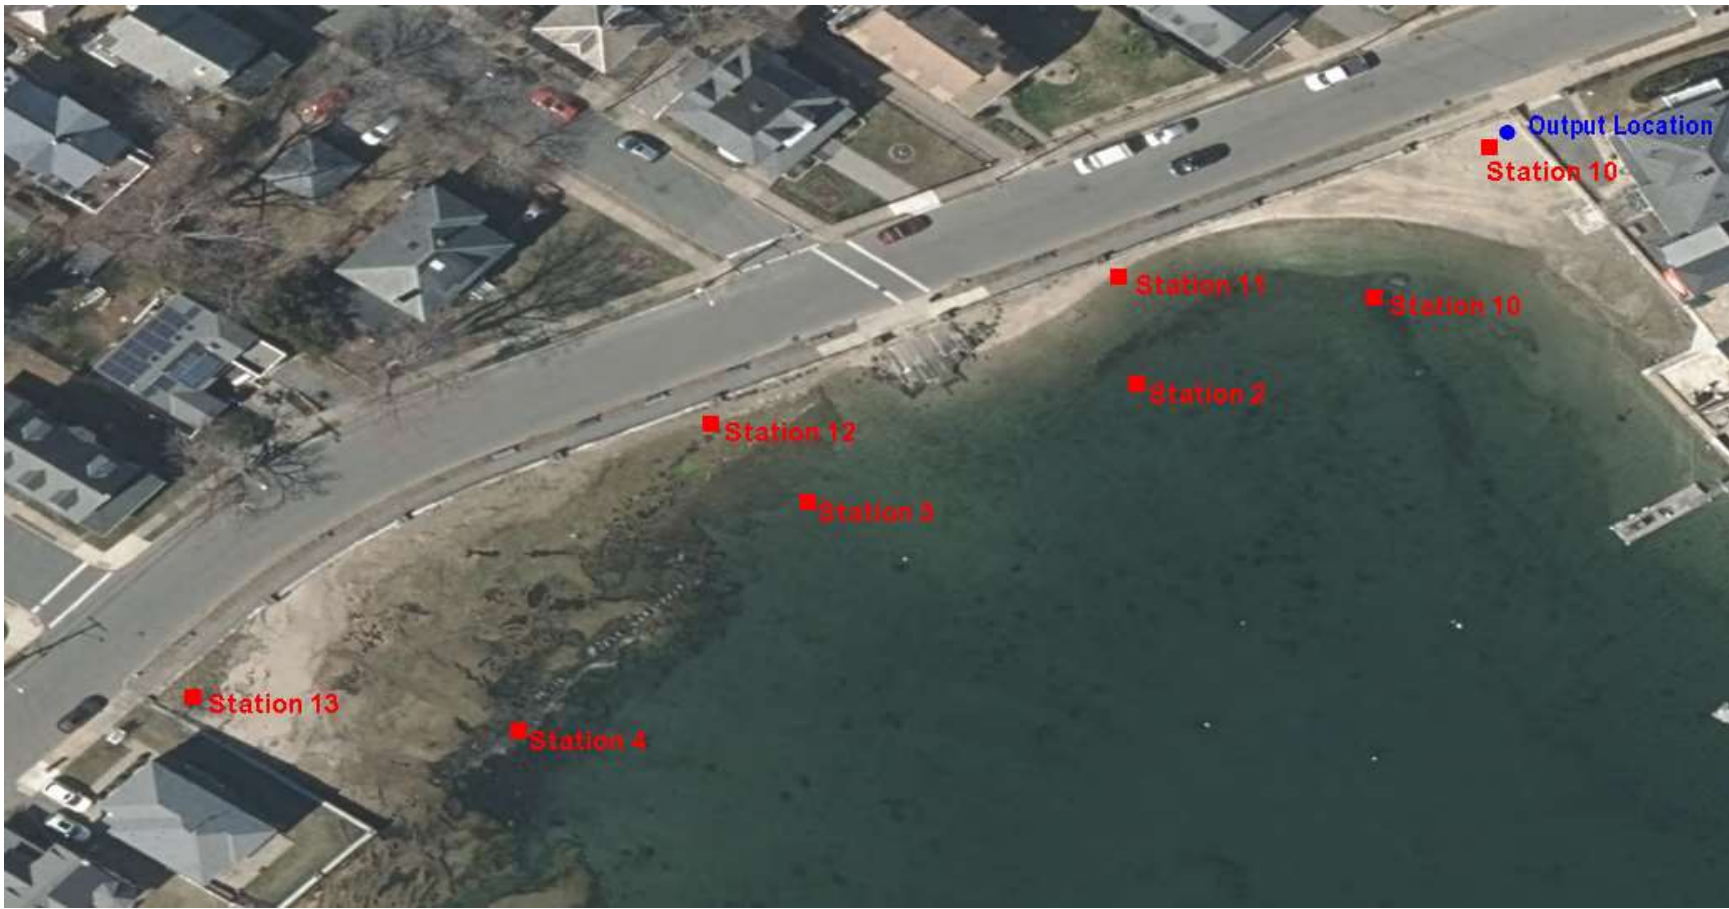
COASTAL MODELING – WAVE HEIGHT/WAVE RUNUP

Output Station ¹	Wall Height (ft, NAVD88)	Bed Condition		Stillwater Condition			Wave Condition				Wave Runup ²		Overtopping Flowrate ²
		Sand Removal	Bed Level ¹ (ft, NAVD88)	Stillwater Elevation (ft, NAVD88)	Water Depth (ft)	Freeboard (ft)	Significant Wave Height ¹ (ft)	Peak Wave Period ² (s)	Wave Crest Elevation ³ (ft, NAVD88)	Wave Breaking?	Wave Runup on Seawall (ft)	Wave Runup Height (ft, NAVD88)	per linear foot (gallon/min)
Northeast Corner	11	No Sand Removal	7	10	3	1	1.4	11.1	11.0	No	2.7	12.7	41
		After Sand Removal	4	10	6	1	1.1	11.1	10.8	No	2.1	12.1	17
	12	No Sand Removal	7	10	3	2	1.4	11.1	11.0	No	2.7	12.7	6
		After Sand Removal	4	10	6	2	1.1	11.1	10.8	No	2.1	12.1	2
Station 11	11	N/A	2.7	10	7.3	1	2.2	11.1	11.5	No	4.2	14.2	157
	12	N/A	2.7	10	7.3	2	2.2	11.1	11.5	No	4.2	14.2	48
Station 12	11	N/A	3.6	10	6.4	1	2.6	11.1	11.8	No	5.0	15.0	243
	12	N/A	3.6	10	6.4	2	2.6	11.1	11.8	No	5.0	15.0	89
Station 13	11	N/A	8.3	10	1.7	1	2.0	11.1	11.4	Yes	3.9	13.9	121
