# City of Salem Municipal Street Tree Assessment Project - Pilot Program

**TASK ORDER No. 2**  
**On-Call Civil Engineering Support Services**  
**City of Salem RFQ R-50**

## August 2016

## City of Salem Municipal Street Tree Assessment Project Pilot Program

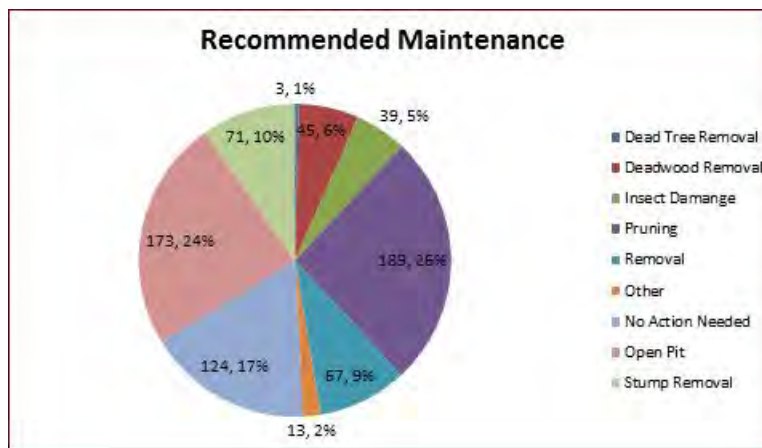
Figure 2

In total, 348 trees were GPS located and assessed as part of the pilot study. The Tree Warden provided some limited information on an additional 376 trees or tree pit locations bringing the total number of trees in the current database to 724 trees or tree pit locations. No action is needed on 124 or 36% of the locations. The majority of maintenance needed is either deadwood removal or pruning of 245 trees. Open tree pits or stumps comprise 244 of the recommended maintenance. See Figures 2 and 3 for a breakdown of maintenance needs. See Attachment A for maps of each entrance corridor tree coded by maintenance need.

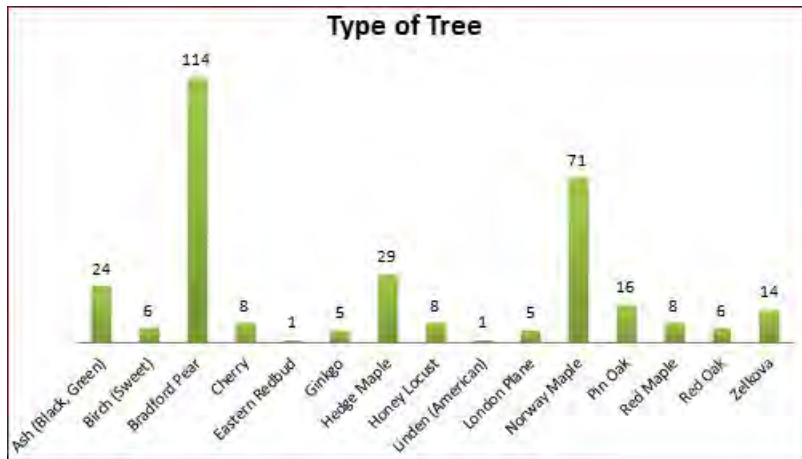
Figure 6

The majority of the trees surveyed are Bradford pear, Norway maple and Ash. The lifespan of the Bradford pear is 20-30 years. The branches tend to break easily in winter storms and often are caught in power lines. The Norway maple is now listed as an invasive species. The emerald ash borer and Asian longhorned beetle have already been observed in nearby communities. These invasive insects target many types of trees but have been reported to affect the Norway maple and Ash more often than other tree species. Refer to Figure 4, 5, and 6 for tables depicting the types of trees observed as well as diameters and heights. A tree identification key was created depicting the trees observed during the survey and can be found in Attachment D. The free app “Leaf Snap” was also utilized to help identify trees. This reference guide and application can also be utilized

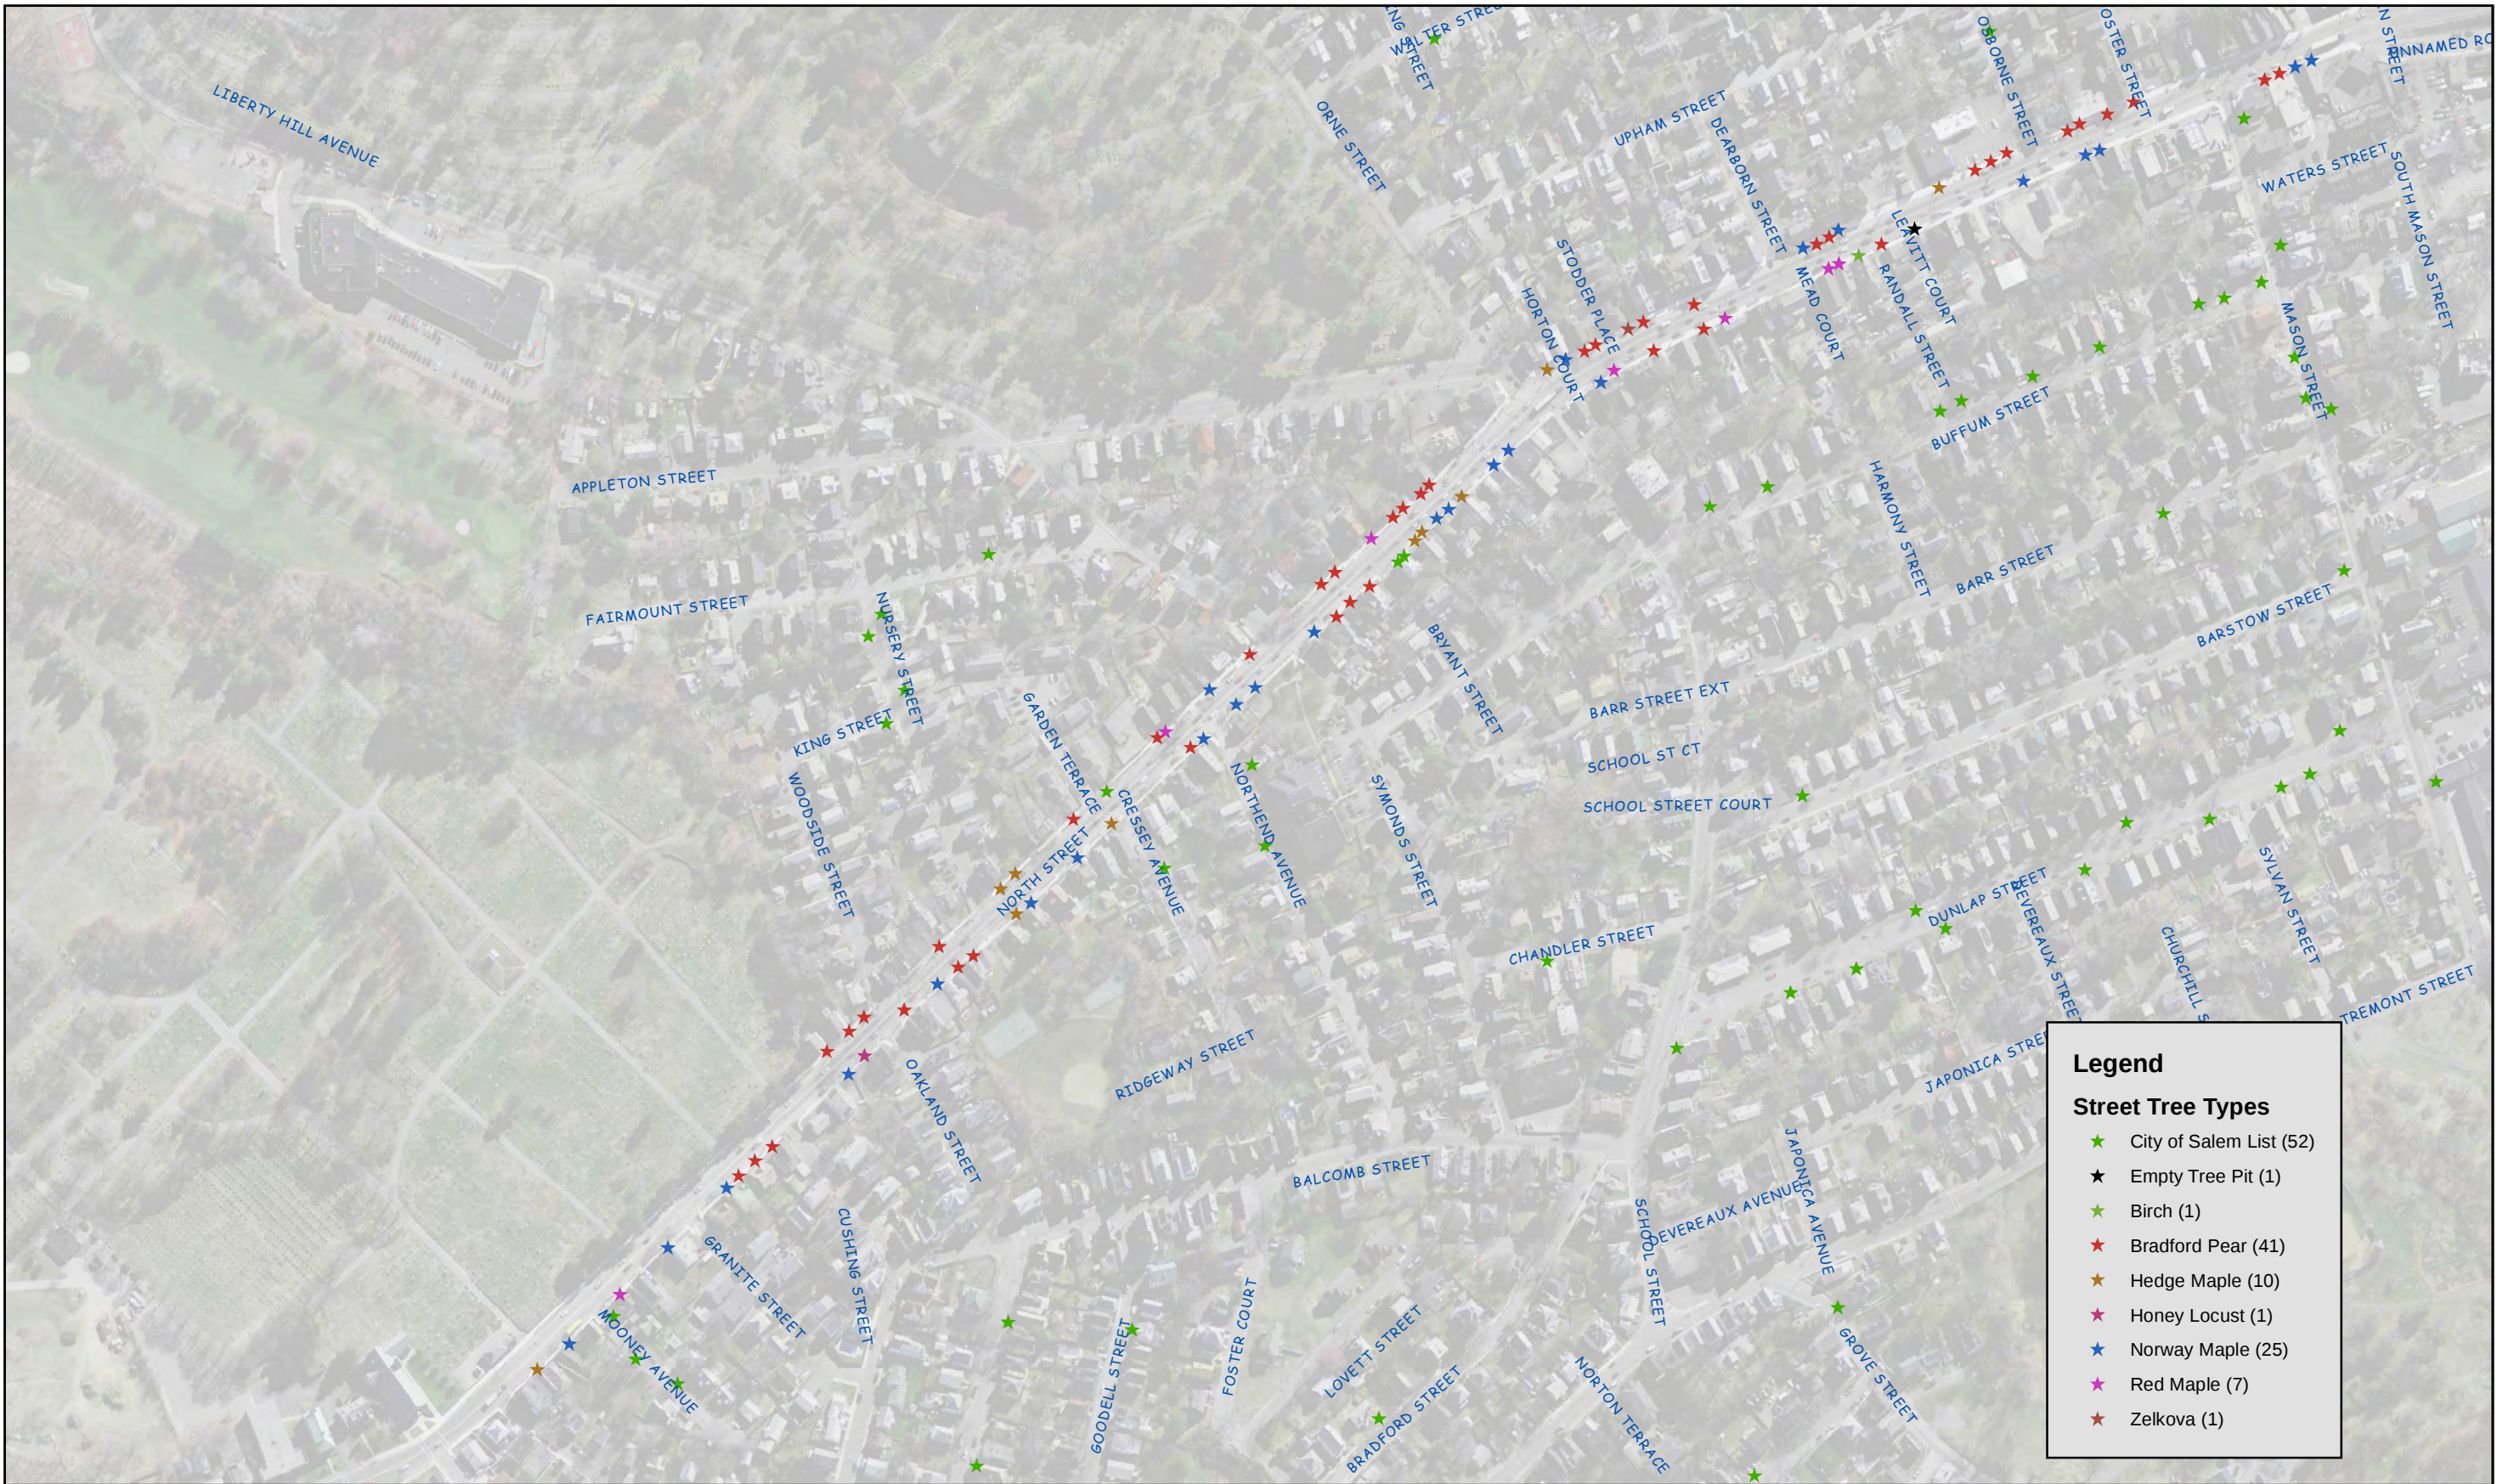
# Corridor Street Tree Mapping Pilot - North Street Salem, MA

- Open Tree Pit (61)
- Stump Removal (16)
- ★ Removal (20)
- ★ Pruning (33)
- ★ Deadwood Removal (7)
- ★ Insect Damage (3)
- ★ No Action Needed (2)

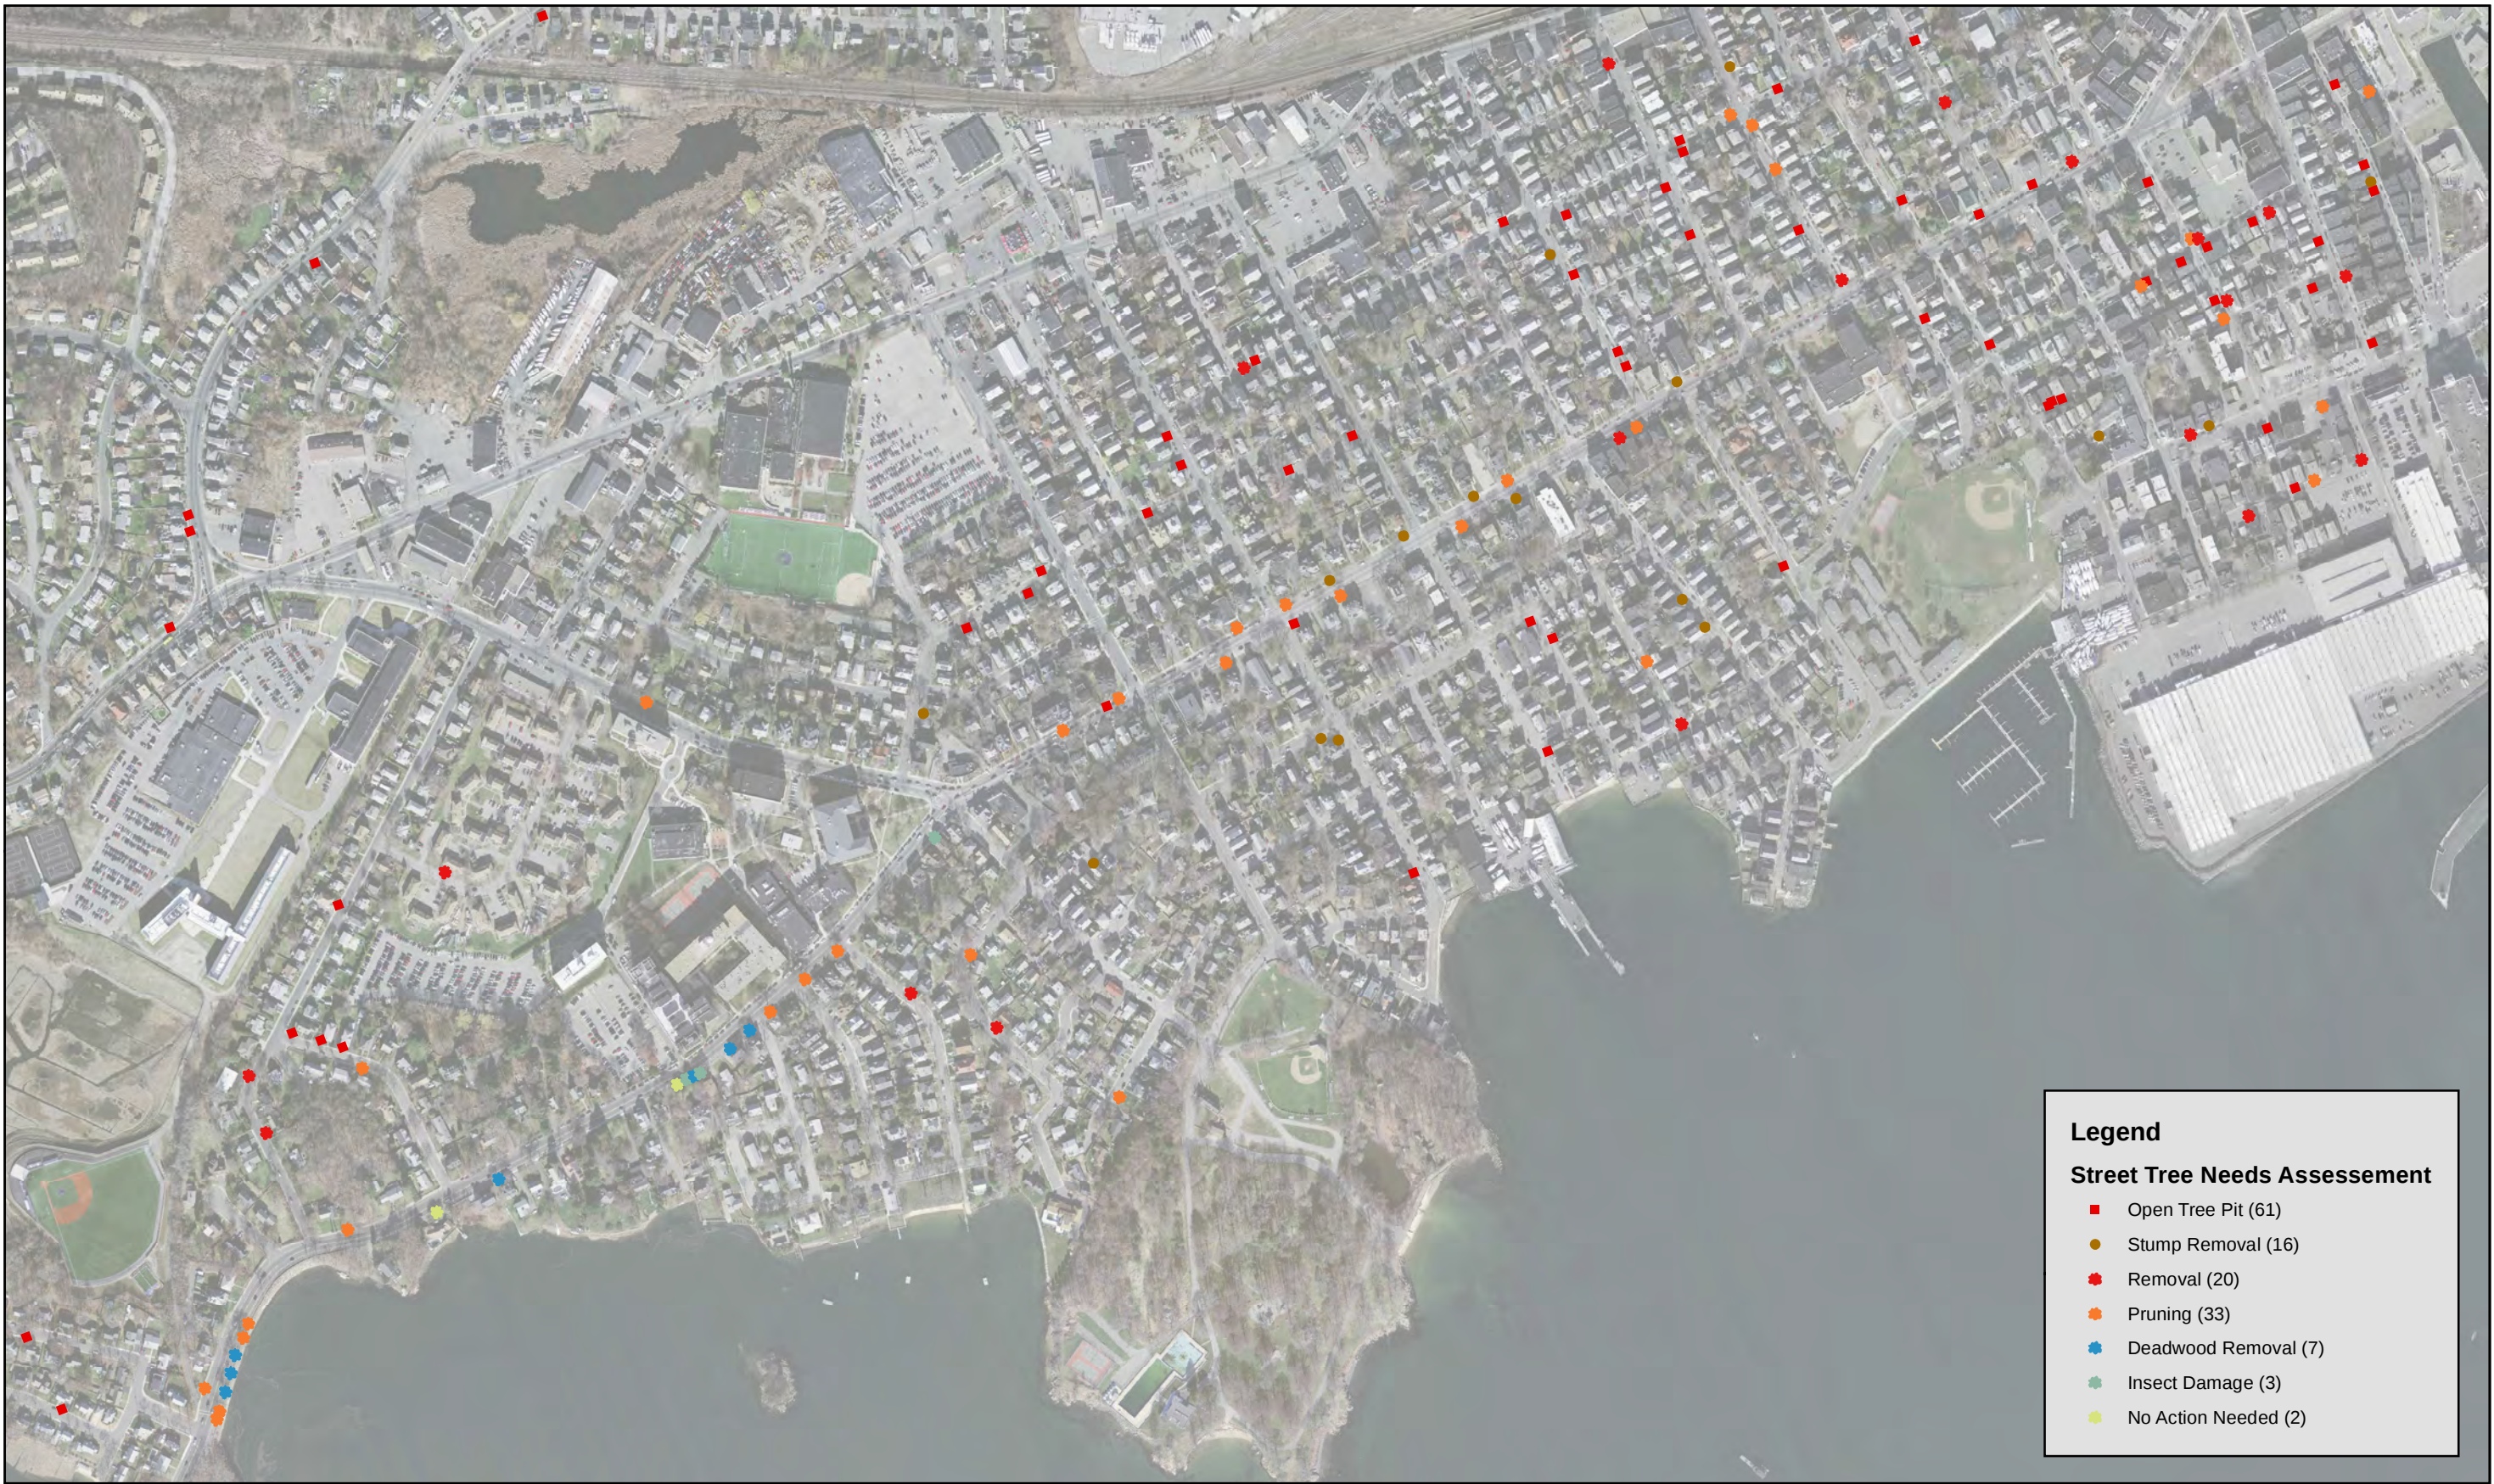
## Corridor Street Tree Mapping Pilot - Lafayette Street Salem, MA

**Street Tree Needs Assessment**

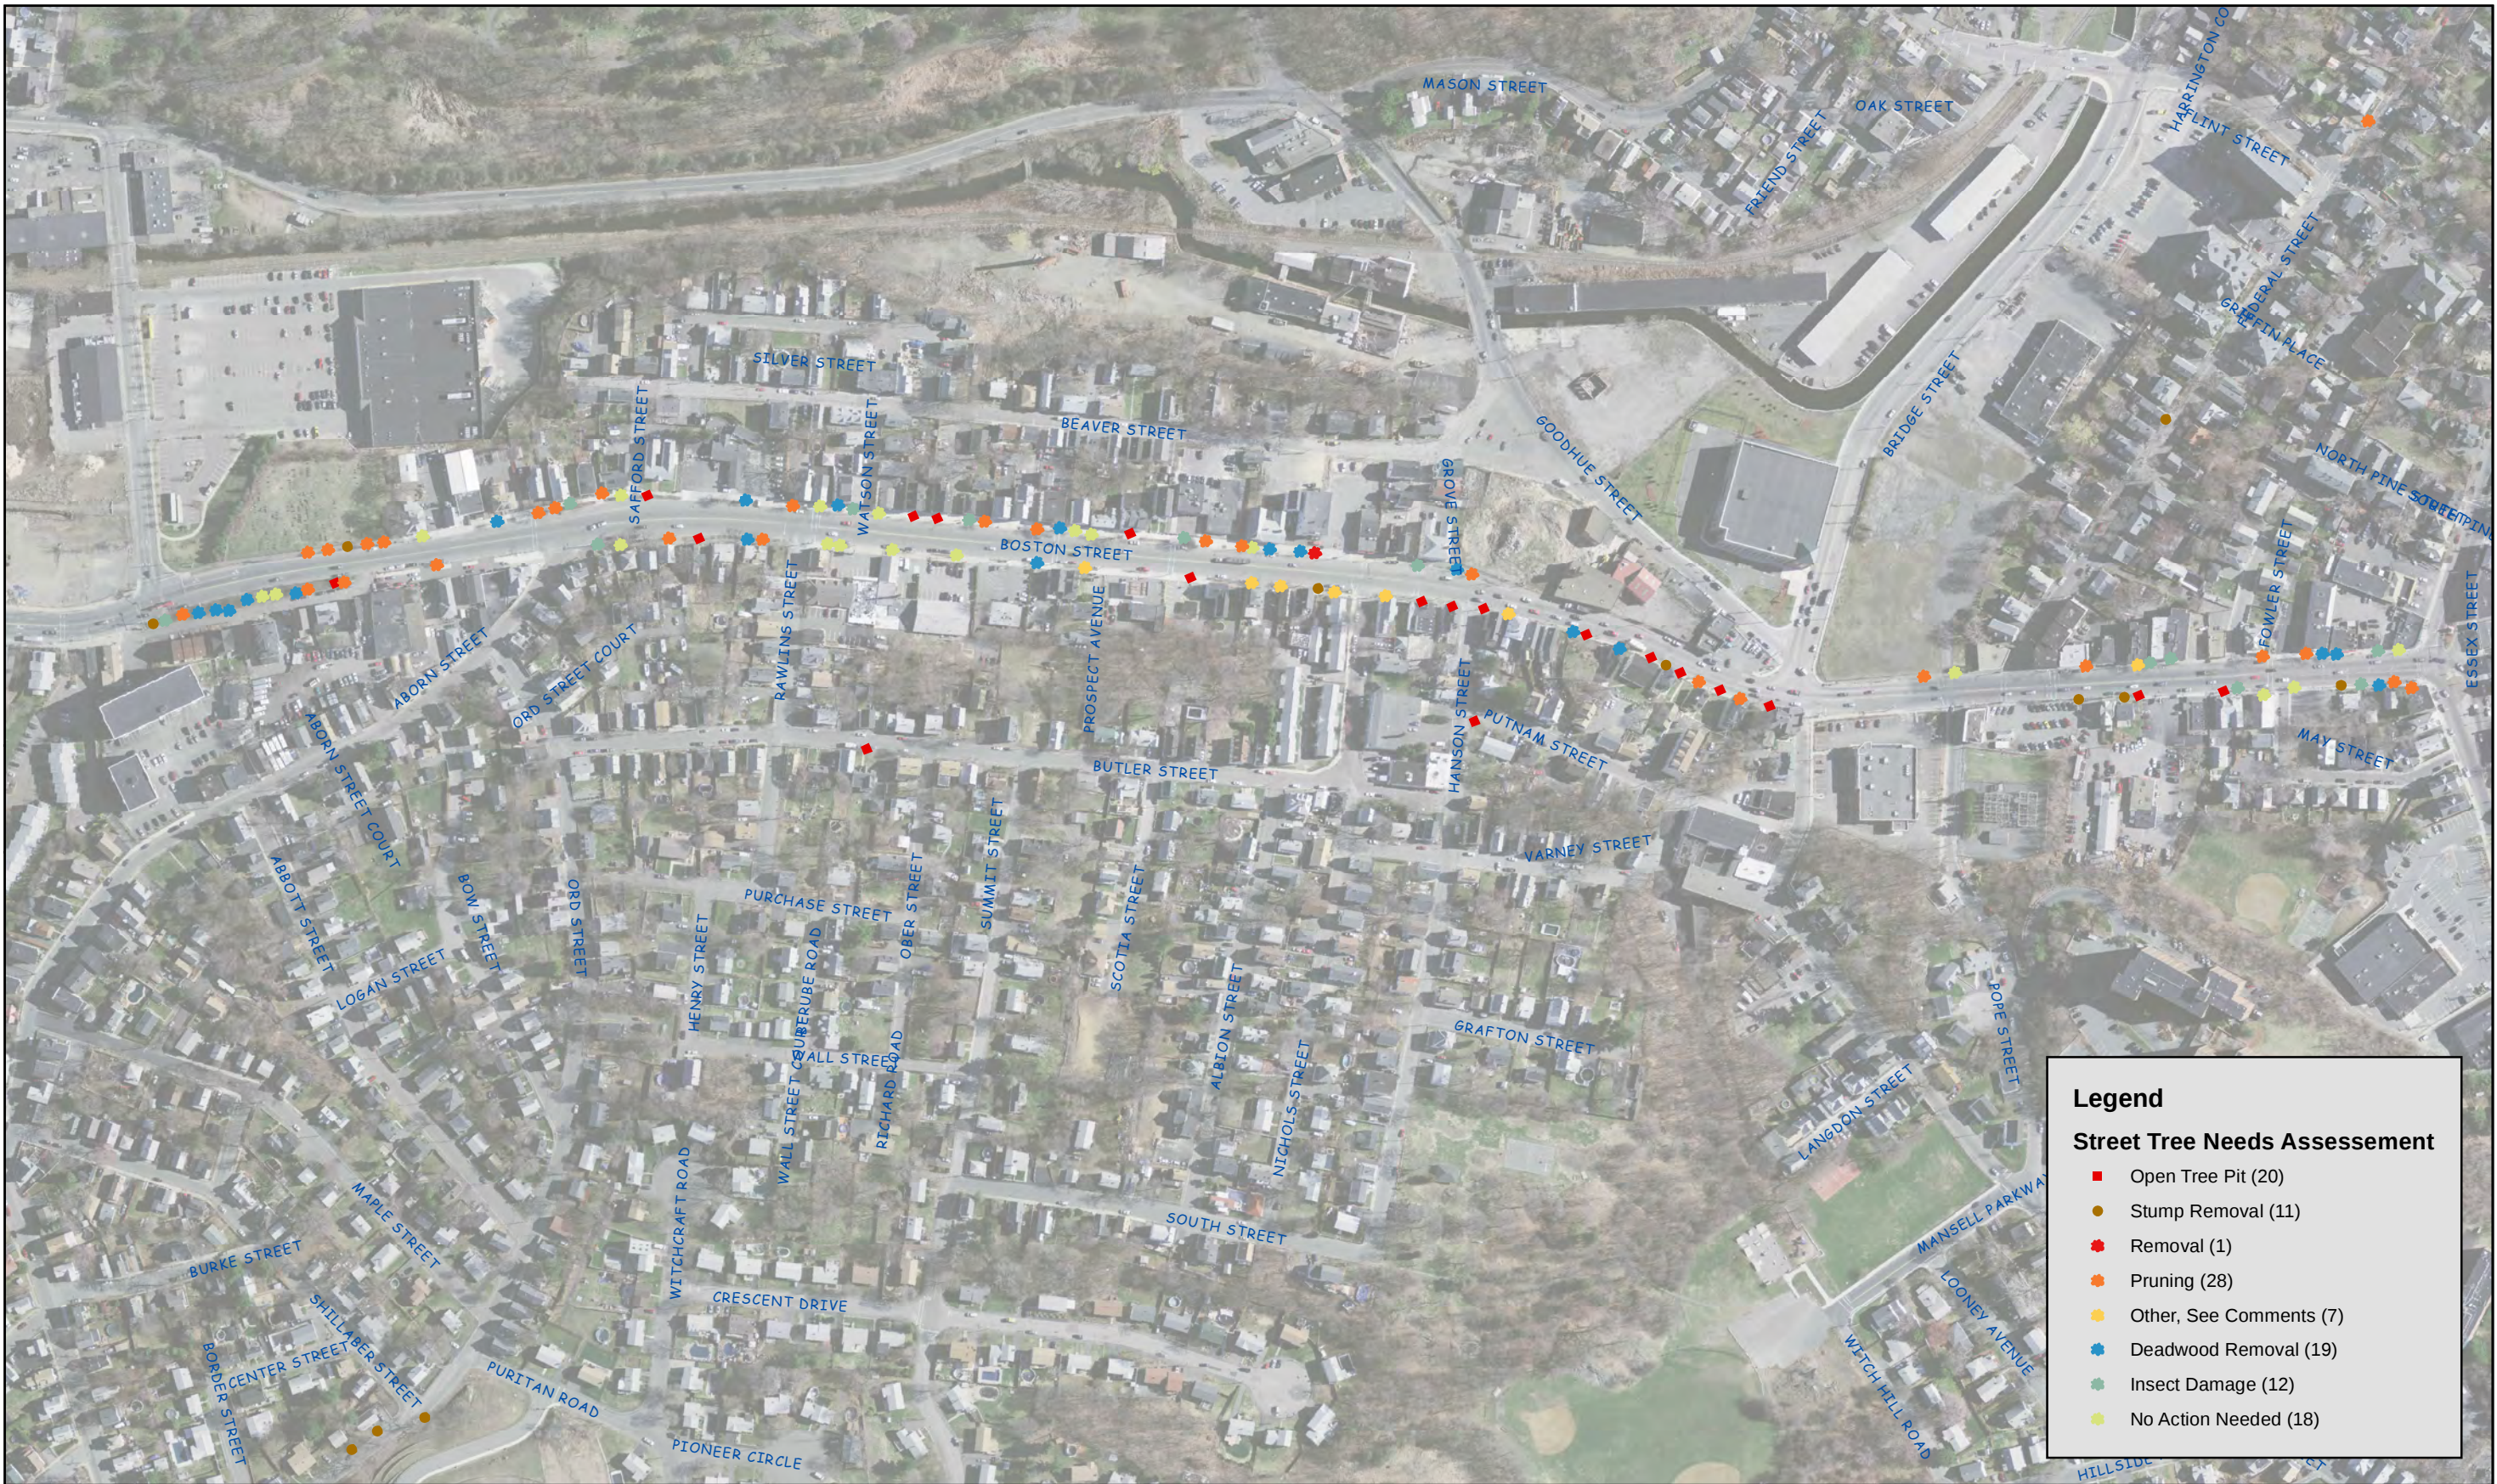
**Corridor Street Tree Mapping Pilot - Boston Street**  
**Salem, MA**  
**Thursday, August 25, 2016**

**Street Tree Needs Assessement**

- Open Tree Pit (20)
- Stump Removal (11)
- Removal (1)
- Pruning (28)
- Other, See Comments (7)
- Deadwood Removal (19)
- Insect Damage (12)
- No Action Needed (18)
