Phase I Report for the South River Drainage Project

218953.00
City of Salem, MA
April 9, 2007

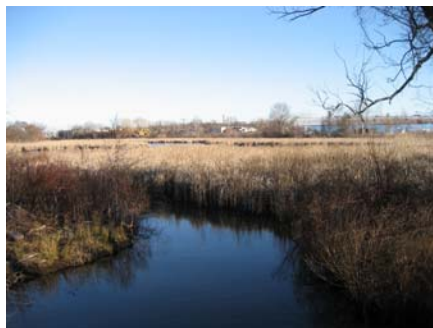
Flow from Rosies Pond is controlled by two drainage features, a low lying berm at the northeasterly end of the pond and the Rosies Pond Bypass. Stormwater is impounded in Rosies Pond by a low lying berm, reportedly constructed as an access drive for construction of a sewer pipeline, located immediately

upstream and to the south of the Boston and Maine Railroad. Flows, under low-flow conditions, are controlled by four 12-inch diameter culverts under the berm. Field observations made in this area indicate the berm and culverts are showing signs of settlement and erosion as well as sediment accumulation. During high-flow conditions, stormwater flows over the berm continue north downstream into the Jefferson Avenue neighborhood. Also during periods of high-flow a portion of the stormwater exiting Rosies Pond is conveyed through the Rosies Pond Bypass to the Forest River. Flow diverted to the Forest River through the bypass no longer contributes to flooding in the downstream reaches of the South River. The South River is conveyed from Rosies Pond under the Boston and Maine Railroad through a 12-foot arched culvert into the Jefferson Avenue area.

- Evaluate, and repair or remove, which ever is appropriate, the earthen berm and culvert outlet to Rosies Pond.
 - Raise the elevation of affected areas.

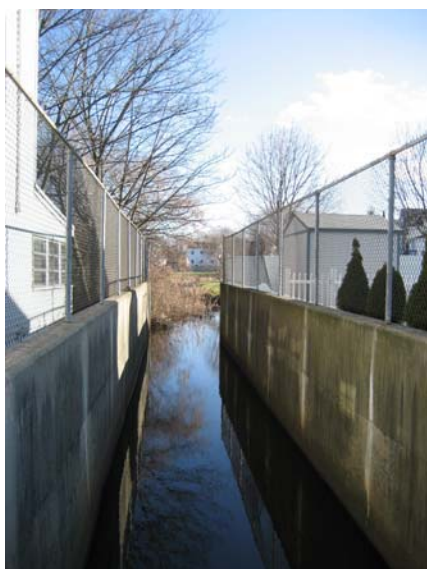
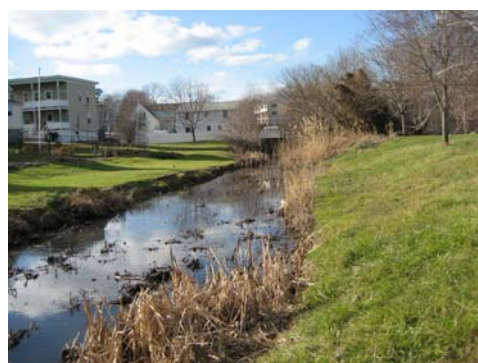
- Construction of a local flood protection works in the Jefferson Avenue neighborhood. A flood control levee and floodwall was constructed in the mid 1970's between the low lying residential areas of Brooks Street and Jefferson Avenue and the South River. This work also included increasing the hydraulic capacity of the Jefferson Avenue culvert. A stormwater pump station was constructed at the end of Ocean Avenue West to collect and pump stormwater from the areas behind the levee. Although these improvements were constructed, it is unclear from the available data if the levee and floodwalls were constructed to elevation 15 as designed.

The frequency and severity of flooding resulting from these storms indicate the existing flood protection works installed in the 1970s are not functioning as intended. The flood control levee protecting the Jefferson Avenue neighborhood has failed numerous times over the last eleven years. The failure is the result of the South River overtopping the earthen levee and eroding the berm. When the levee fails floodwaters inundate the Jefferson Avenue neighborhood since the Ocean Avenue West Pump Station does not have the capacity to remove the floodwaters resulting from the breach. The pump station appears to have sufficient capacity to remove runoff generated from catchments intended to serve. Based on these observations, it is unclear if the protection afforded by the levee has decreased as a result of additional development within the headwaters of the watershed or if the top elevation of the levee is at the elevation originally specified.

Temporary repairs to the Brooks Street levee should be conducted to restore the levee to pre-storm elevations. It is our understanding that this work was been permitted with the Salem Conservation Commission however the decision has been appealed to the MADEP. These repairs should be implemented following resolution of the appeal.

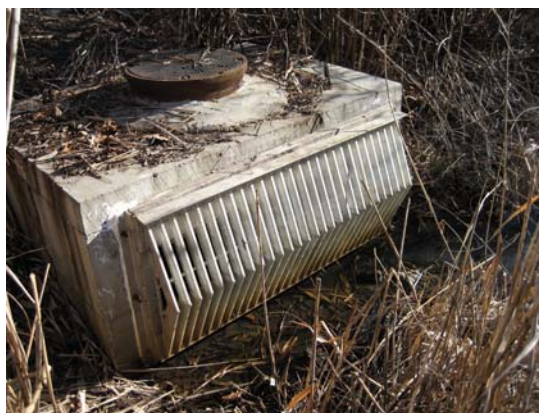
- The Rosies Pond Bypass was constructed in June, 2001. The purpose of the bypass was to divert flows from Rosies Pond to the Forest River watershed. A flow diversion structure was constructed adjacent to the abandoned railroad bed along the eastern shore of Rosies Pond. The structure consists of a concrete box structure with adjustable weir and trash rack to prevent debris from clogging the diversion pipe. The diversion pipe runs approximately 3,000 feet south along the abandoned railroad bed to the Forest River tidal estuary. Tide gates were specified at the end of the diversion pipe to prevent high tides in the Forest River estuary from backing up through the diversion pipe and entering Rosies Pond.

- An as-built survey to confirm the bypass was built as intended and identify deficiencies, if any.
- A hydraulic evaluation to determine if the inlet configuration can be modified to improve performance. Improvements for consideration should be; lower the inlet elevation; increasing the size of the inlet, and changing the inlet configuration to be less prone to clogging.
